Construction and Stormwater Inspection

November 19, 2019

Operator: NICKEL ROAD OPERATING LLC #10669

Inspection Photos
Location Name: ELDER /PAD
Location ID: 465636

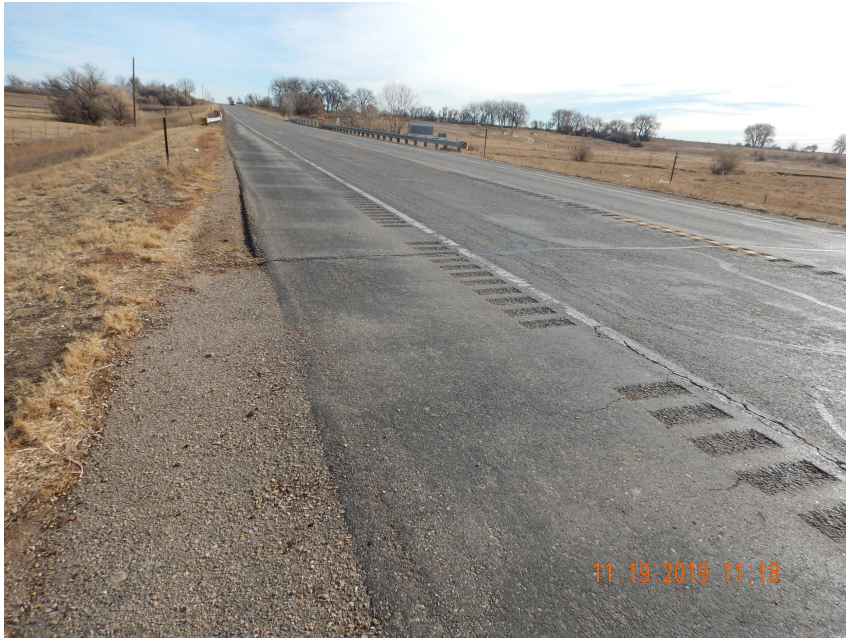
Photo 1. Photo taken from the entrance of the location off HWY 14, facing East. Photo illustrates no vehicle track out issues. Operator has not yet installed the planned vehicle tracking device BMPs.

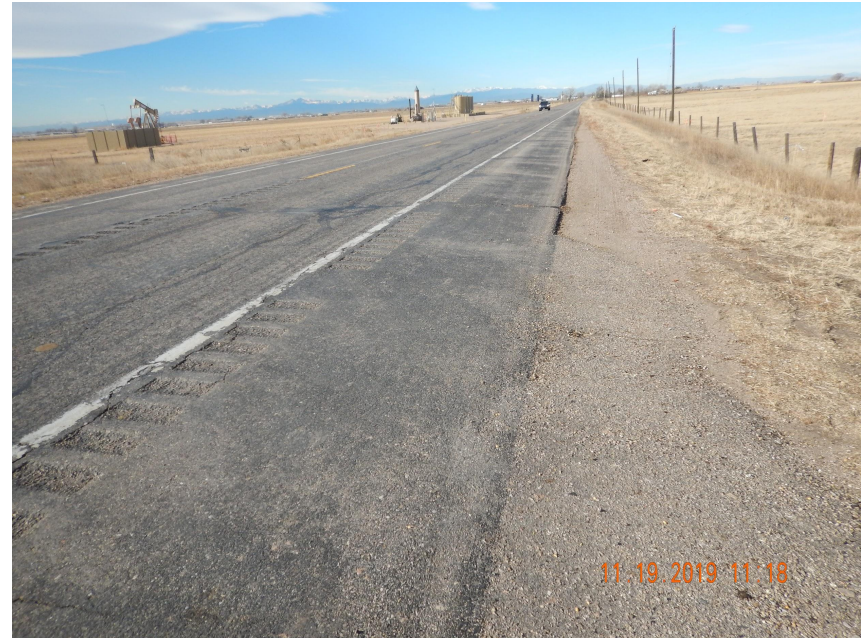
Photo 2. Photo taken from the entrance of the location off HWY 14, facing West. See comments under Photo 1.

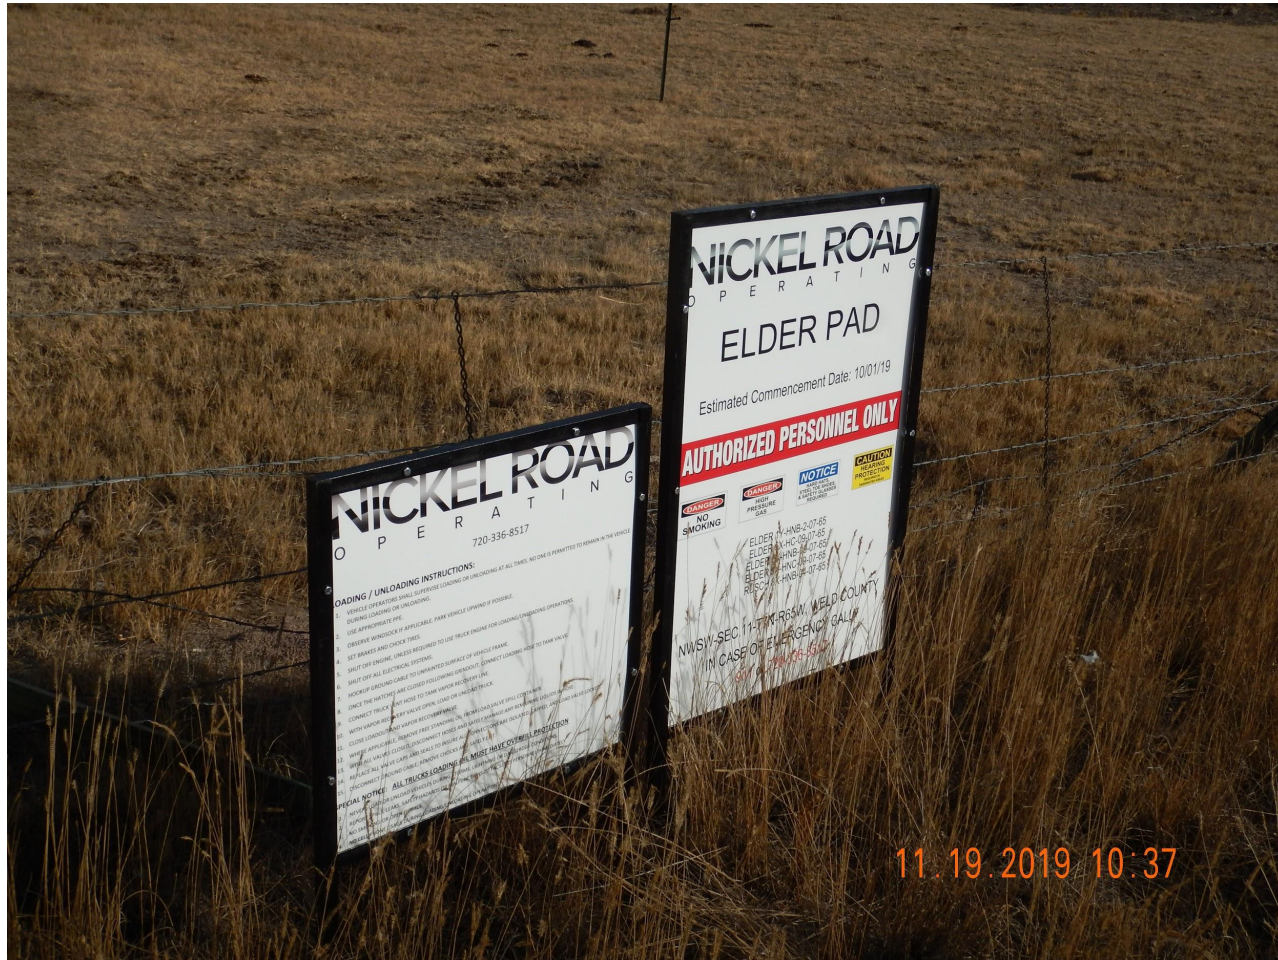
Photo 3. Photo taken from the entrance of the location. Photo illustrates Operator signage.

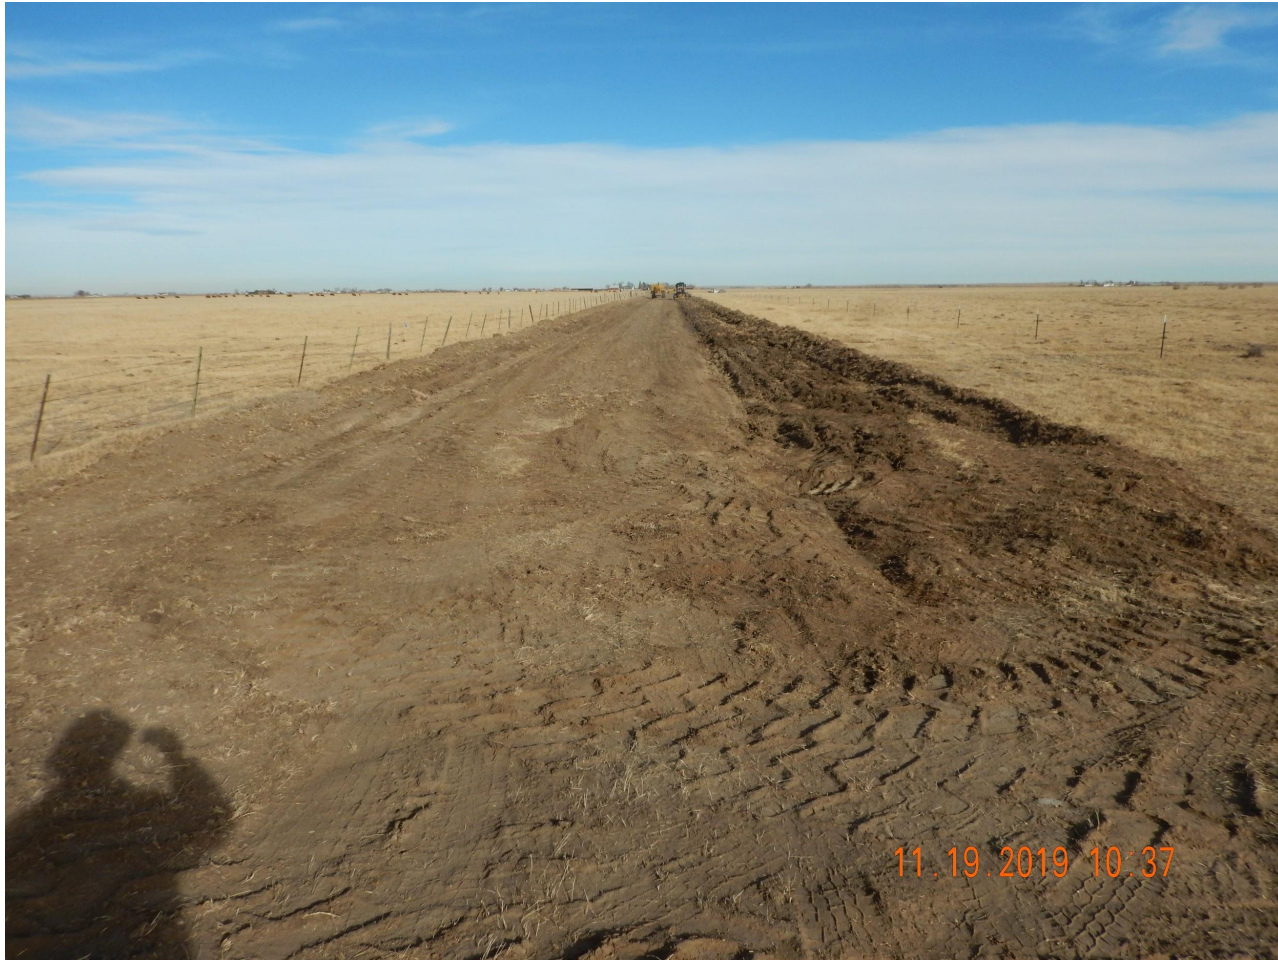
Photo 4. Photo taken from the entrance of the location, facing North. Photo illustrates Operator in process of constructing the access road. A ditch BMP and surface roughening BMP were implemented on either side of the access road during construction operations.
