## Inspection Photos

Location Name: BURRO FEDERAL 11-18 FOLLOW UP

API#: 05-071-06236

INSP. #: 695101798

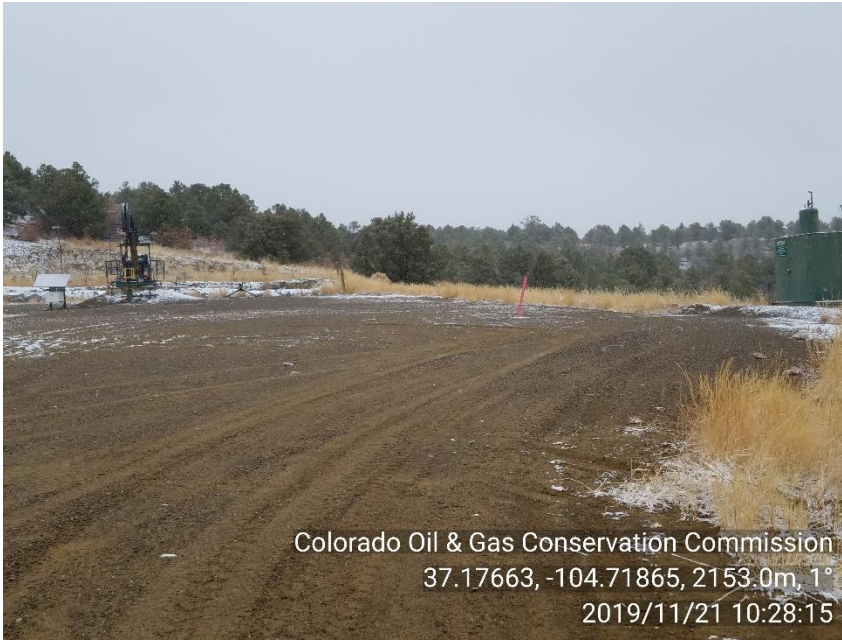
PHOTO 1: LOCATION

Colorado Oil & Gas Conservation Commission  
37.17663, -104.71865, 2153.0m, 1°  
2019/11/21 10:28:15

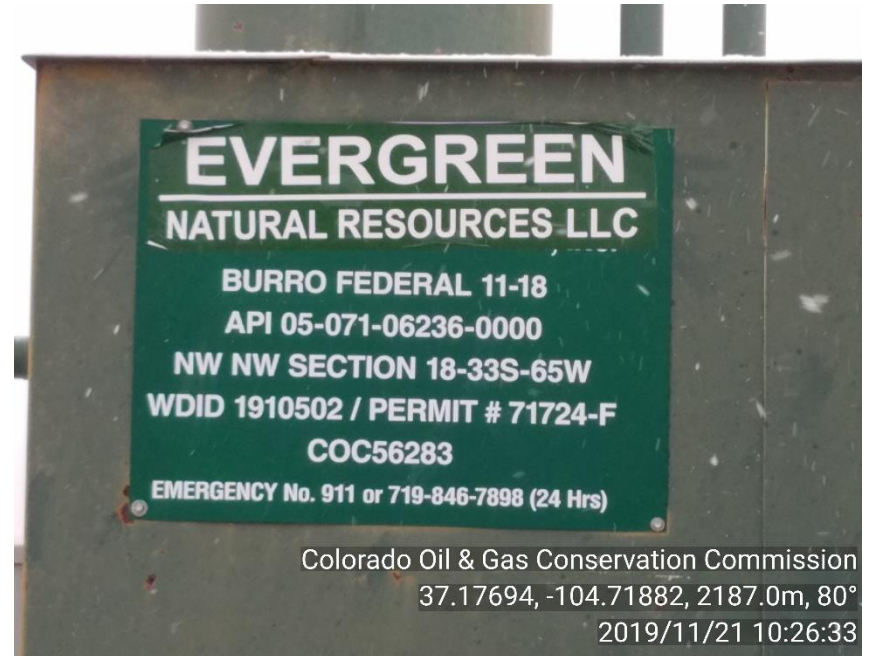
PHOTO 2: WELL SIGN

Colorado Oil & Gas Conservation Commission  
37.17694, -104.71882, 2187.0m, 80°  
2019/11/21 10:26:33

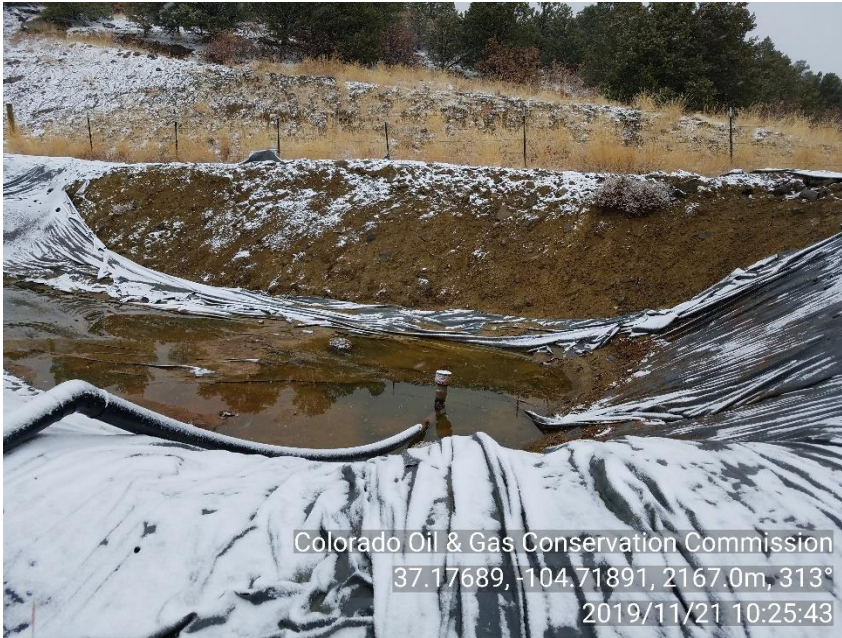
PHOTO 3: Multiple holes in pit liner on pit wall and on top edge of liner. Water level is well below holes in liner and well is not Producing water at the time of inspection. **Lack of pit liner or pit liner compromised (Rule 904). CA DATE 12-21-19. THIS IS THE 2<sup>ND</sup> NOTICE FOR PIT LINER IF CA IS NOT ADDRESS PRIOR TO NEXT INSPECTION ENFORCMENT WILL BE CONSIDERED.**
