Nicholson GeoSolutions LLC
3433 East Lake Drive

November 25, 2019

Subject: Givan No. 1 Additional Reclamation

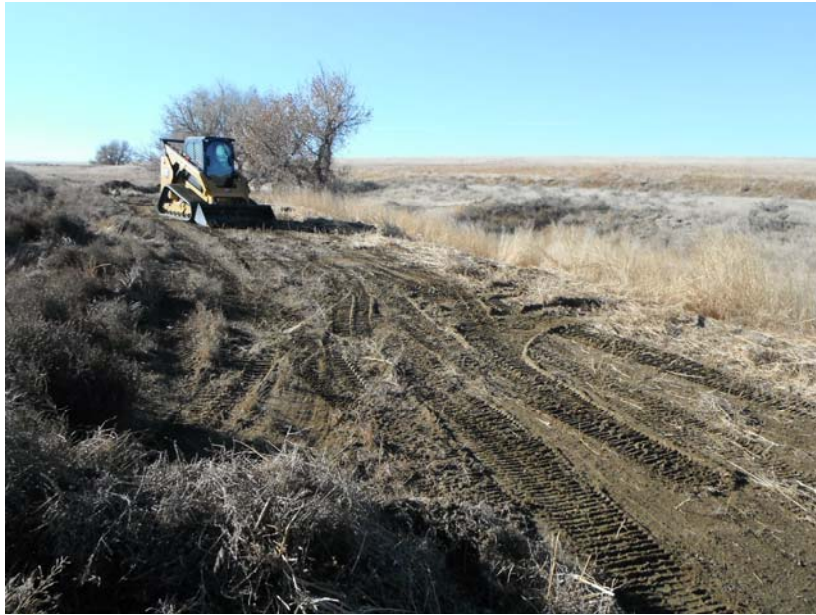
Removal of weeds

The erosion control structures along the edge of the drainage were repaired by Jayhawk with oversight from Nicholson GeoSolutions on November 18th, 2019. The old silt fence was also removed at this time. Weeds on the lease site and wellhead area were mowed to prepare the site for reseeding.

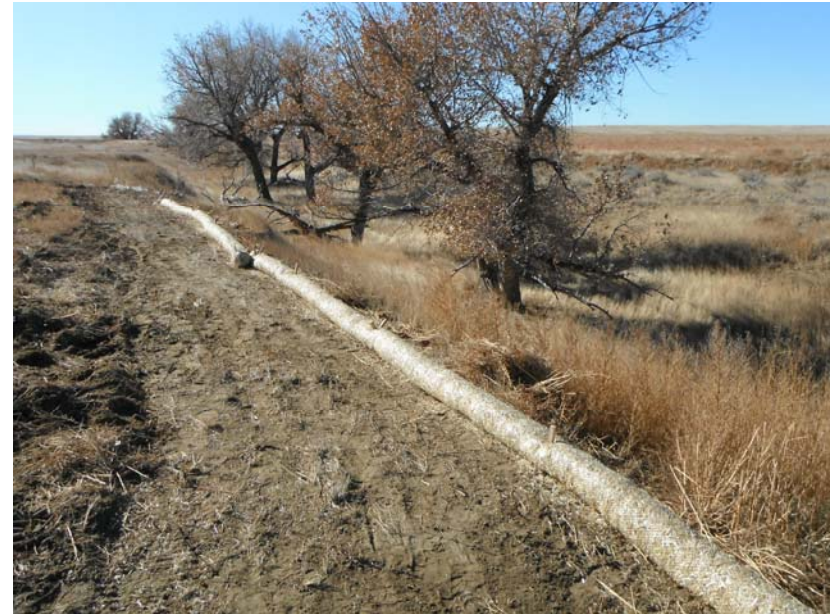
Repaired erosion control structures along drainage

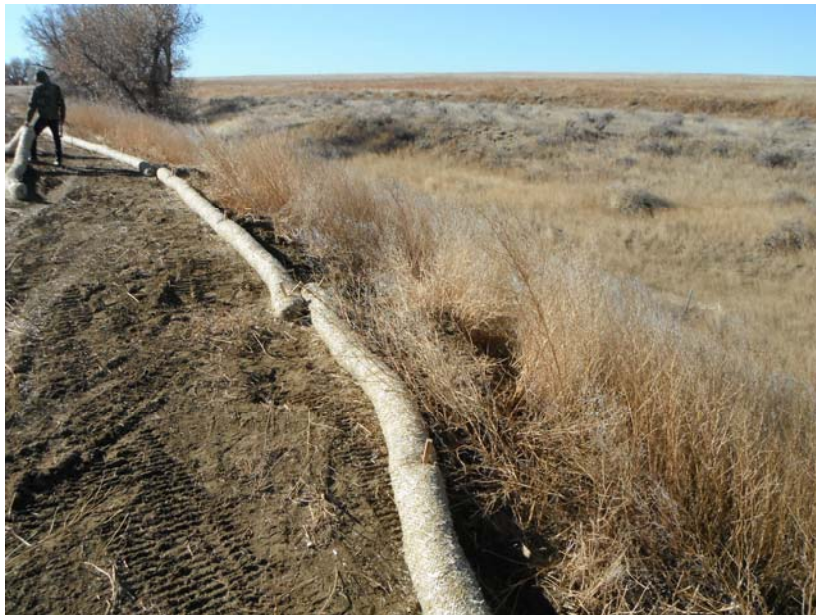
Installing new wattles

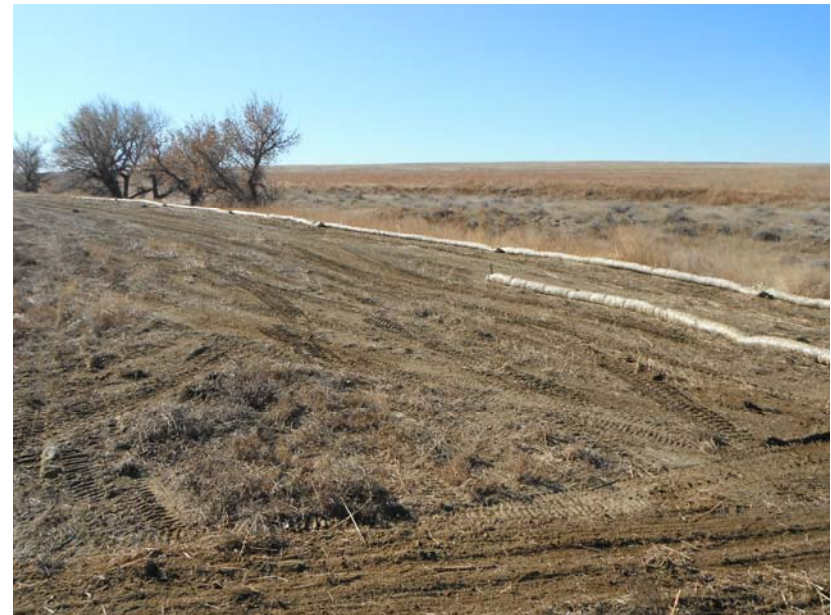
Repaired erosion control structures along drainage

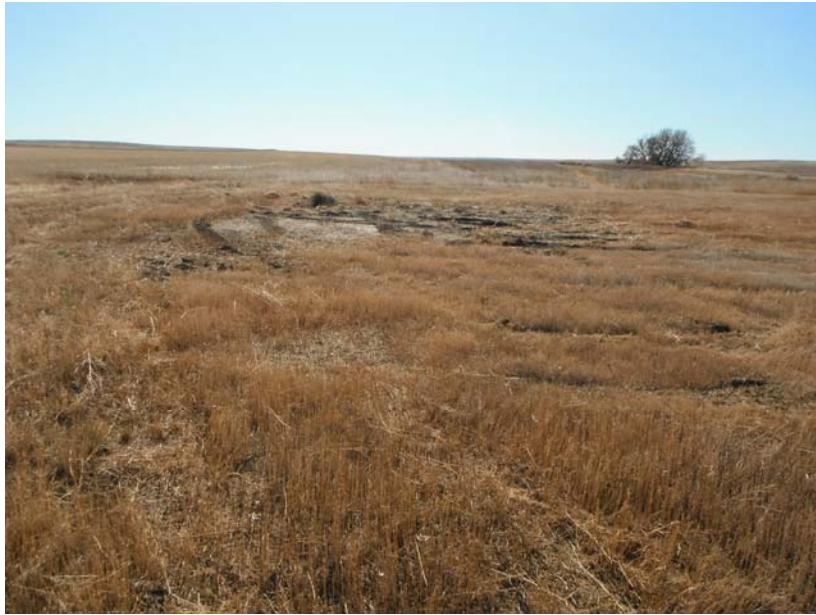
Former well pad area after mowing

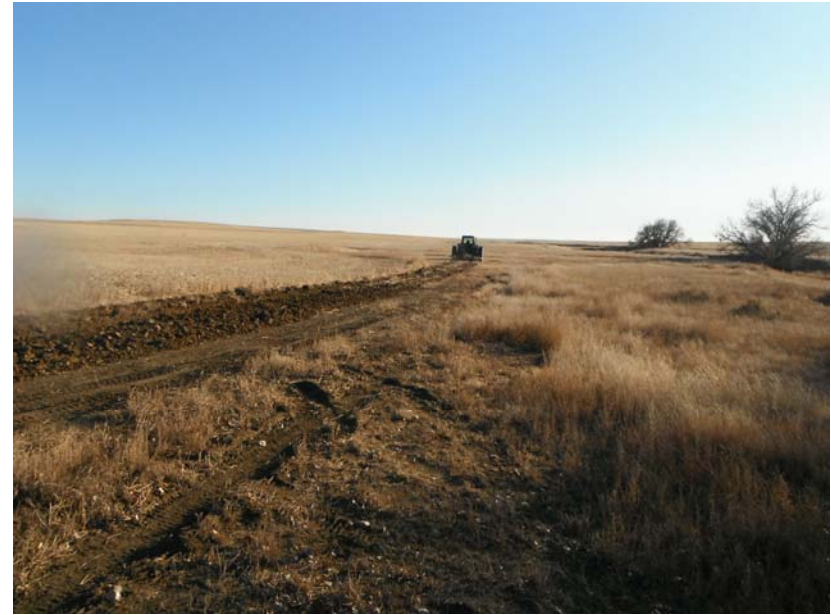
Deep ripping of access road to well pad

Additional reclamation was performed by RMR on November 23rd, 2019. Portions of the lease area that were not backfilled after removal of impacted soil in 2018, including the former storage tank area, the access road to the former well pad, and the wellpad area, were deep cross-ripped using a large 24" ripper capable of ripping to depths of greater than 18". The site was then reseeded using a dry prairie seed mix. Seed was placed using a seed drill towed by a tractor. Table 1 provides the seed mix details. After reseeding, hay mulch was spread on the site at the rate of 2.0 tons per acre and crimped into the ground using a disc attachment towed by a tractor.

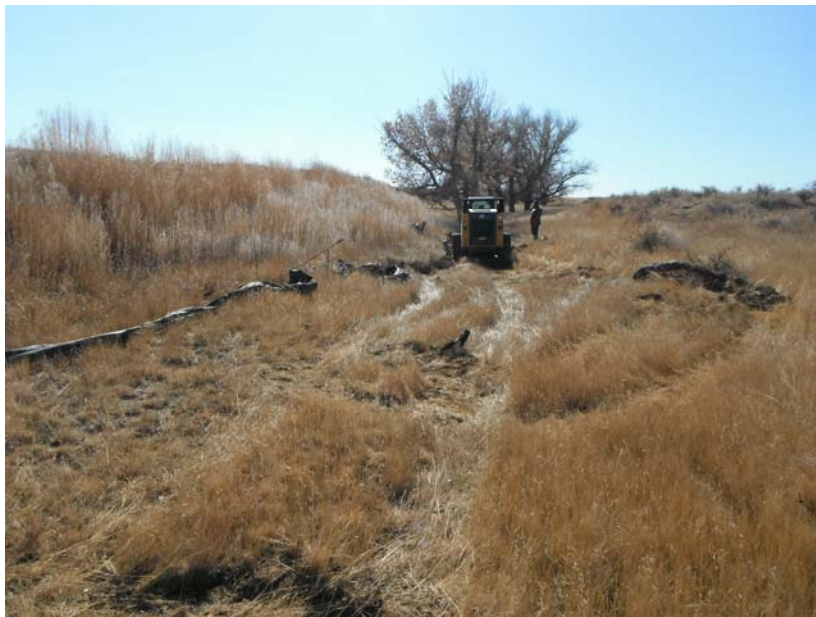
Removal of old silt fence

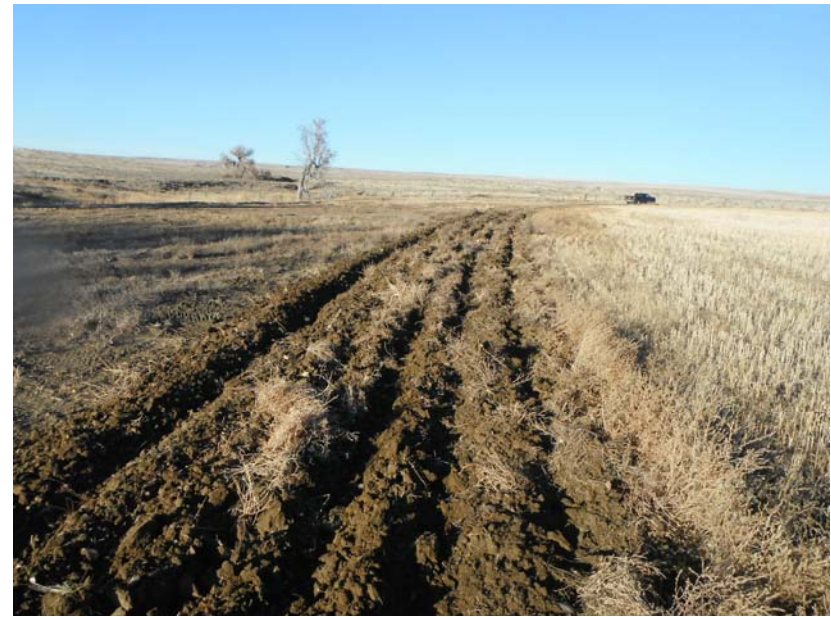
Deep ripping of access road

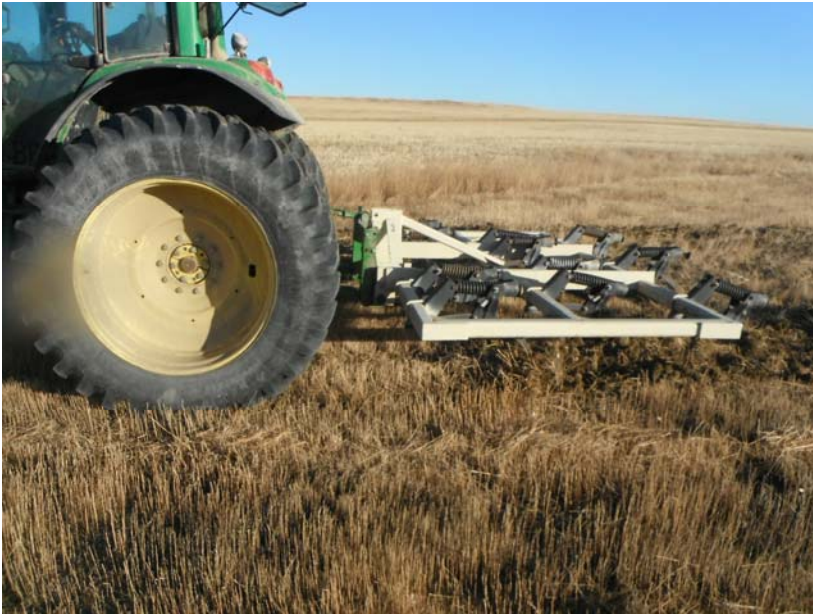
Deep ripper attachment

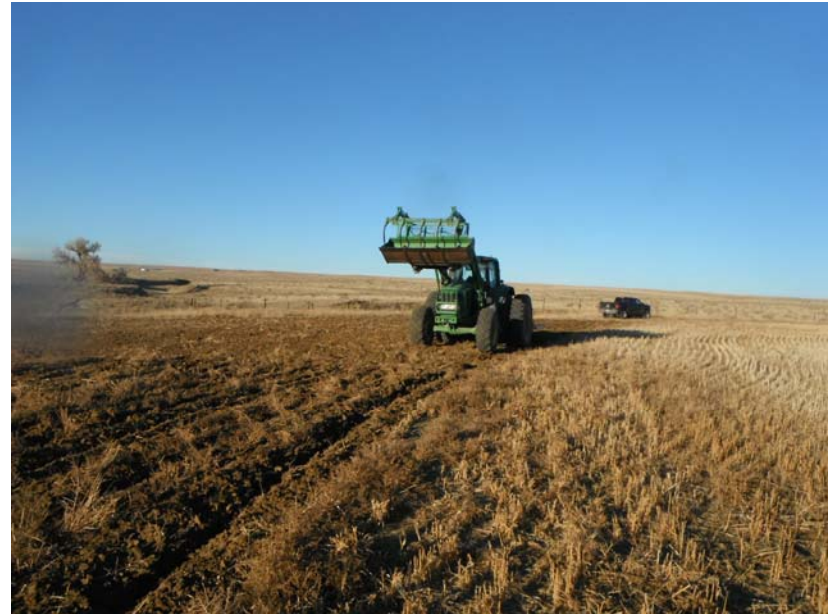
Deep ripping

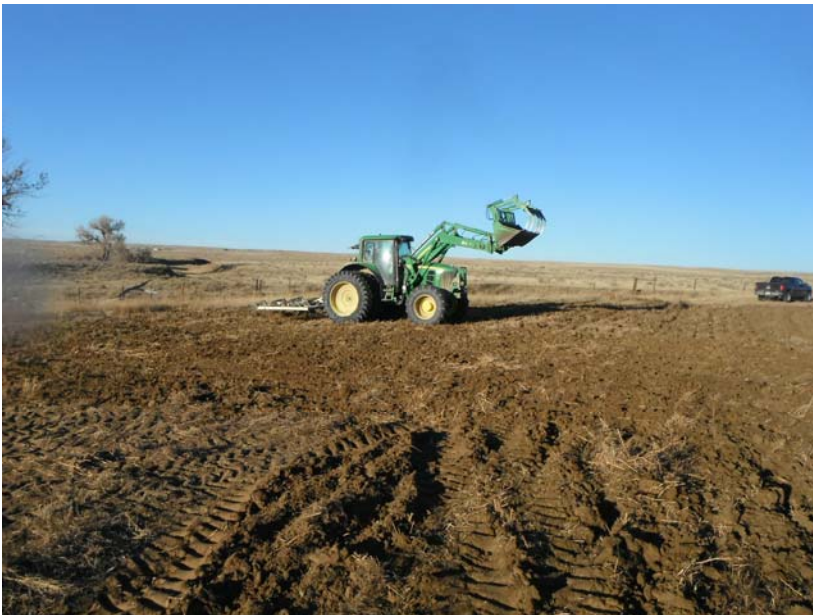
Cross ripping of lease area

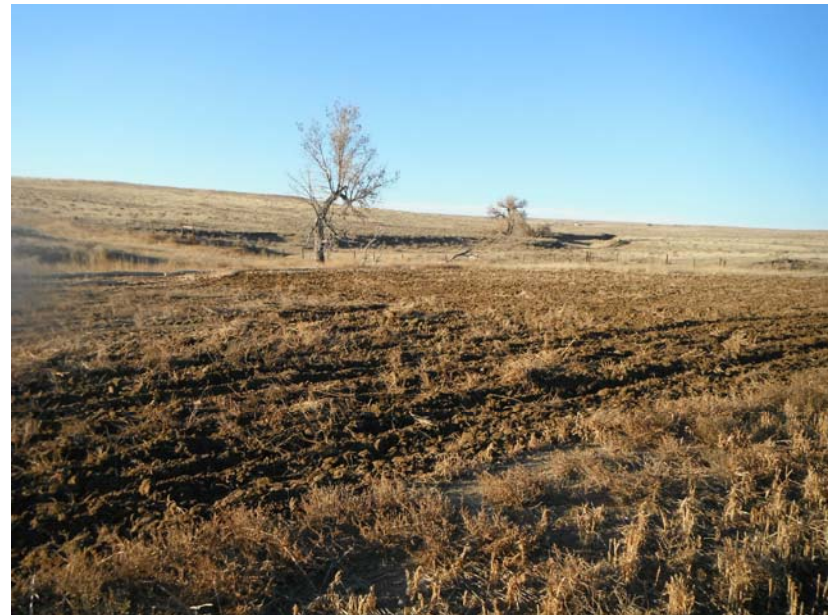
Former tank and process area after deep cross ripping

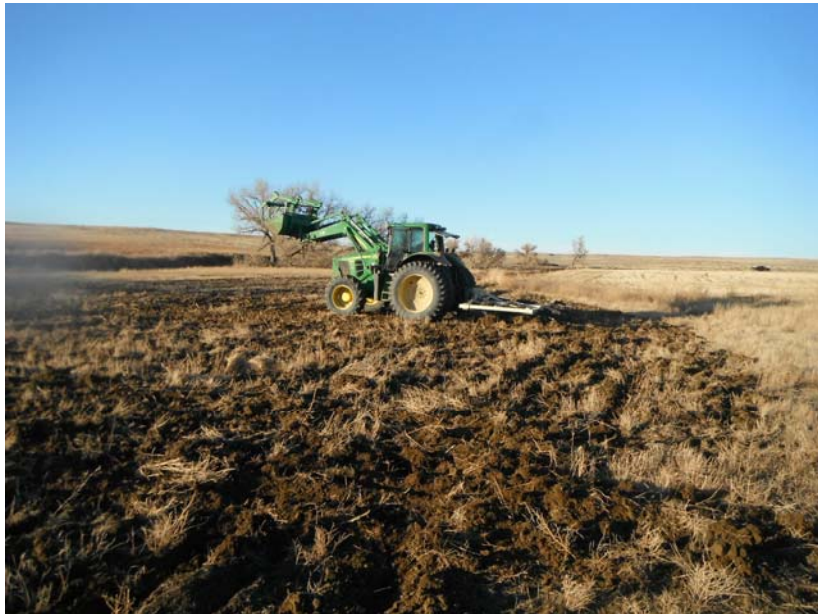
Cross ripping of former well pad

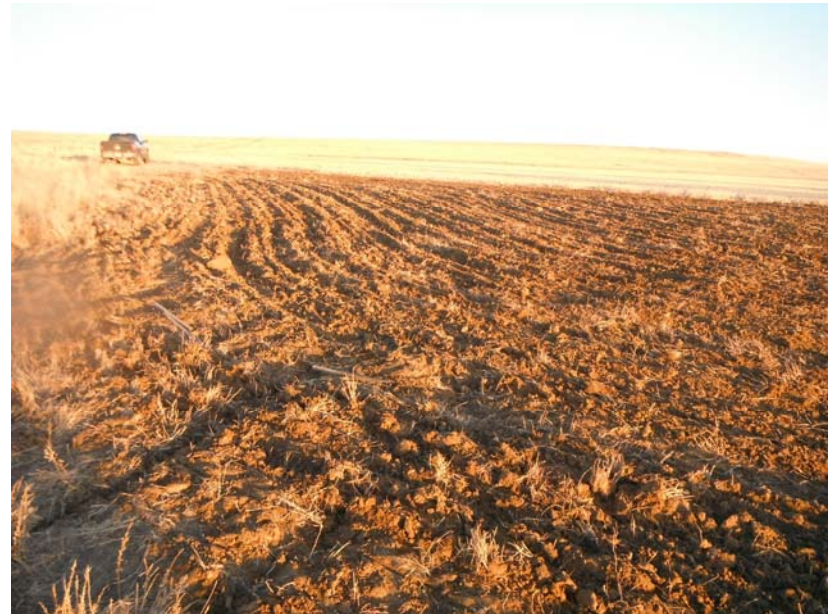
Lease area after reseeding

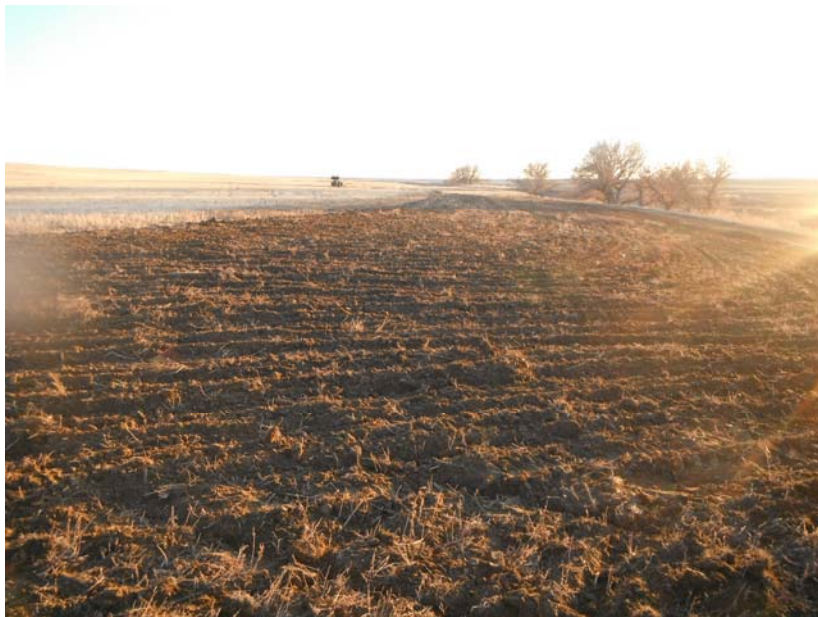
Former process area after deep cross ripping

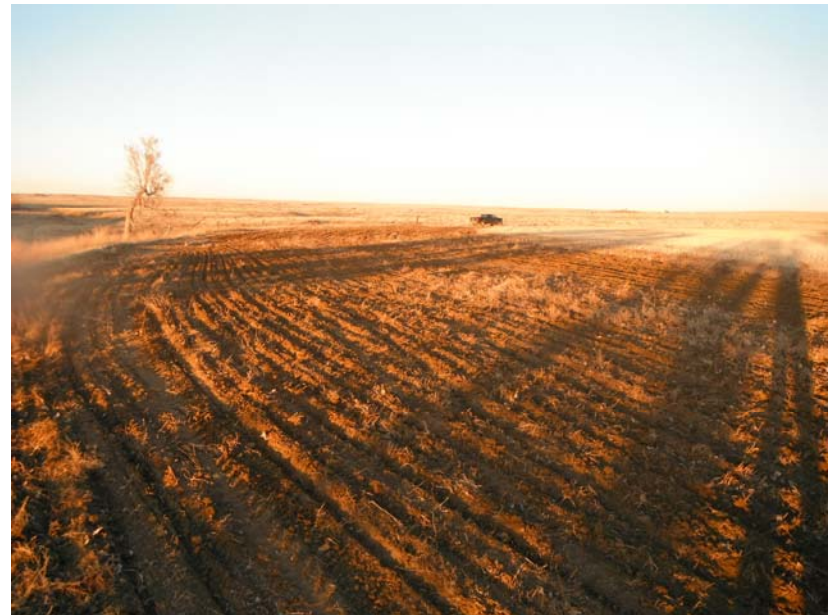
Former tank and process area after reseeding
