# Construction and Stormwater Inspection

Operator: WHITING OIL & GAS CORPORATION- #96155

Location ID: 439542

Inspection Photos  
Location Name: Razor /29H Pad  
Location ID: 439542

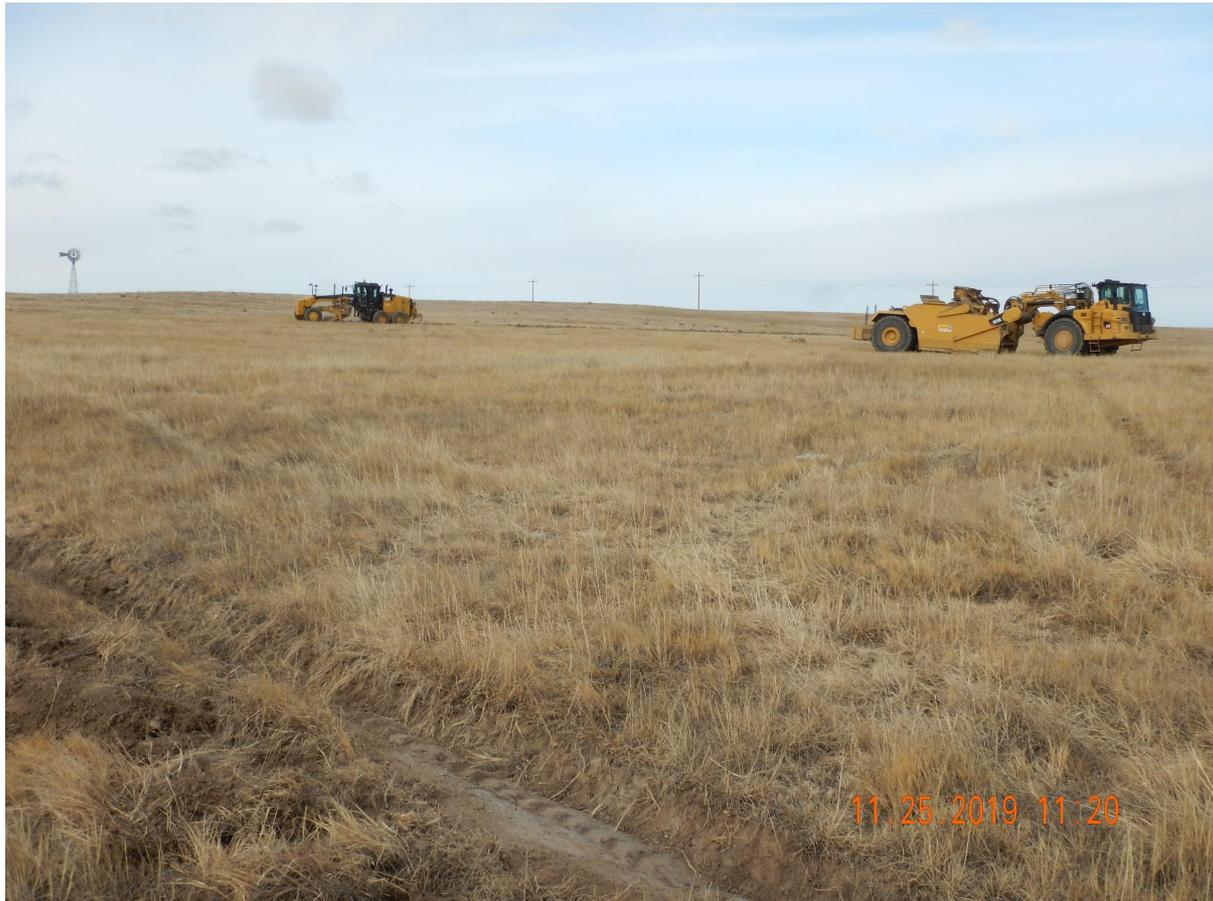
**Photo 1.** Photo taken from the southern perimeter of location, facing West. Photo illustrates Operator was installing perimeter stormwater BMPs. Operator indicated that topsoil salvage operations would not start until the ditch and berm BMP were properly installed (i.e., berm was stabilized). Operator also indicated that sediment traps would also be installed in conjunction with the ditch and berm BMP.

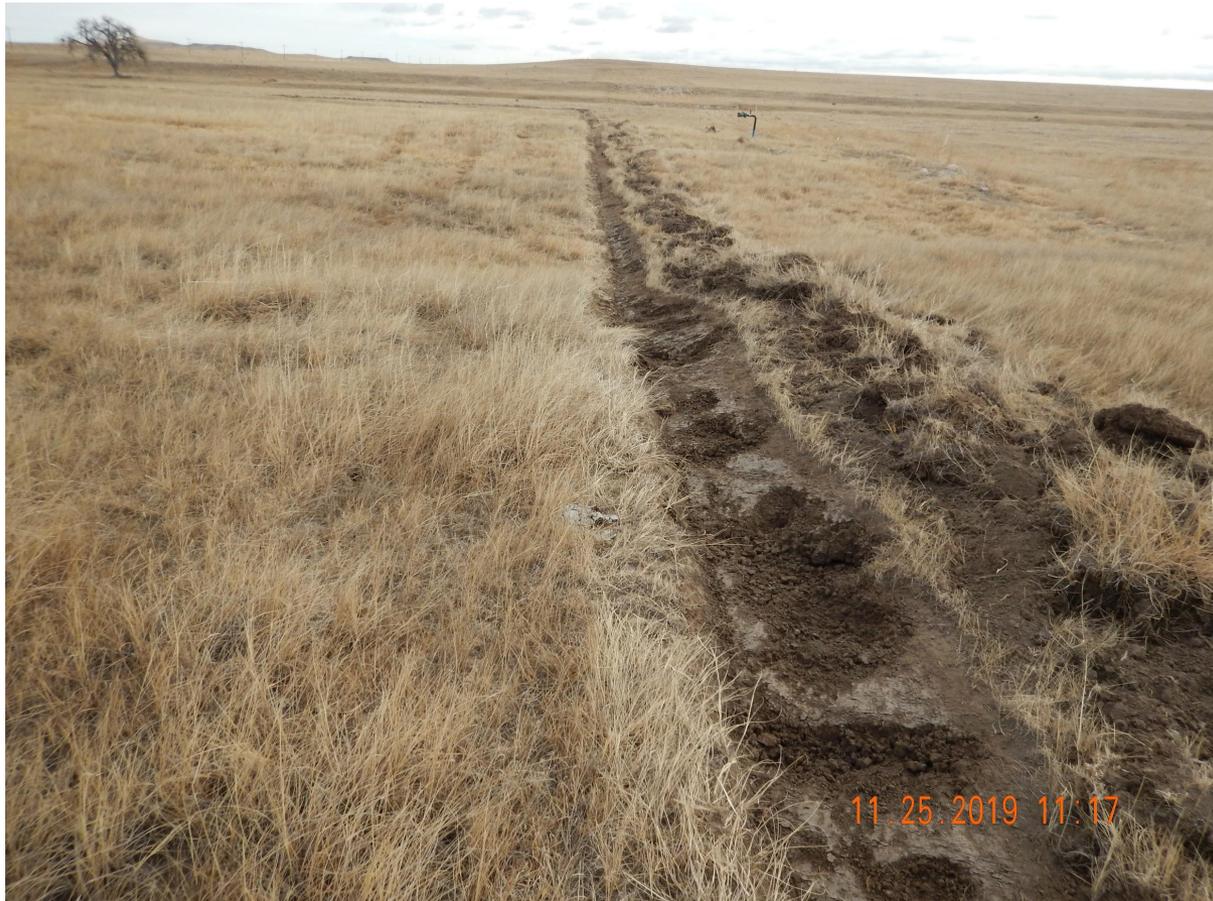
**Photo 2.** Photo taken from the southern perimeter of location, facing East. Photo illustrates the first pass with plans to install a ditch and berm BMP.

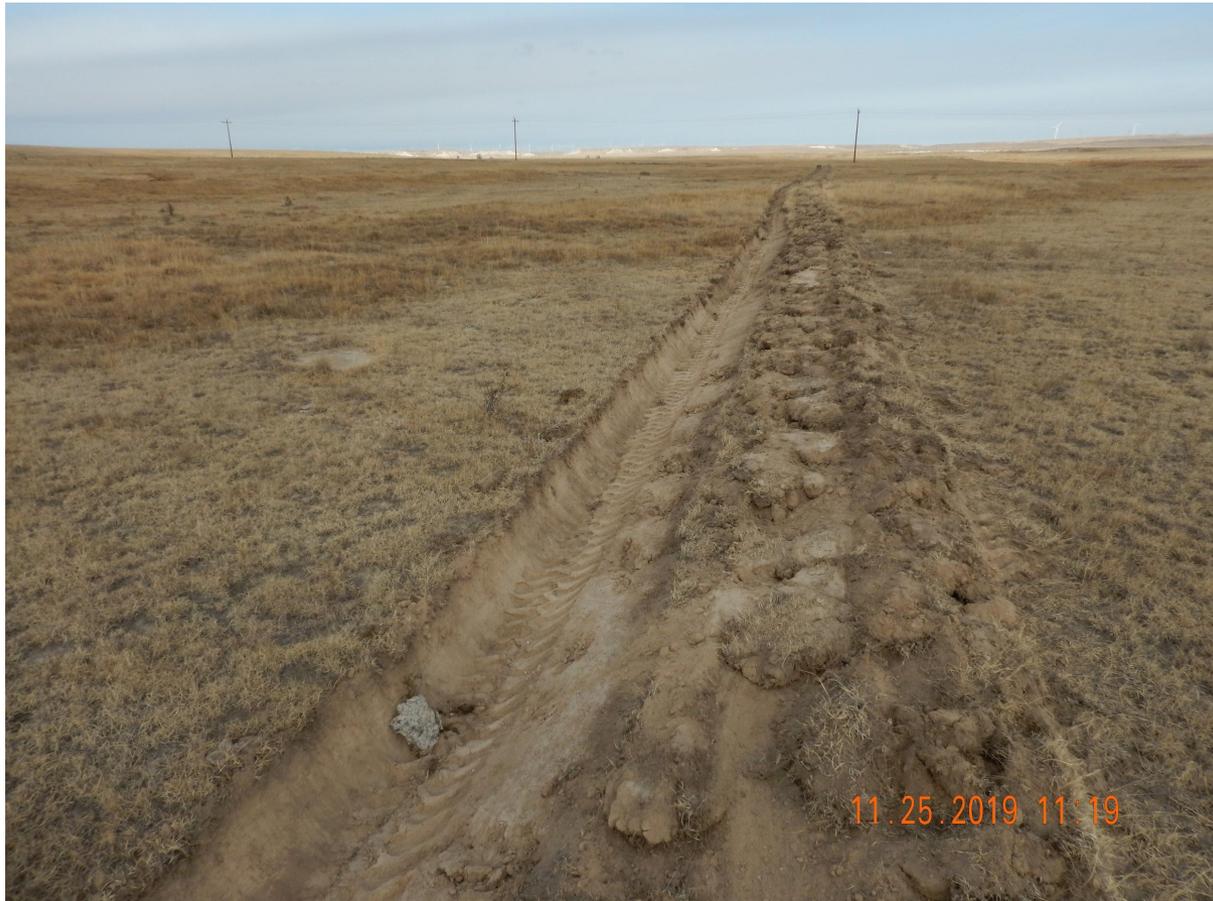
**Photo 3.** Photo taken from the southeastern perimeter of location, facing North.  
See comments under Photo 2.
