# Final Reclamation and Stormwater Inspection

November 25, 2019

Operator: WHITING OIL & GAS CORPORATION- #96155

Location ID: 331145

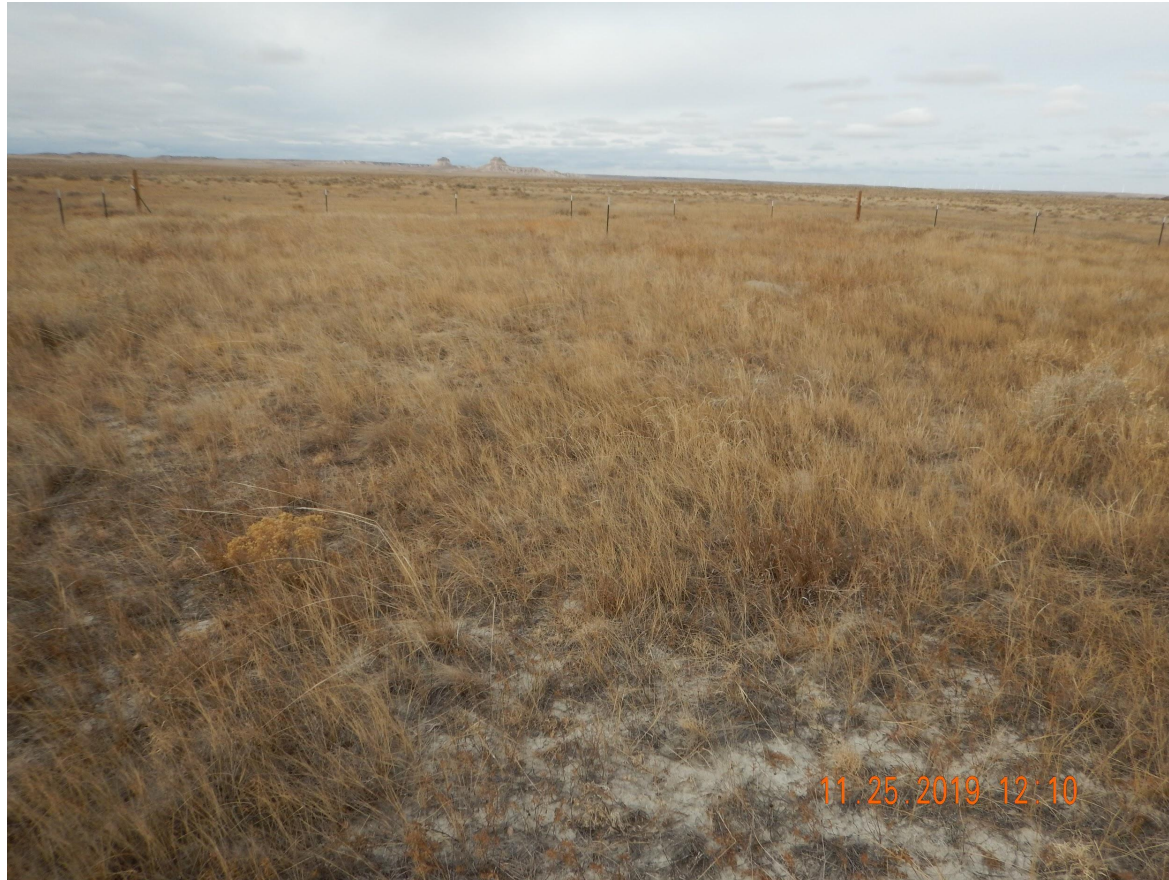
**Photo 1.** Photo taken from the eastern well location, facing West. Photo illustrates Operator has performed Final Reclamation activities with the evidence of desirable vegetation establishment. Well location appears reflective of reference area vegetative levels; however, the access road and tank battery location will remain in process. Operator will need to remove the perimeter fence.

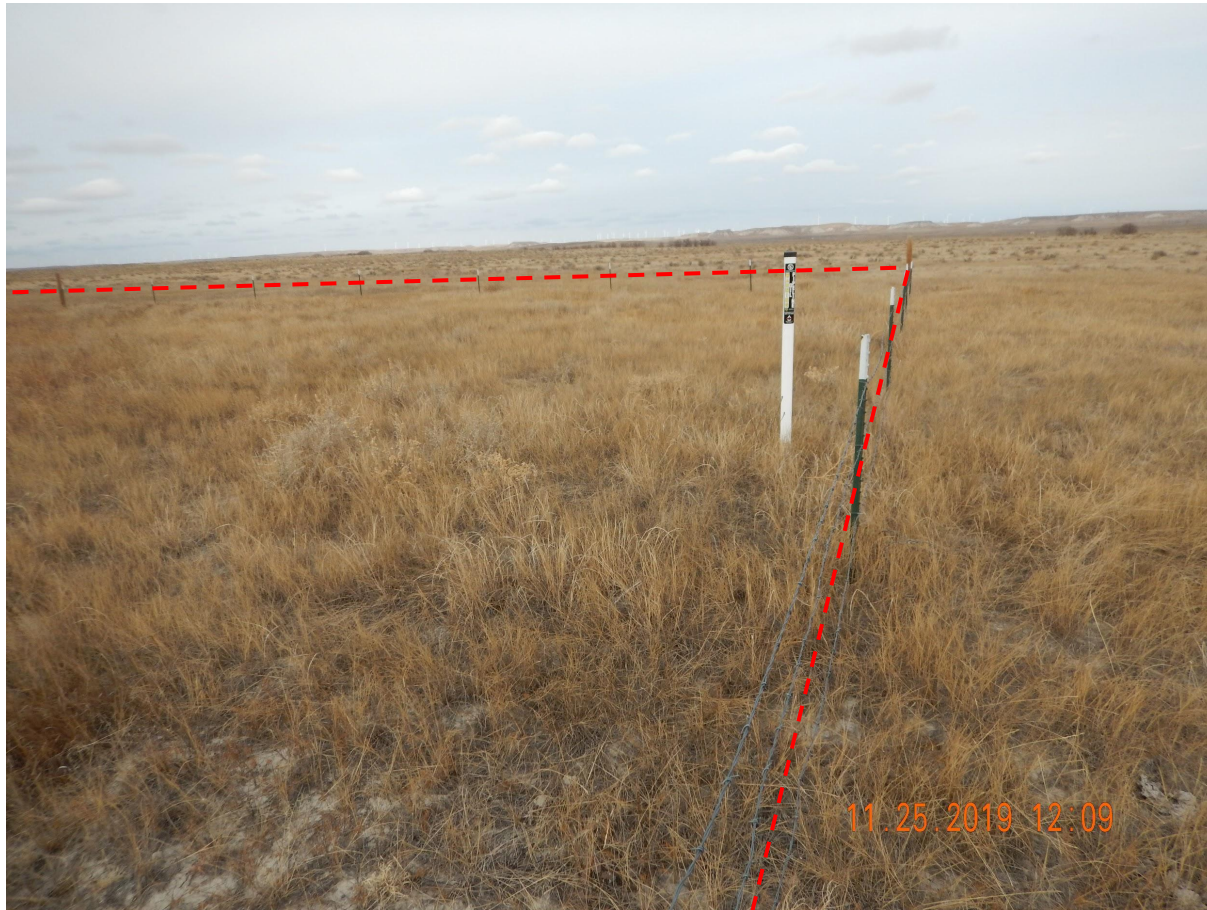
**Photo 2.** Photo taken from the eastern well location, facing North. See comments under Photo 1. Reference area vegetation is illustrated outside of the red-dashed line.

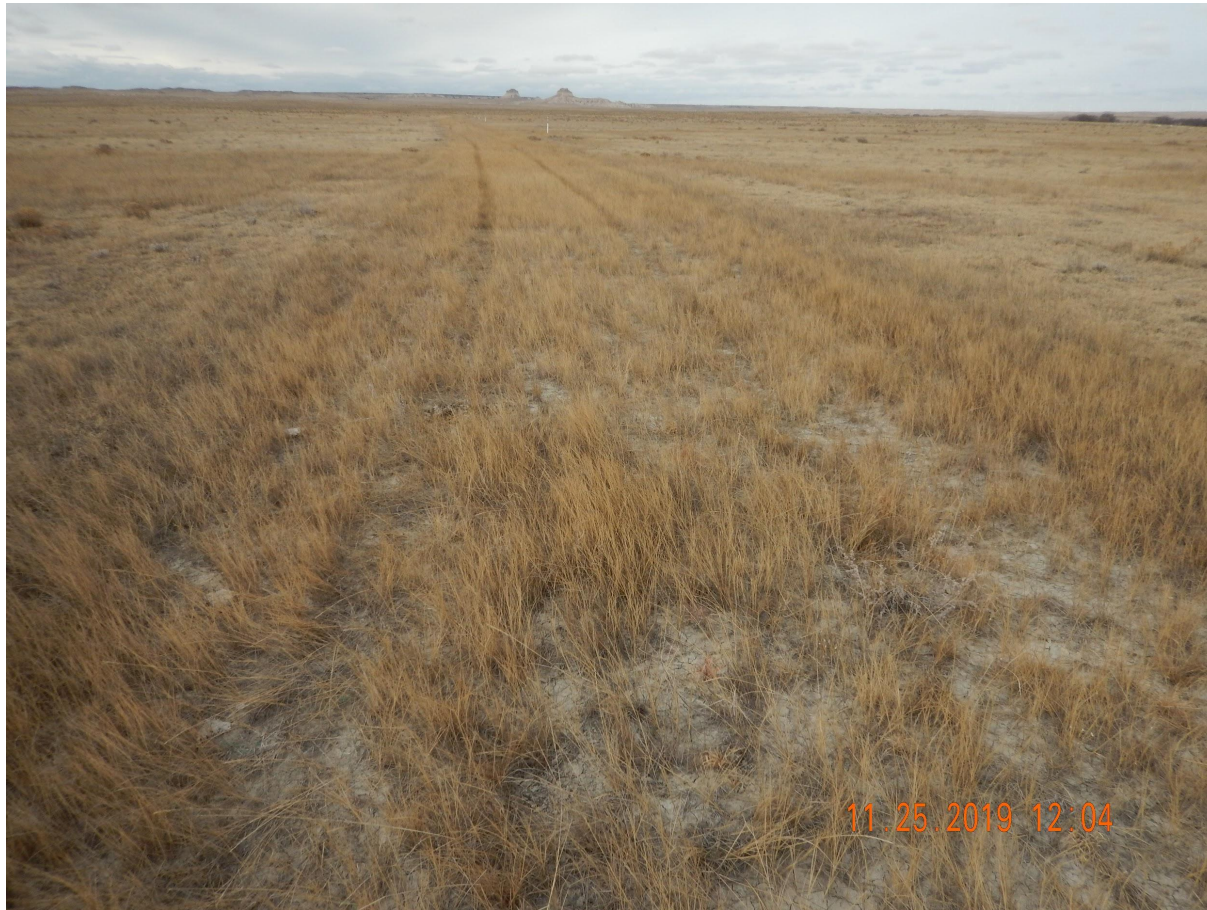
**Photo 3.** Photo taken from a portion of the central access road, facing West. See comments under Photo 1.

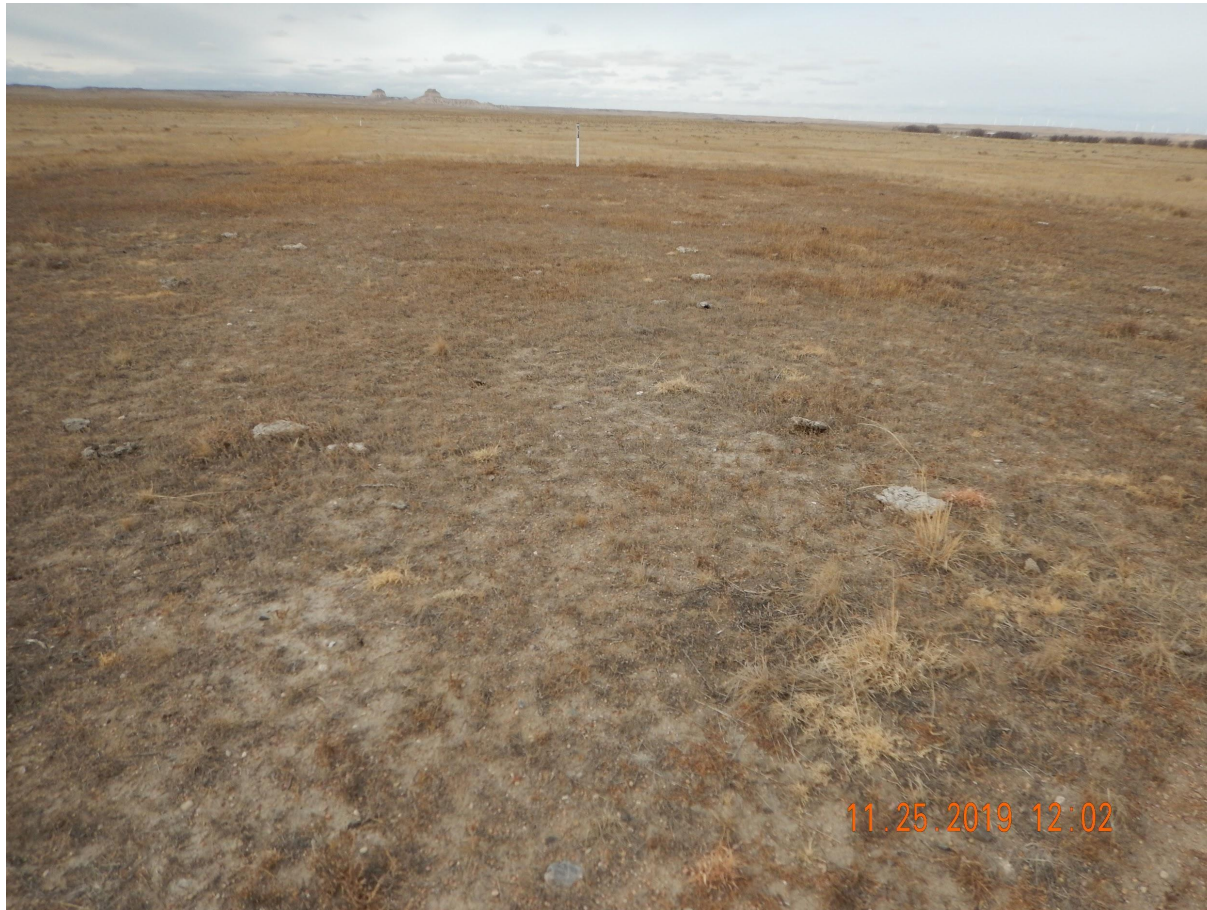
**Photo 4.** Photo taken from the central tank battery location, facing West. See comments under Photo 1.
