# Inspection Photos

ID: 150396

Operator: CHEMCO INC

Inspection Date: 11/25/2019

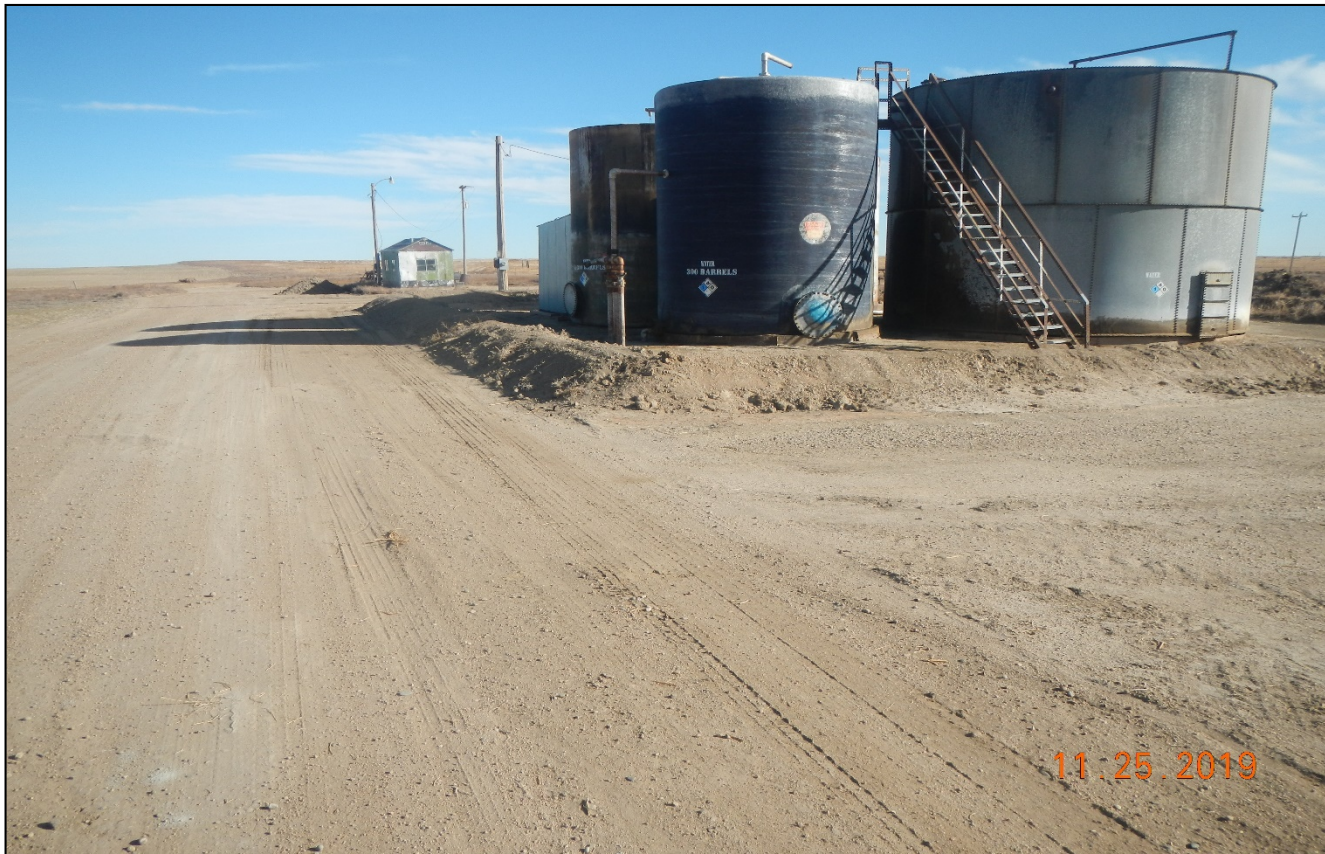
**Photo 1.** Facing east toward the tank battery.

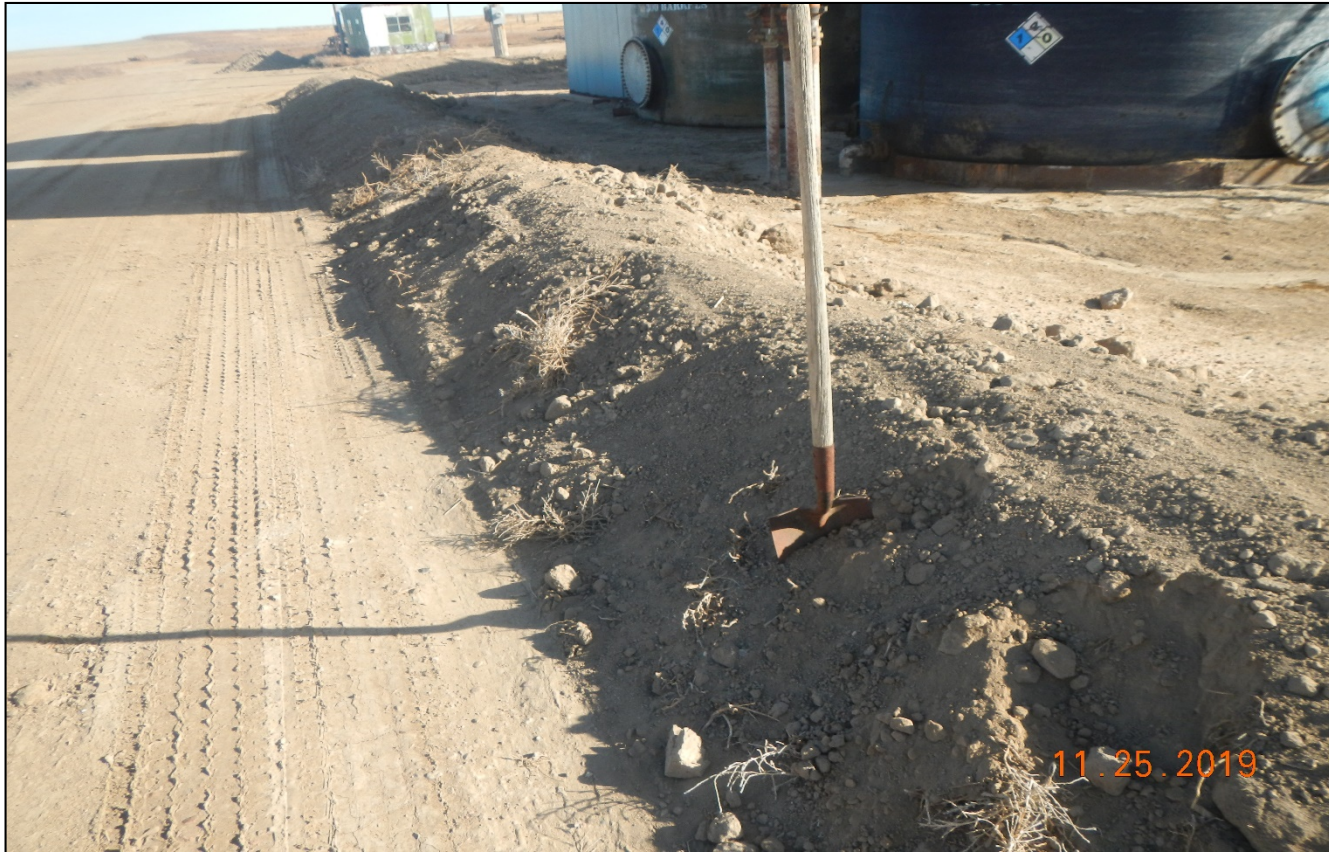
**Photo 2.** The berm around the tanks have been built up however, soils are loose and not compacted.

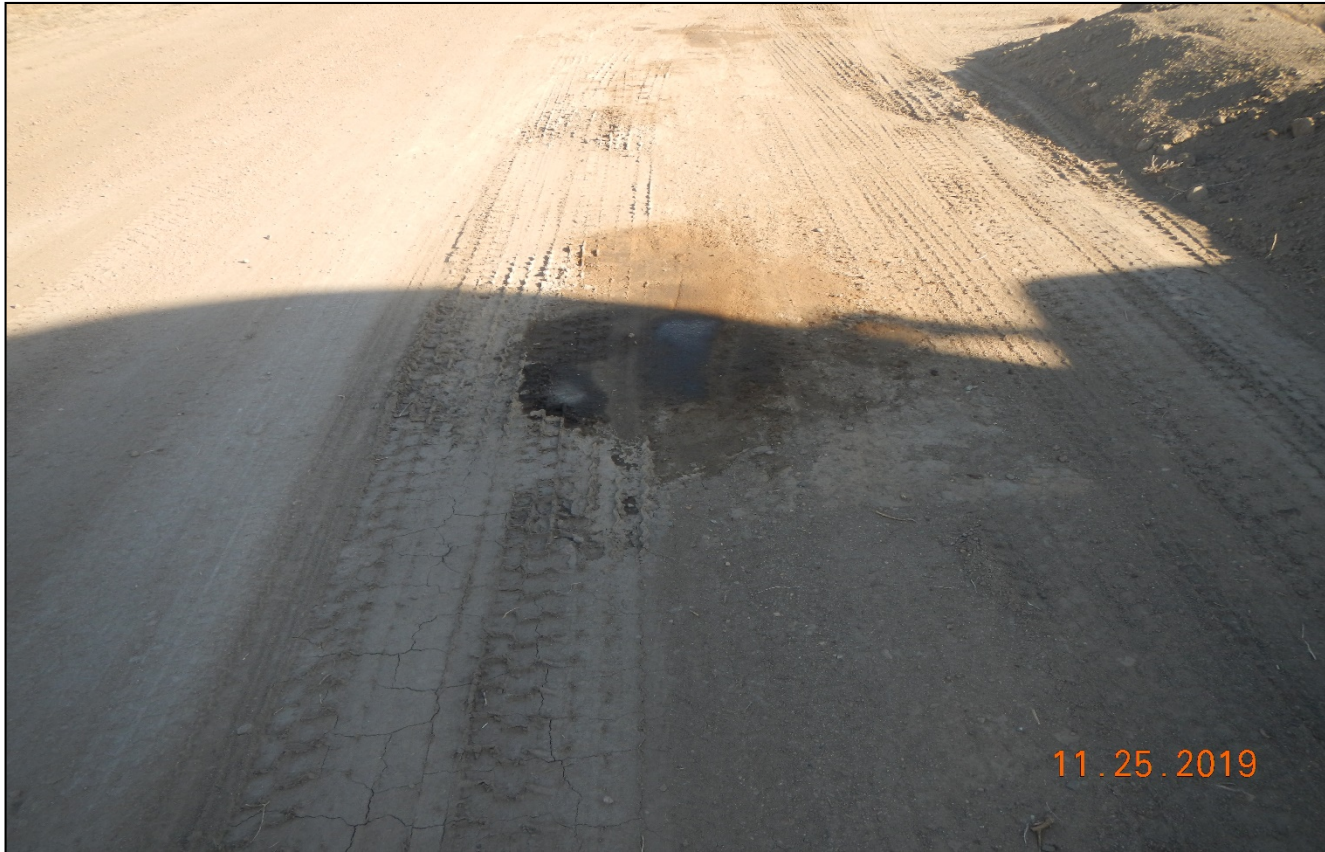
**Photo 3.** There is oil stained soil on the road surface near the tank battery has not been cleaned up. Approximately 4 ft. x 4 ft. area.

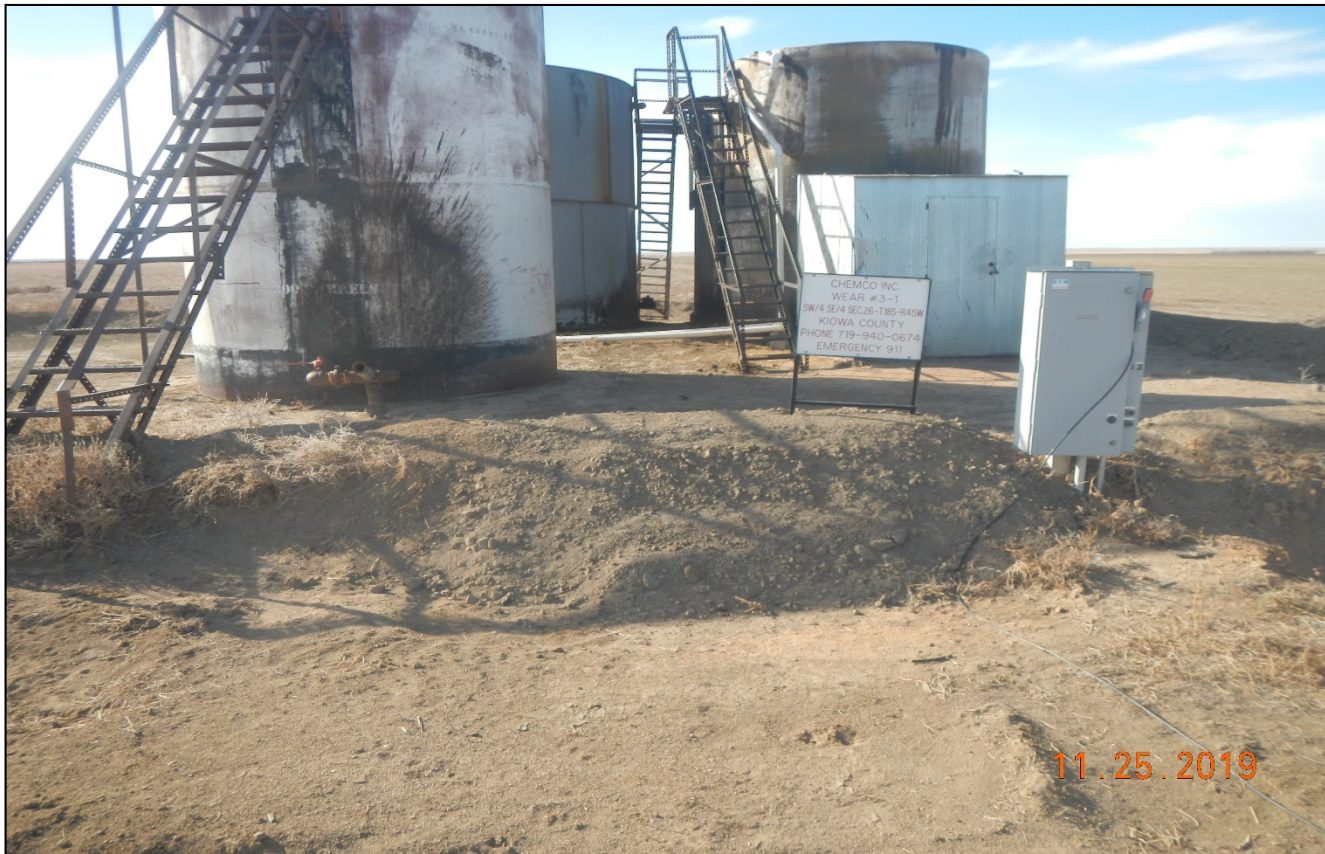
**Photo 4.** Facing west toward the tank battery. Sign is posted.

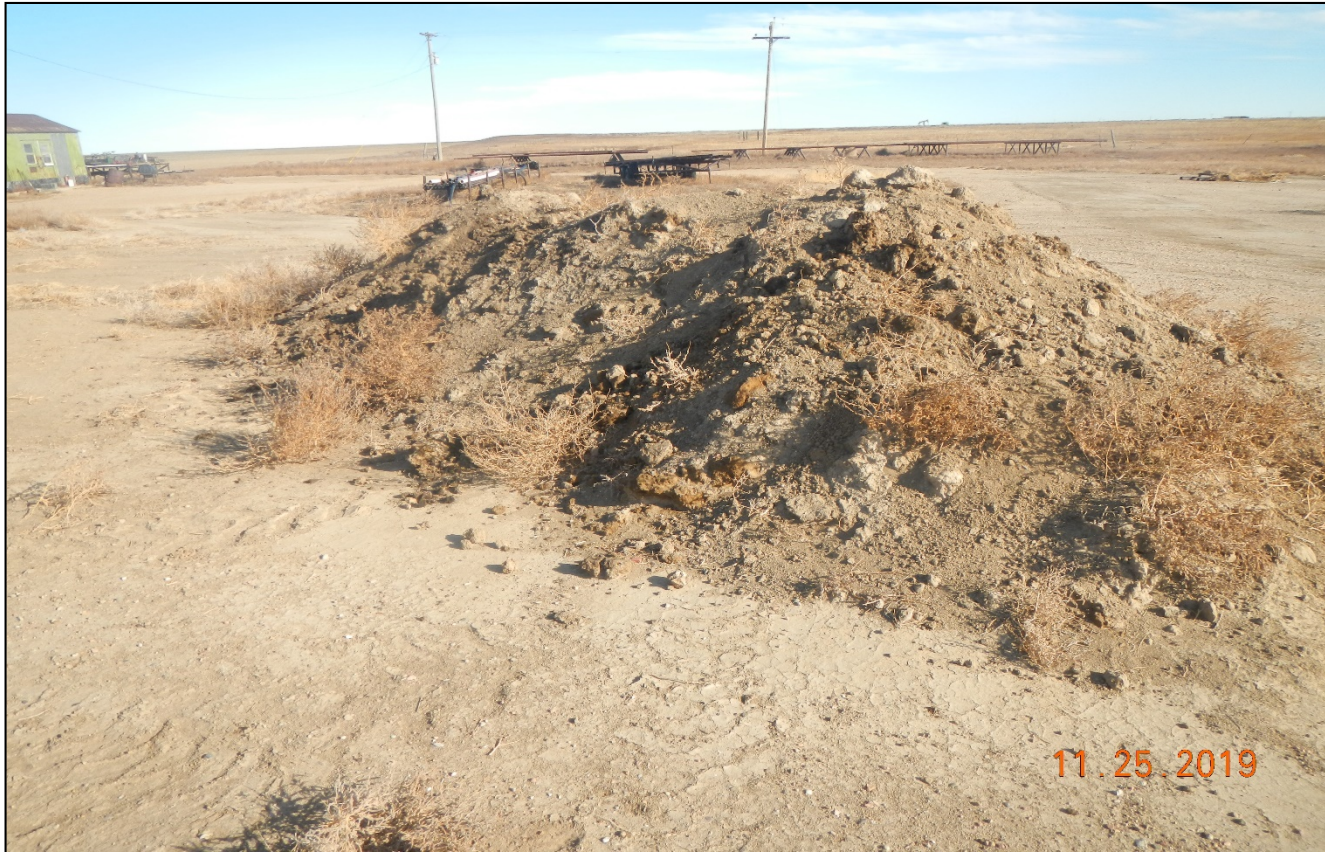
**Photo 5.** There is a pile of soil material which contains oily soil stored near the tank battery. This soil waste pile must be removed and properly disposed of.

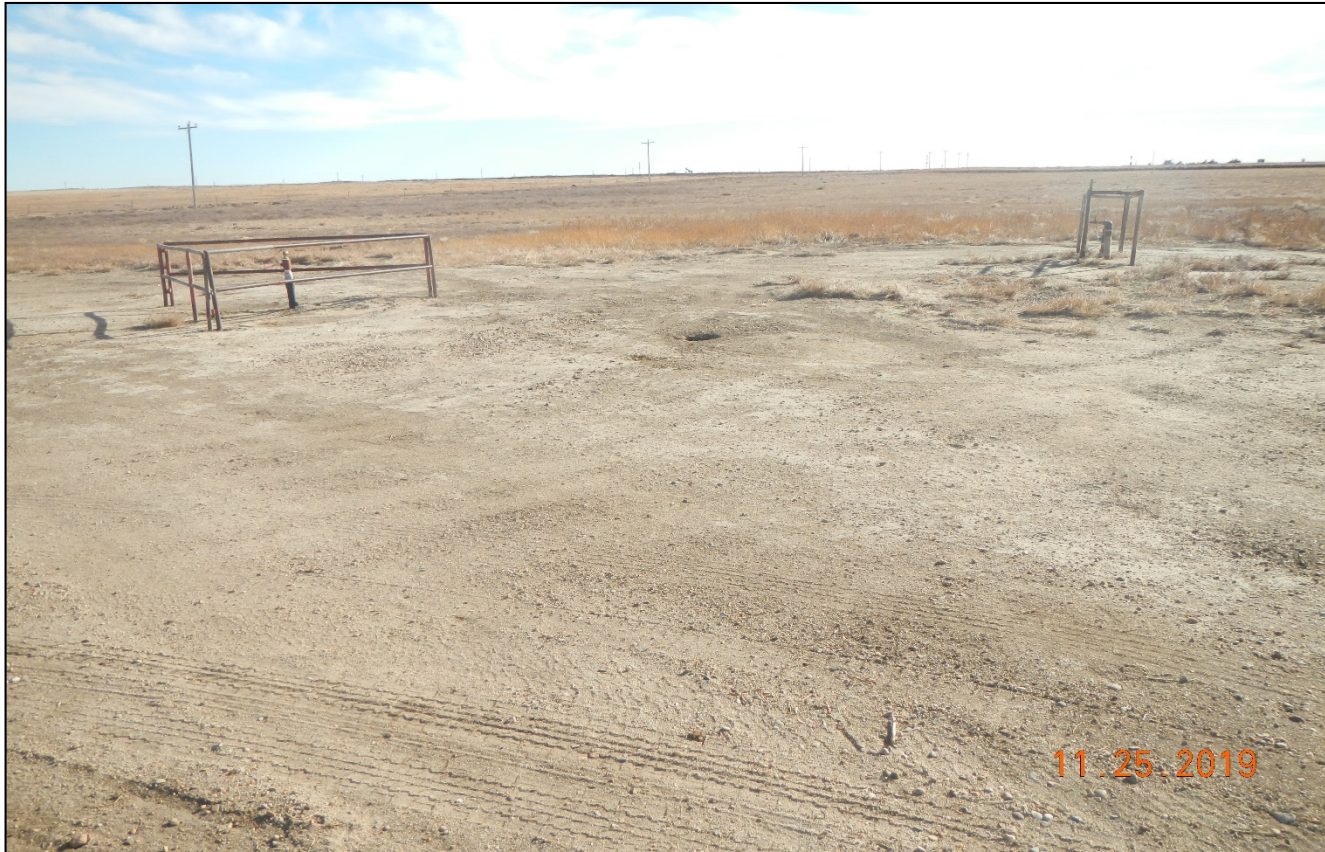
**Photo 6.** The pipe risers are now protected by a metal fence. The left riser in the photo has LO/TO. The right does not.

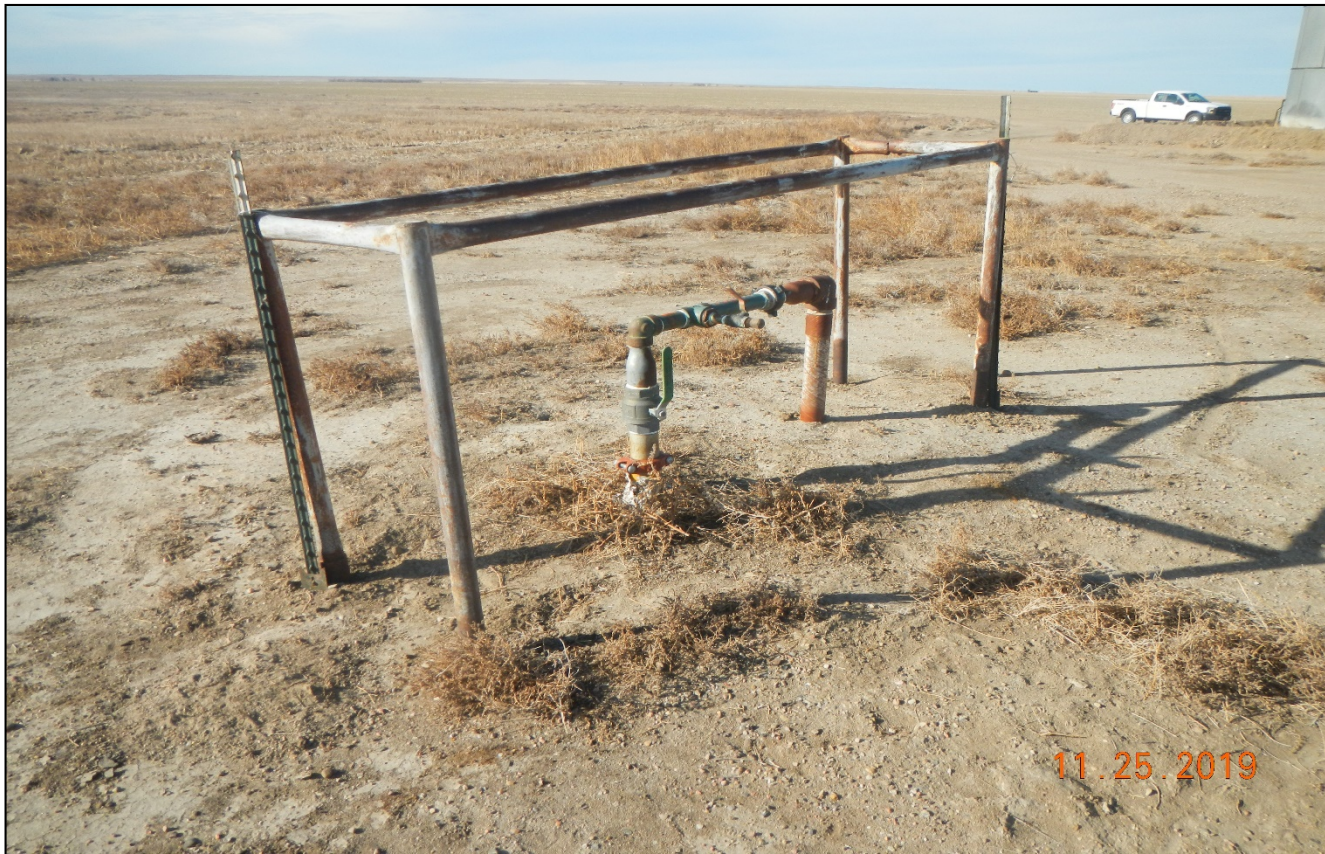
**Photo 7.** Facing northeast at the south side of the location. This pipe riser has no LO/TO.

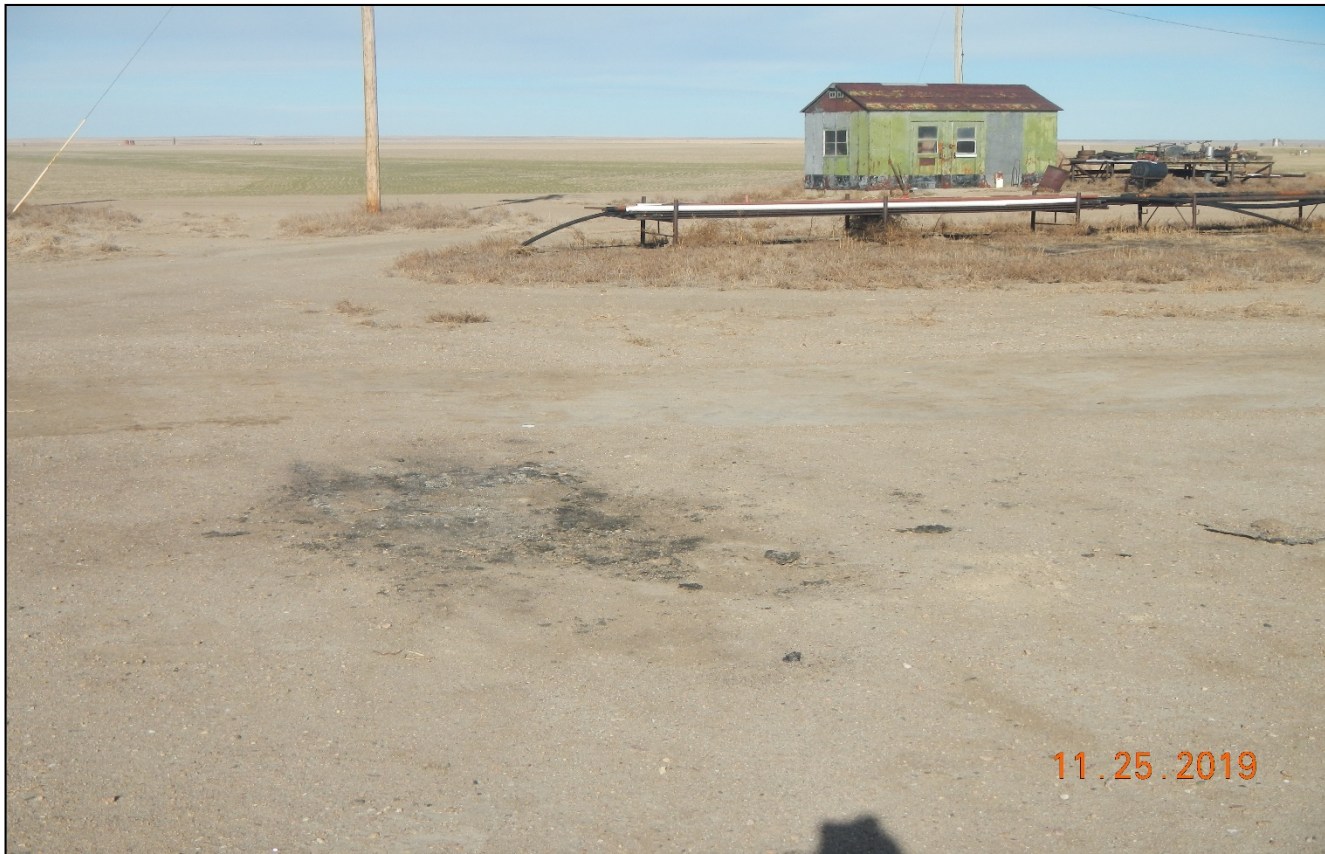
**Photo 8.** Facing northeast toward the location. The burnt debris in this area was removed.

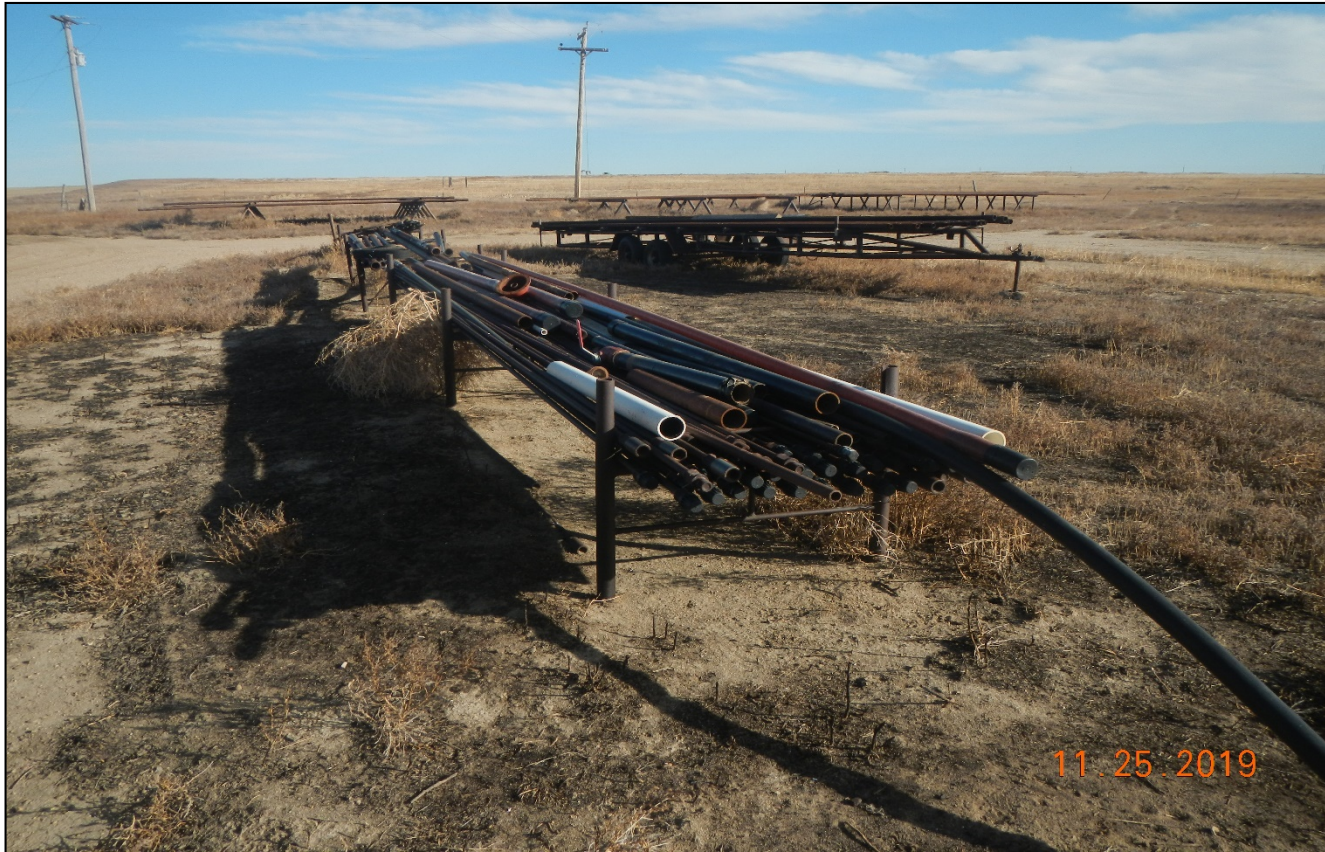
**Photo 9.** There is various unused equipment such as pipe being stored at the location. The corrective action to remove unused equipment has not been completed.

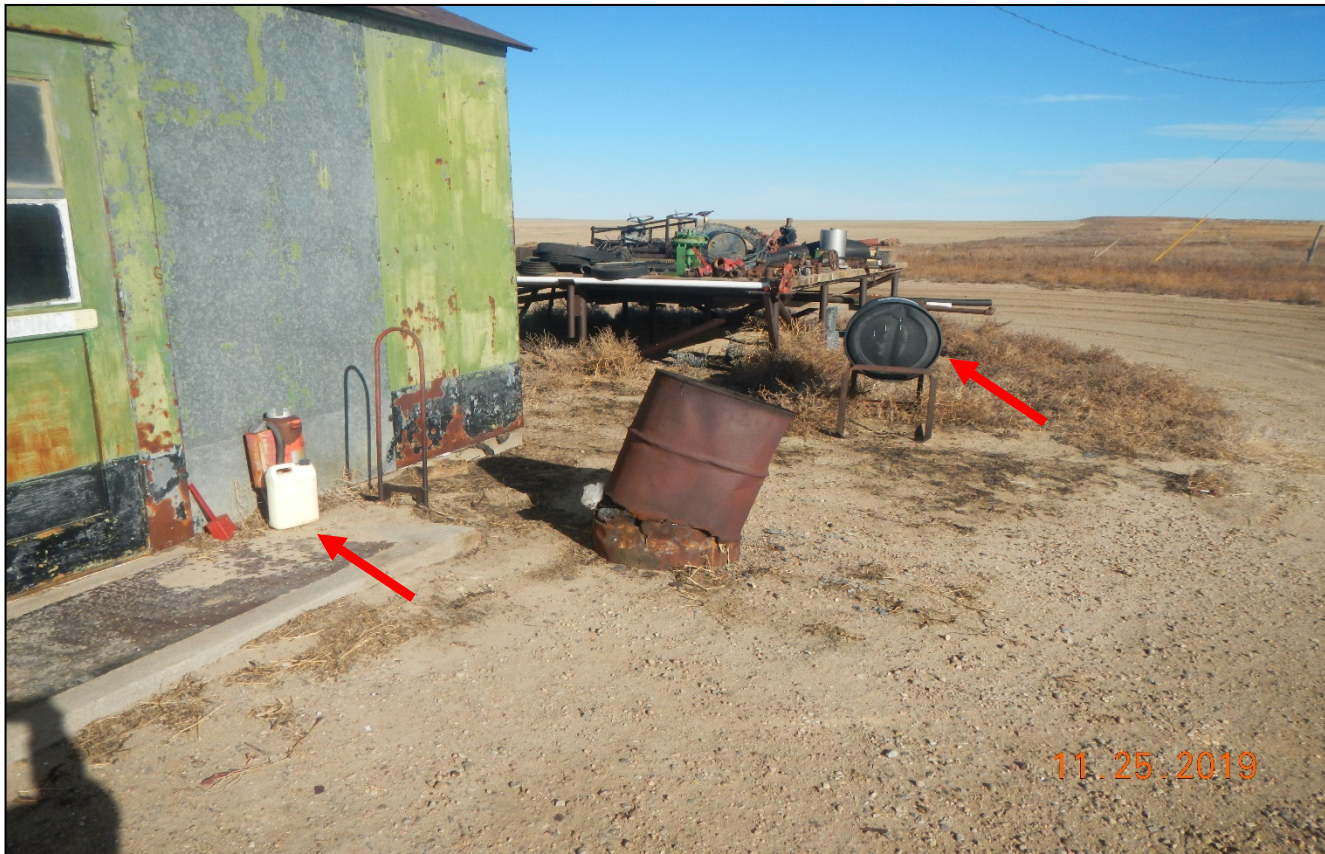
**Photo 10.** There is various unused equipment being stored at the location. There are barrels and containers with no labeling. The corrective action to remove unused equipment has not been completed.
