Inspection Photos

Location Name: GOLDEN EAGLE 28-7X

API#: 05-071-08732

INSP. #: 695101844

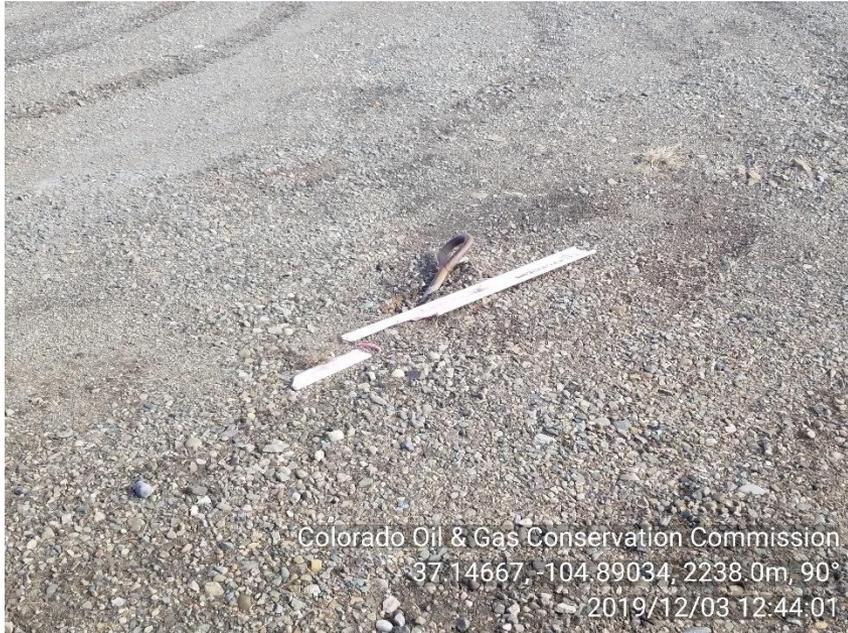
PHOTO 3: GUY LINE ANCHOR MARKER DOWN. INSTALL GUY LINE ANCHOR MARKER IN ACCORDANCE WITH RULE 1003.a. CA DATE 01-3-20.

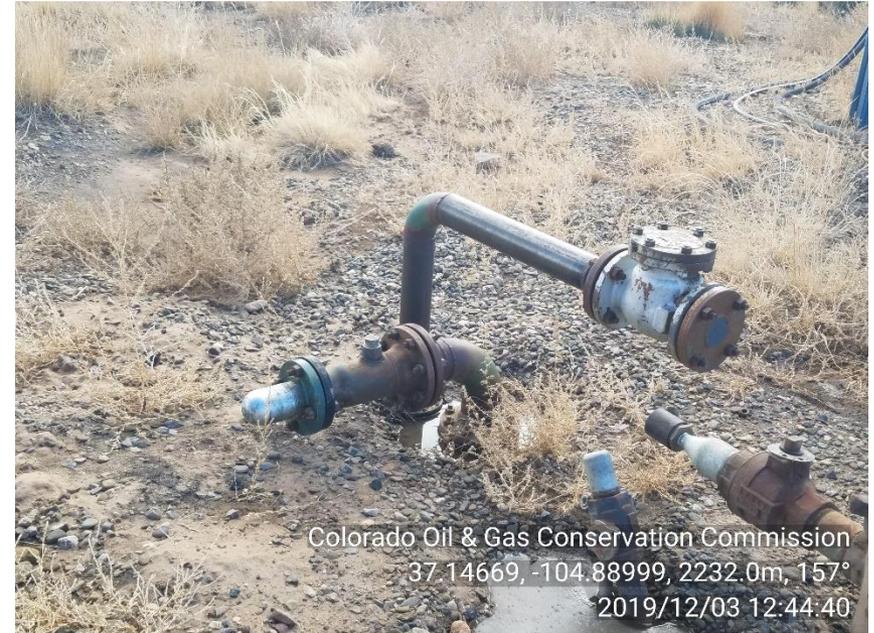
PHOTO 4: TWO UNMARKED UNUSED RISERS NEAR X WELLHEAD. REMOVE UNUSED RISER IN ACCORDANCE WITH NTO AND RULE 603.f. CA DATE 02-3-20.

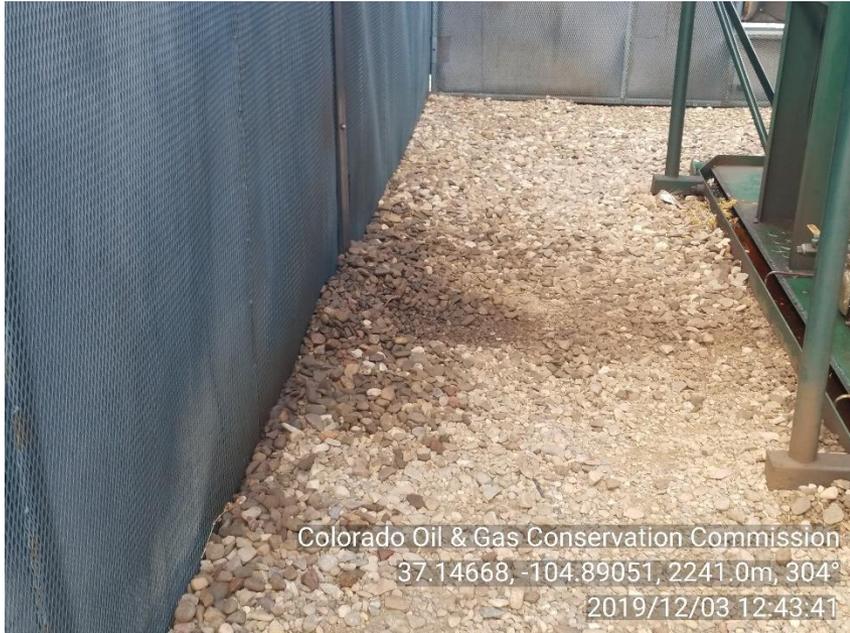
PHOTO 5: OILY IMPACTED SOIL INSIDE SOUND WALLS FOR COMPRESSOR ON ORIGINAL WELL. Remove and dispose impacted material in approved manner, service and maintain equipment and self inspect to prevent recurrence of conditions per 1002.f(2) and 907. CA DATE 01-03-20

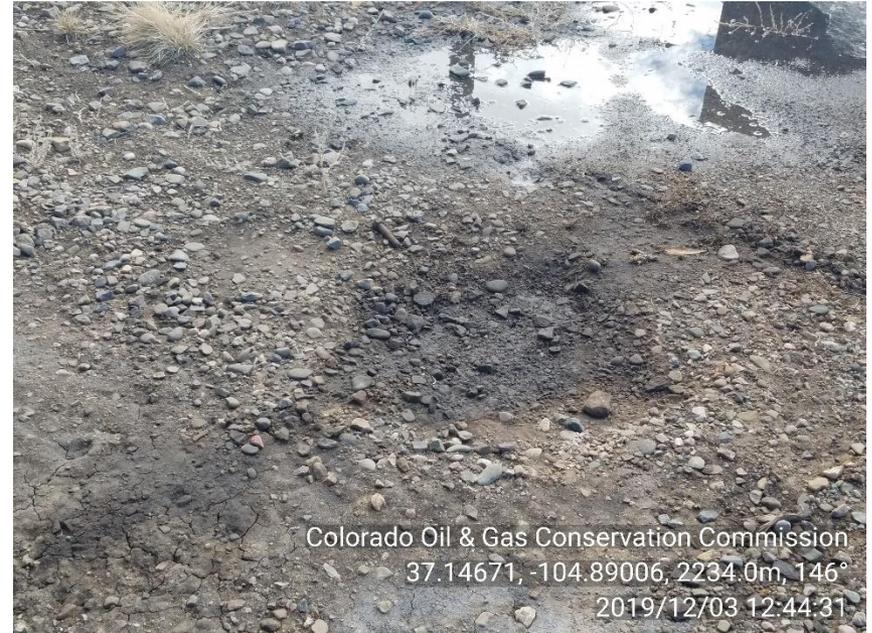
PHOTO 6: OILY IMPACTED SOIL NEAR X WELLHEAD. Remove and dispose impacted material in approved manner, service and maintain equipment and self inspect to prevent recurrence of conditions per 1002.f(2) and 907. CA DATE 01-03-20

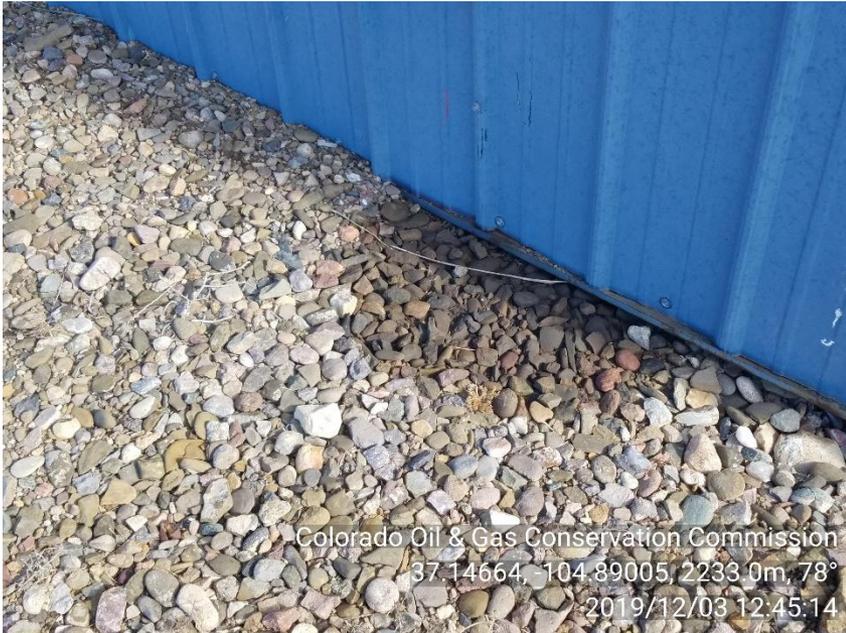
PHOTO 7: OILY IMPACTED SOIL OUTSIDE SOUND WALLS FOR ENGINE SKID FOR X WELL. Remove and dispose impacted material in approved manner, service and maintain equipment and self inspect to prevent recurrence of conditions per 1002.f(2) and 907. CA DATE 01-03-20

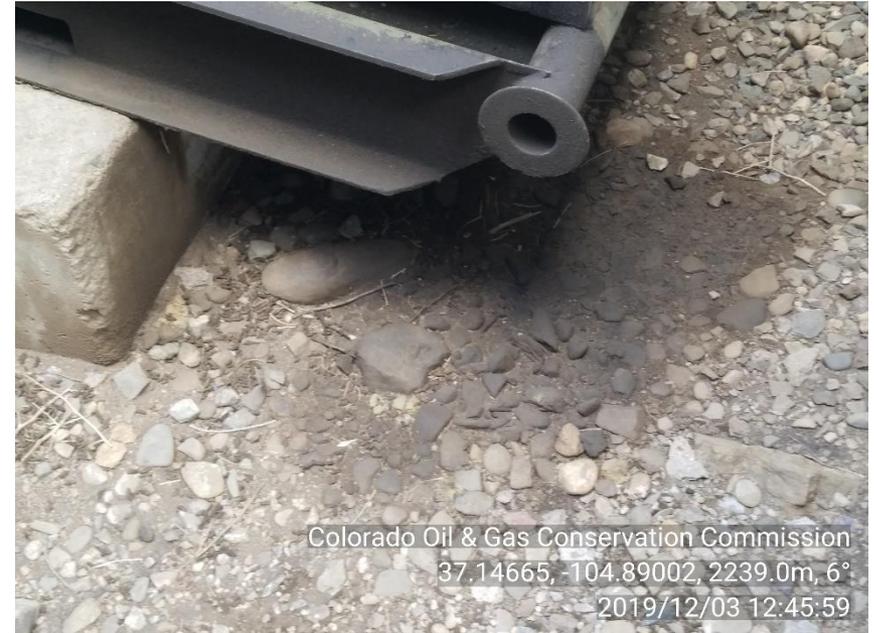
PHOTO 8: OILY IMPACTED SOIL INSIDE SOUND WALLS OF X WELL UNDER ENGINE SKID. Remove and dispose impacted material in approved manner, service and maintain equipment and self inspect to prevent recurrence of conditions per 1002.f(2) and 907. CA DATE 01-03-20
