Inspection Photos
Location Name: GOLDEN EAGLE 21-10
API#: 05-071-08417
INSP. #: 695101850

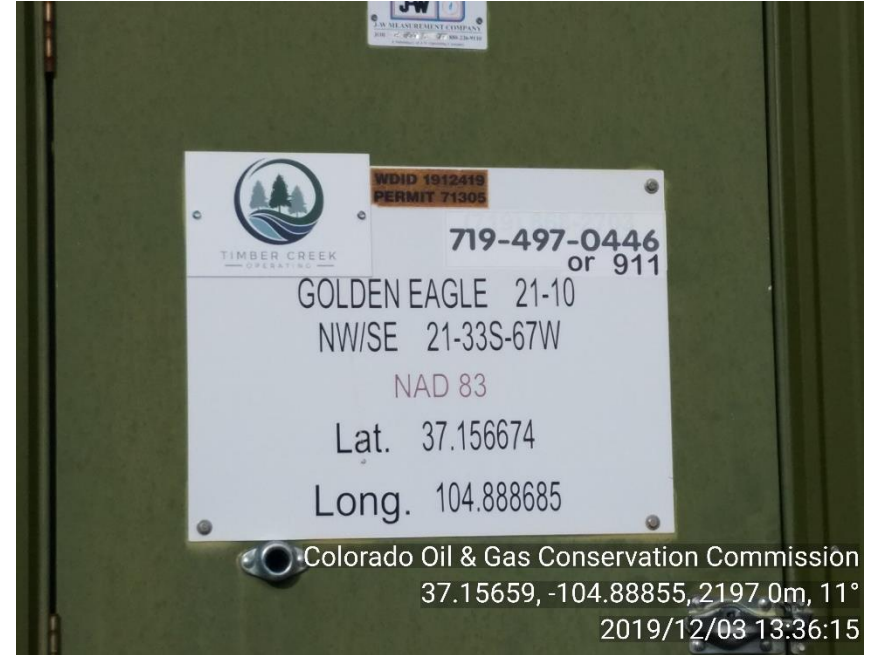
PHOTO 2: WELL SIGN

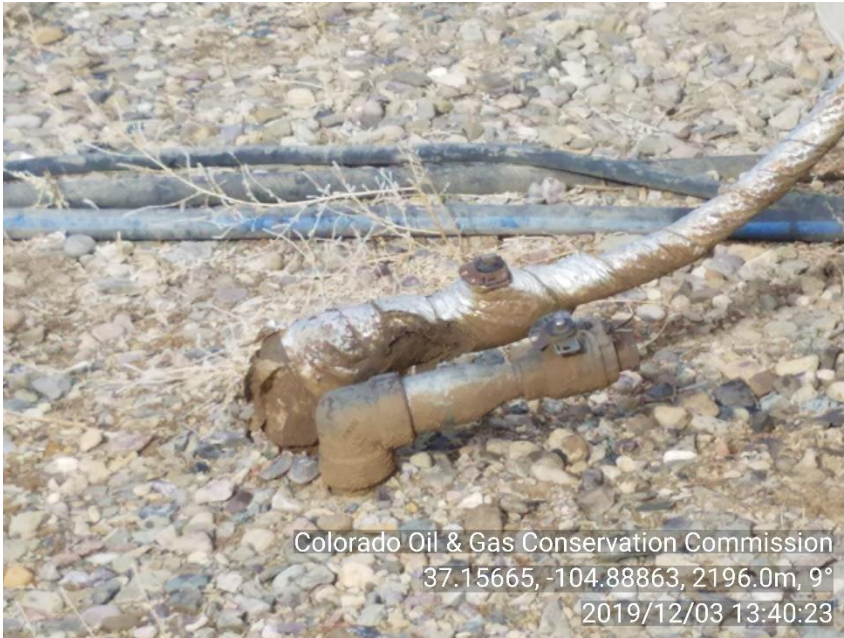
PHOTO 3: UNUSED UNMARKED RISER NEAR ENGINE SKID.
REMOVE UNUSED RISER IN ACCORDANCE WITH NTO AND
RULE 603.f. CA DATE 2-3-20
