Inspection Photos
Operator: Williford Resources
Location/API #: 067-06698
Date: 11-19-2019

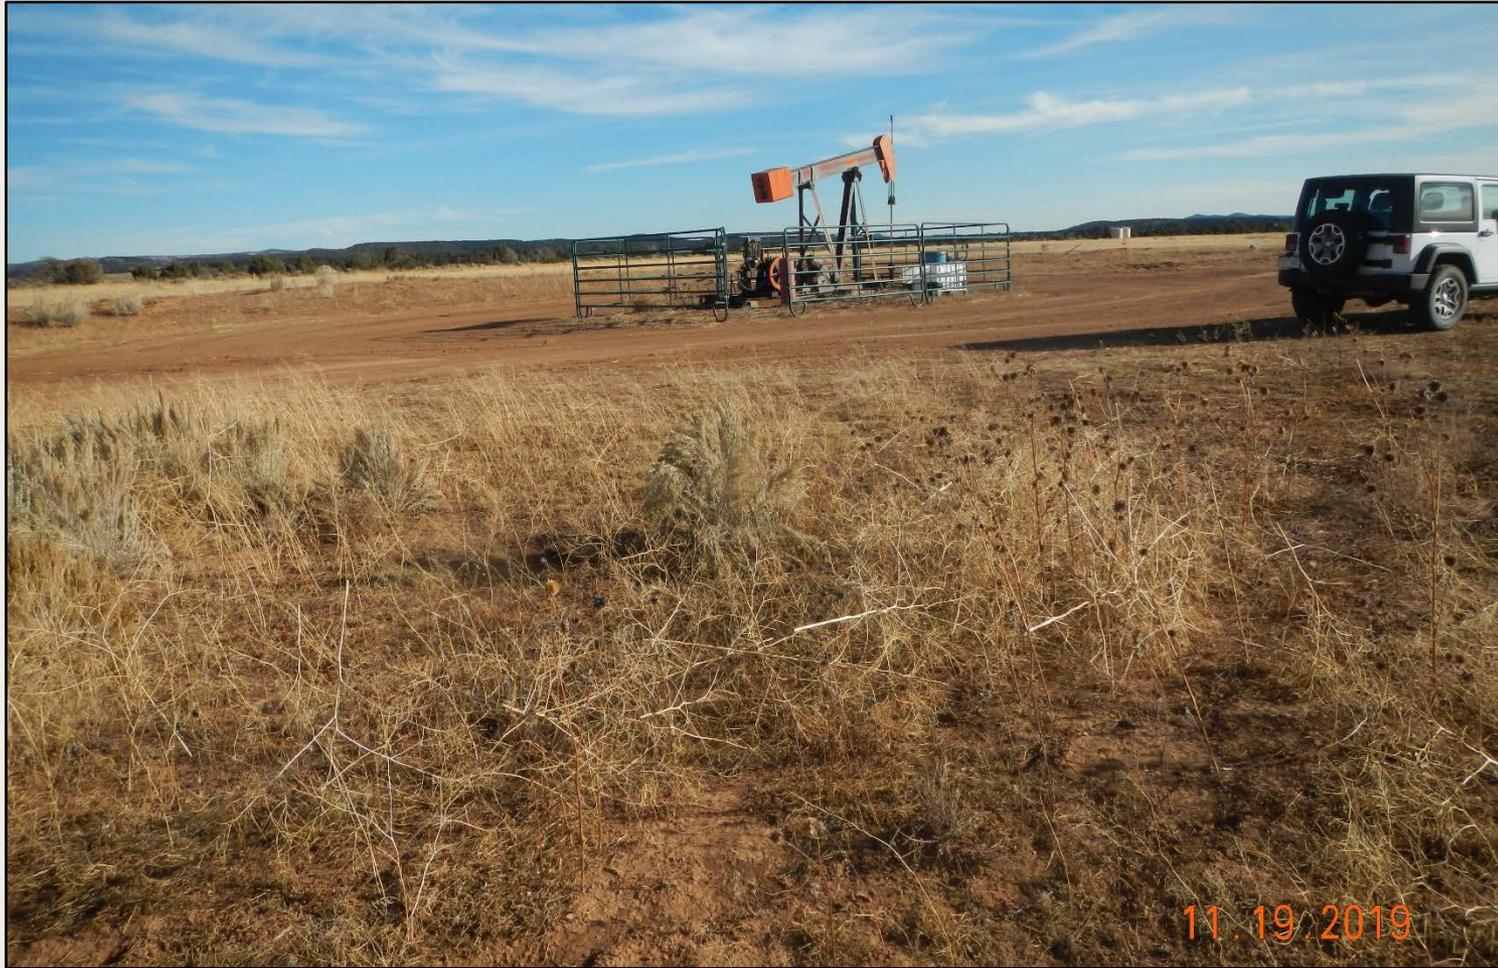
Photo 1. View of the project area from the northwestern corner facing center.

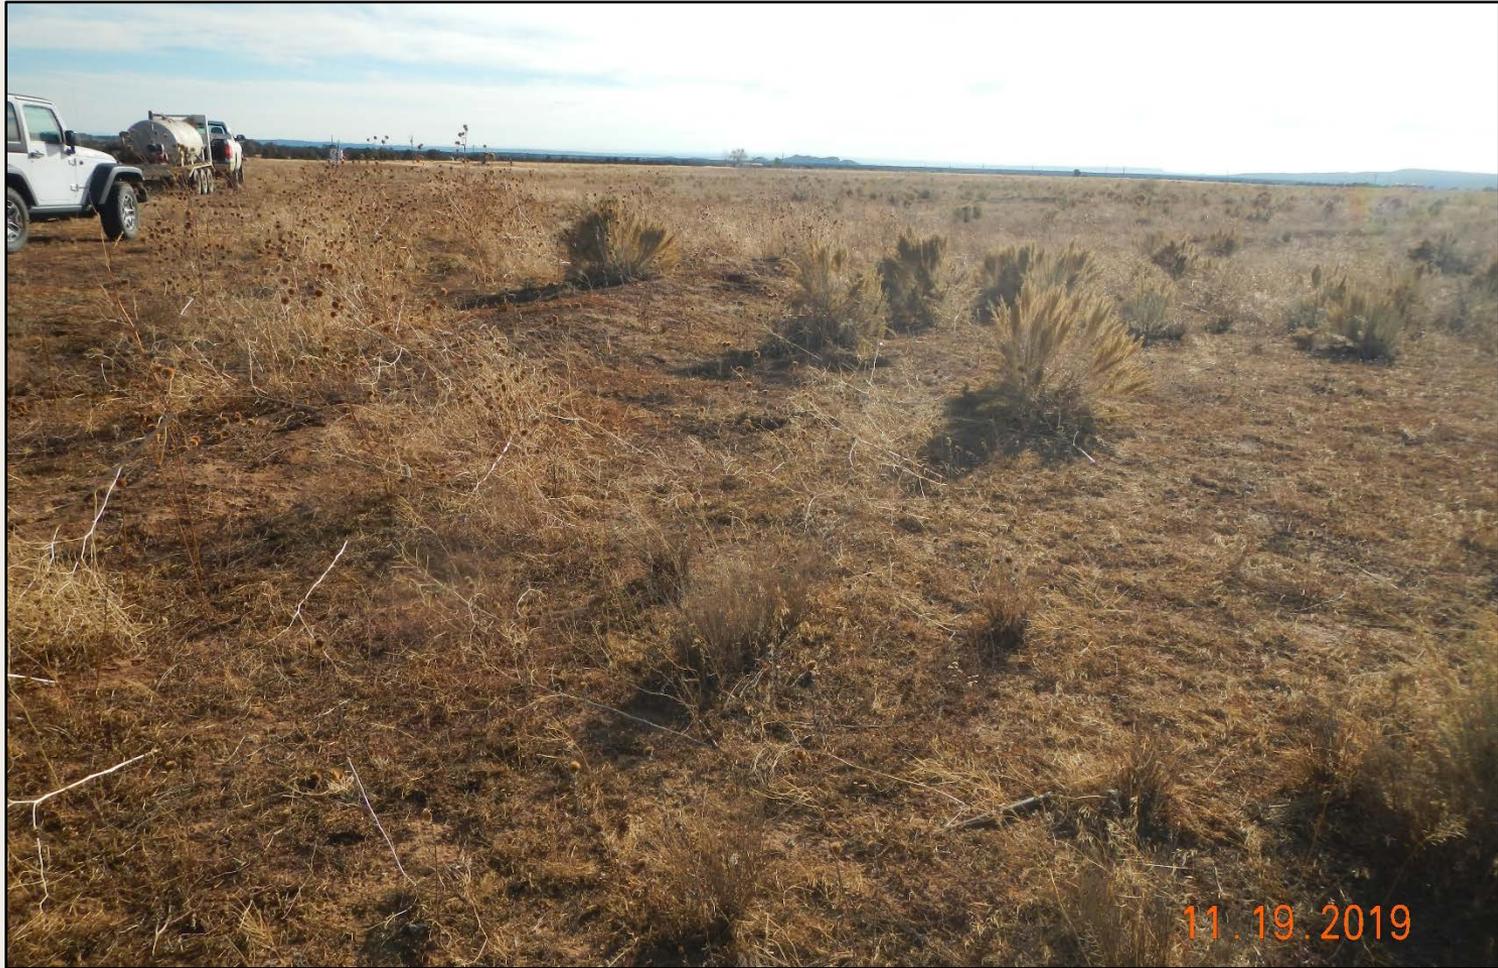
Photo 2. View of the western project area from the northwestern corner facing southward. Vegetation is comprised of big sagebrush, snakeweed, crested wheatgrass, and annual weeds such as yellow tumbled mustard.

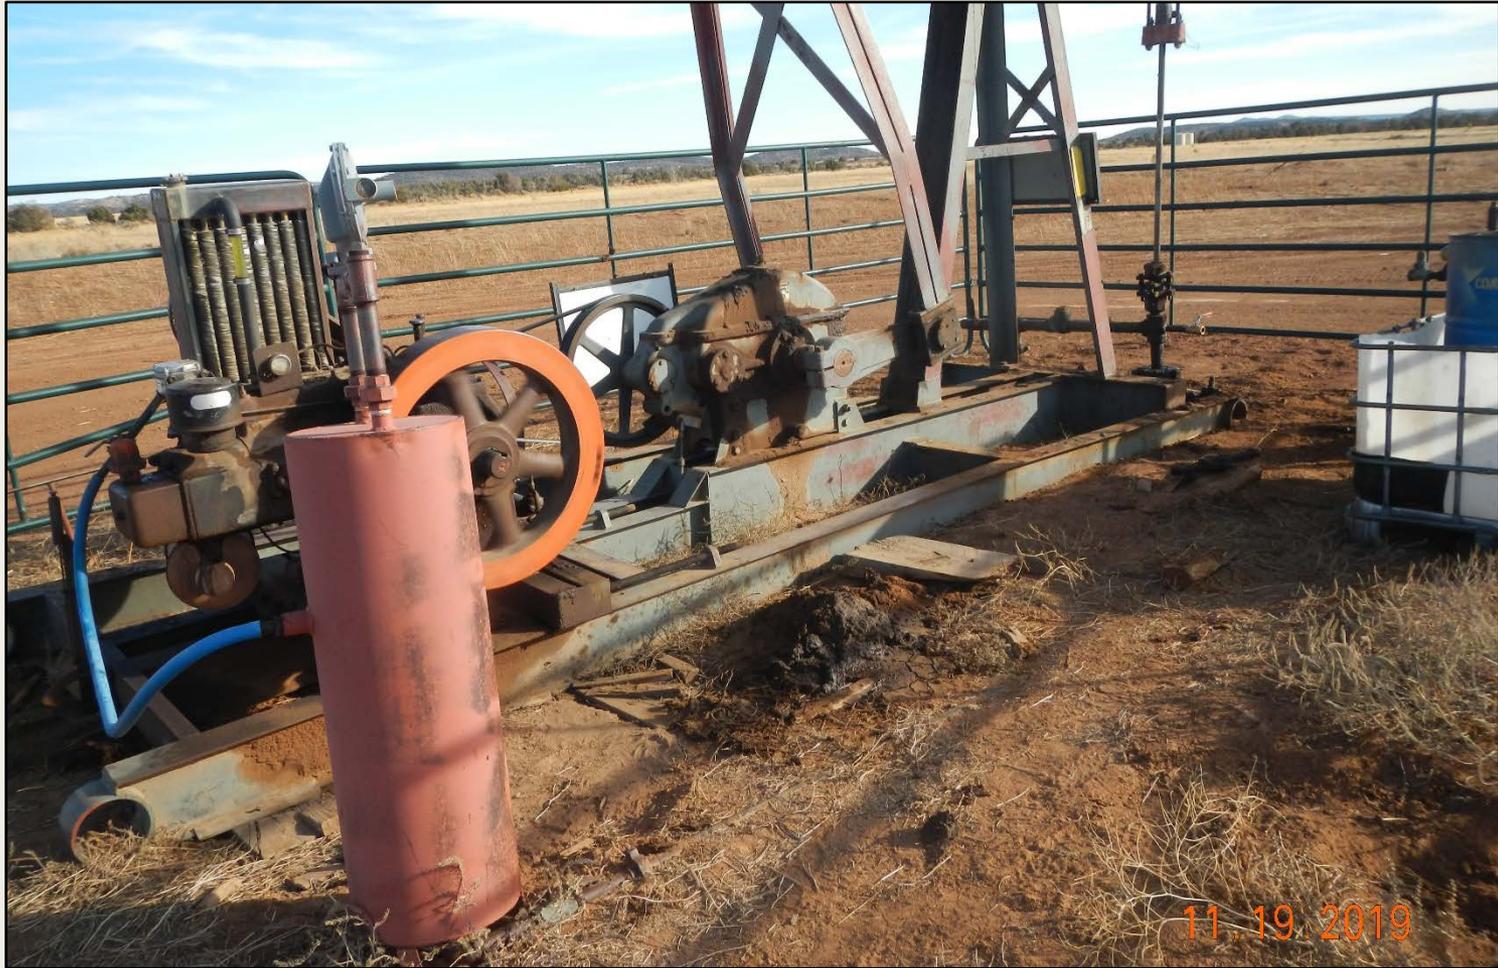
Photo 3. View of stained soils at well pump-jack, need to be cleaned and properly disposed of.
