Construction and Stormwater Inspection

December 9, 2019

Operator: VERDAD RESOURCES LLC- #10651

Location ID: 462094

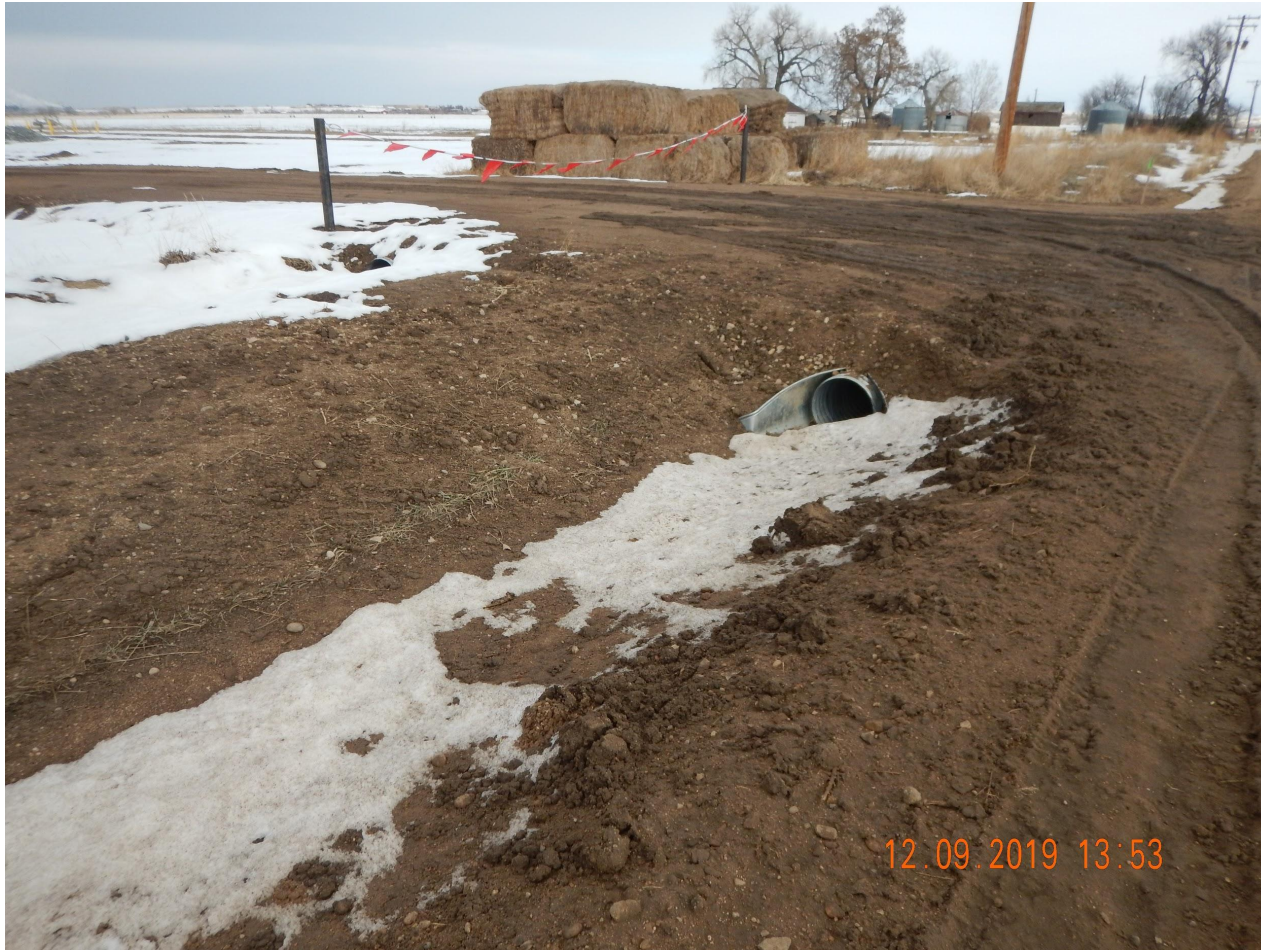
Photo 1. Photo taken from the entrance of location, facing East. Photo illustrates Operator has installed culverts, one of which is in conjunction with the roadside ditch.

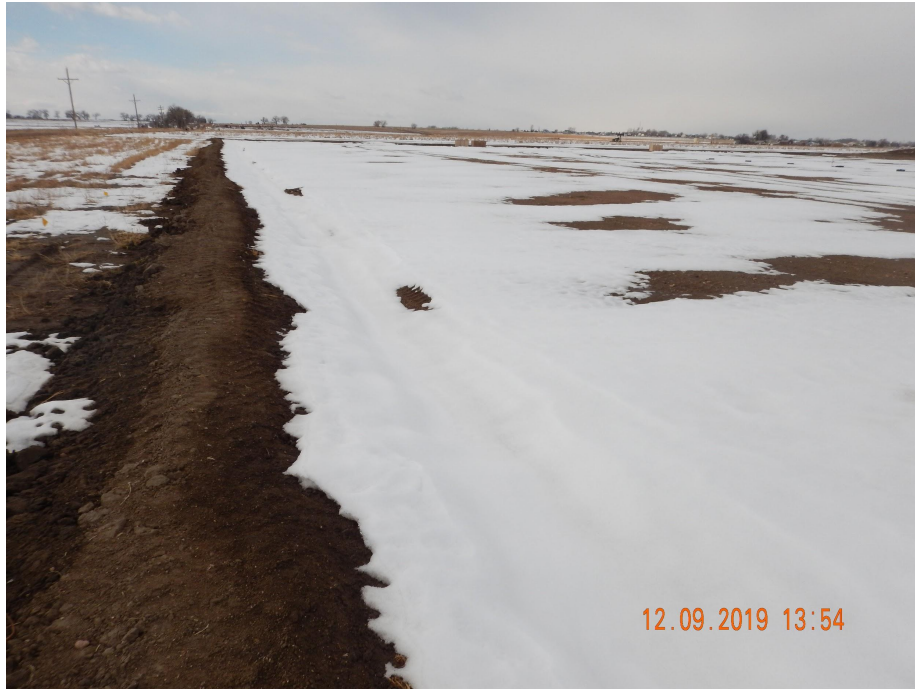
Photo 2. Photo taken from the southern perimeter of location, facing West. Photo illustrates a ditch and berm BMP.

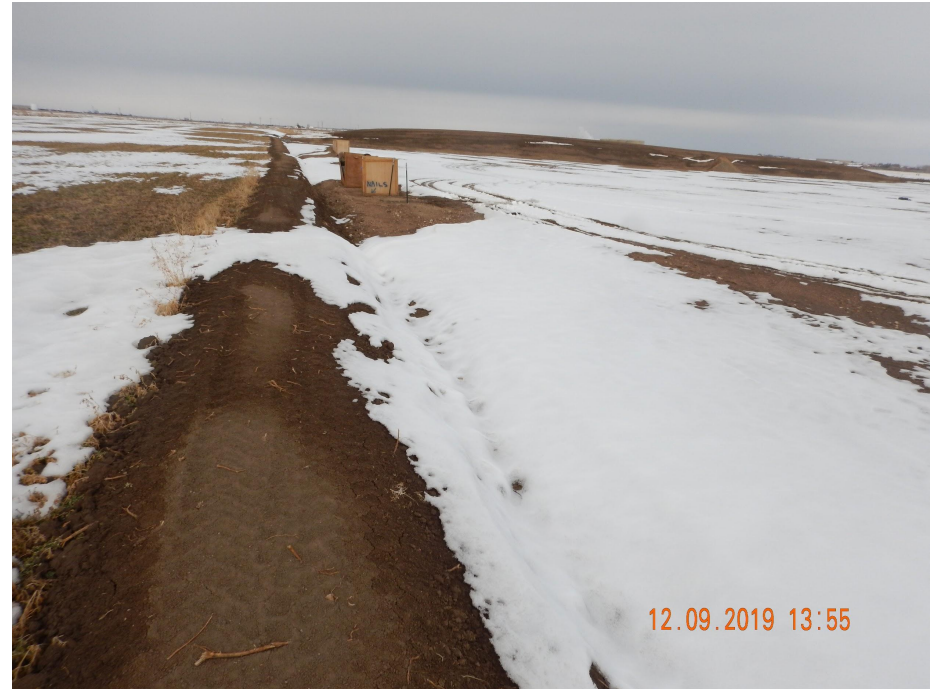
Photo 3. Photo taken from the southwestern perimeter of location, facing North. See comments under Photo 2.

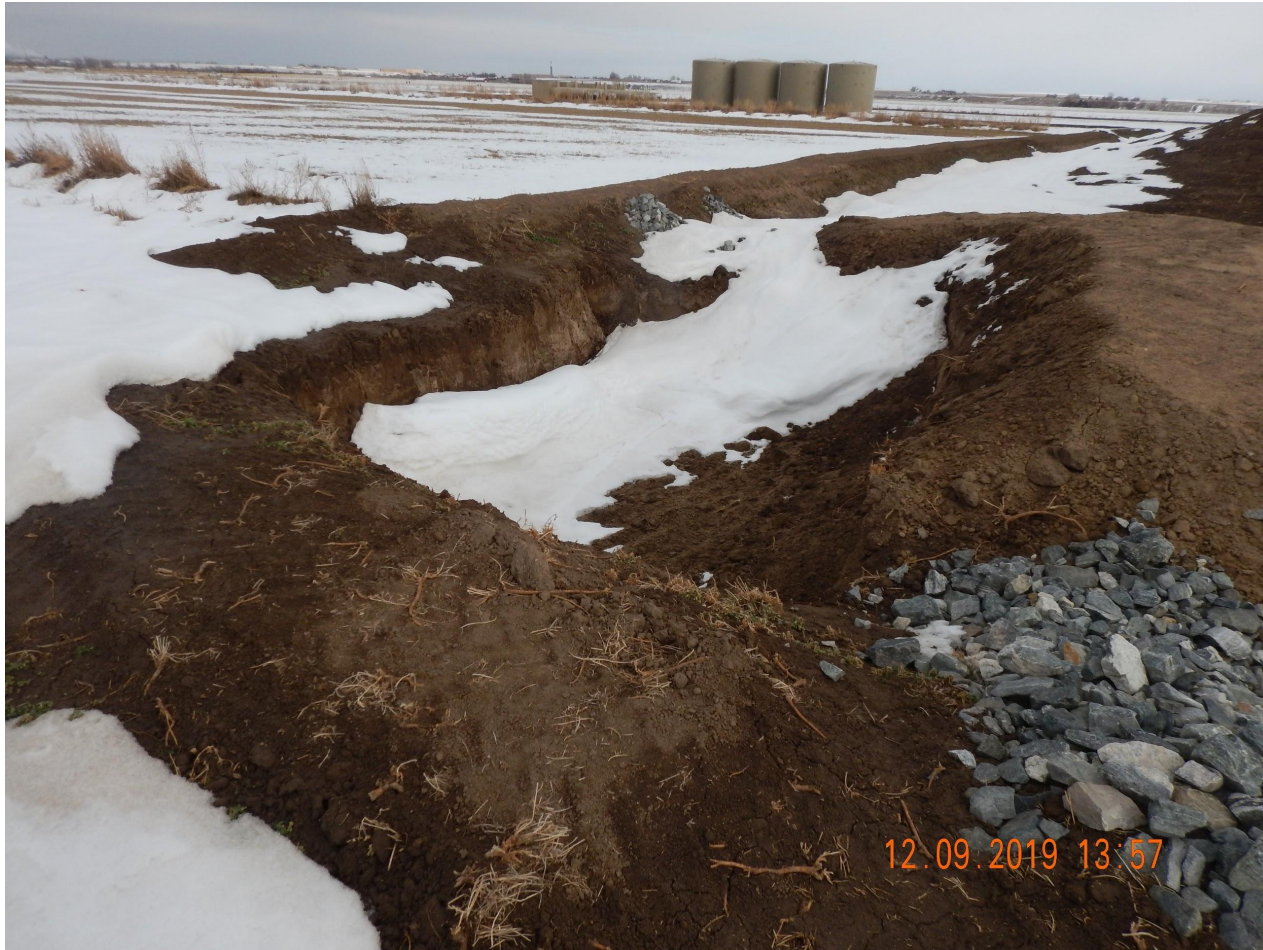
Photo 4. Photo taken from the western location, facing East. Photo illustrates Operator has installed a sediment trap in conjunction with the ditch and berm BMPs. Operator has not constructed the sediment trap with good engineering practices, as the side slopes should not be vertical (1:1) but rather 2:1 slope or flatter.

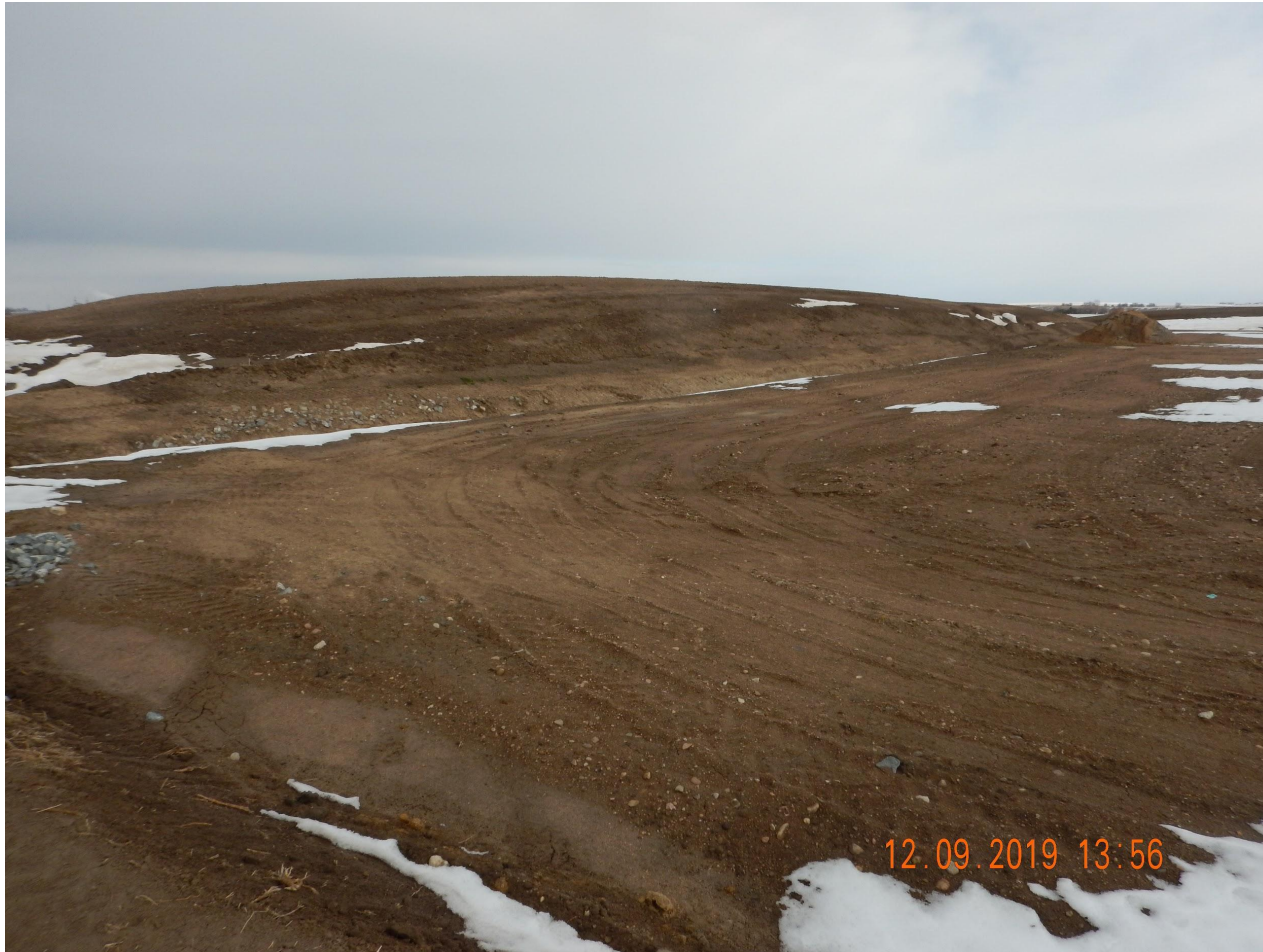
Photo 5. Photo taken from the western location, facing East. Photo illustrates one of two topsoil stockpiles which has been temporarily stabilized with equipment tracking.

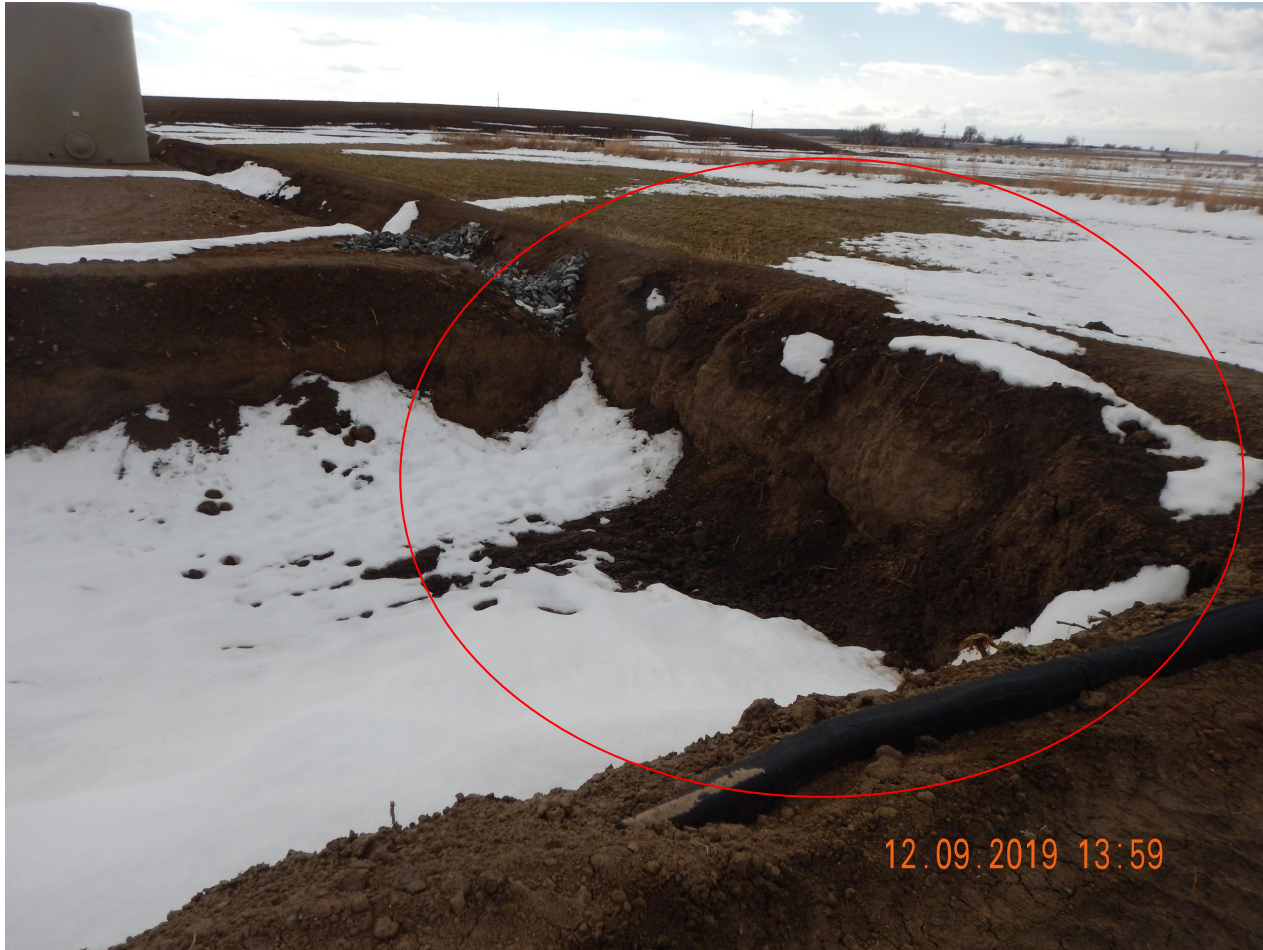
Photo 6. Photo taken from the northwestern location, facing East. See comments under Photo 4.

Also, photo illustrates sloughing of the sediment trap because of a vertical side slope.

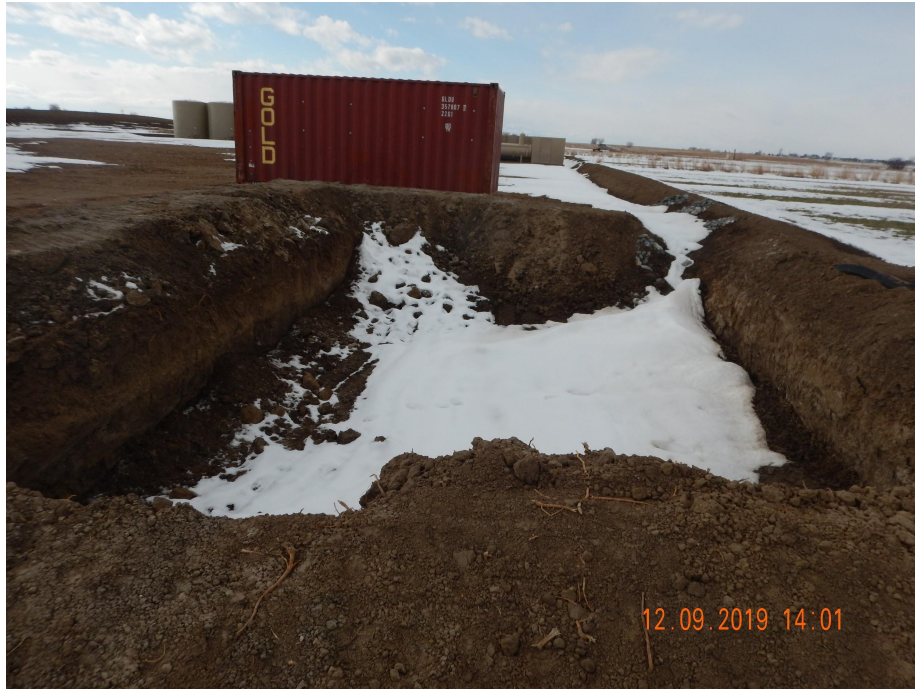
Photo 7. Photo taken from the northeastern perimeter of location, facing West. See comments under Photo 4.

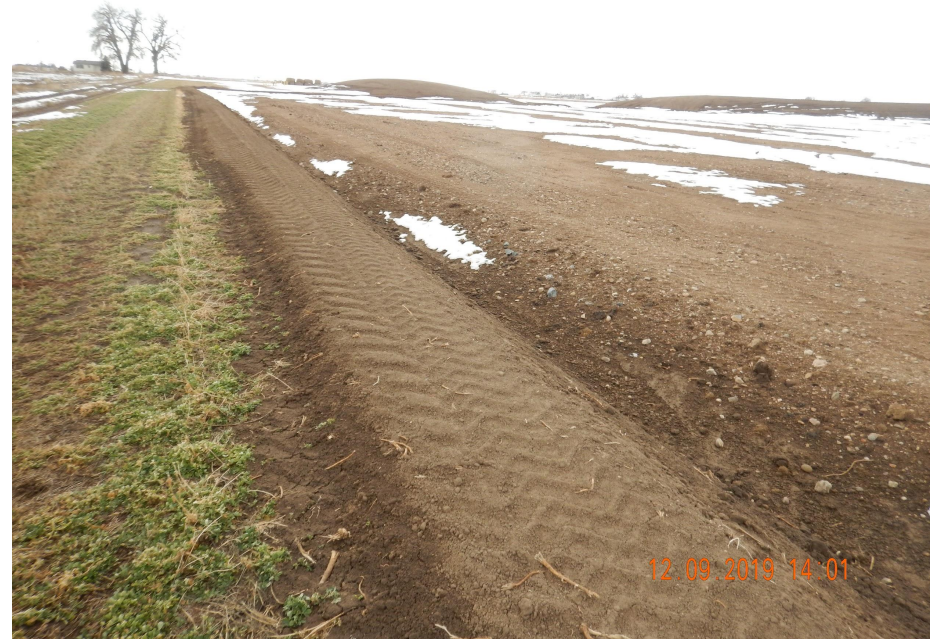
Photo 8. Photo taken from the eastern perimeter of location, facing South. See comments under Photo 2.

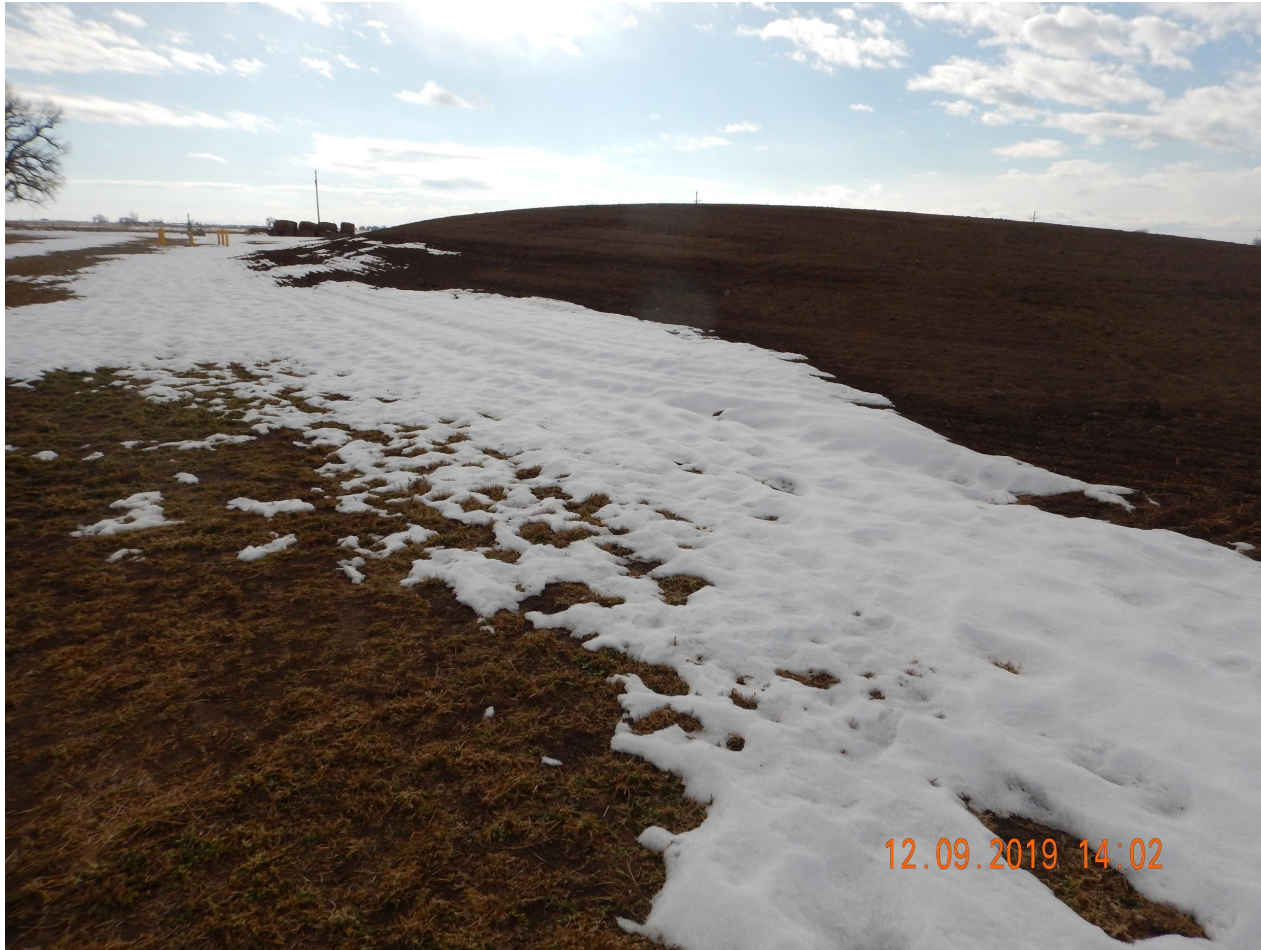
Photo 9. Photo taken from the southeastern location, facing South. Photo illustrates the second topsoil stockpile. With the snow cover it is hard to demonstrate, but there is not perimeter BMP around the topsoil stockpile.
