## Inspection Photos

Location Name: UPTOWN FEDERAL 22-27

API#: 05-071-06725

INSP. #: 695101944

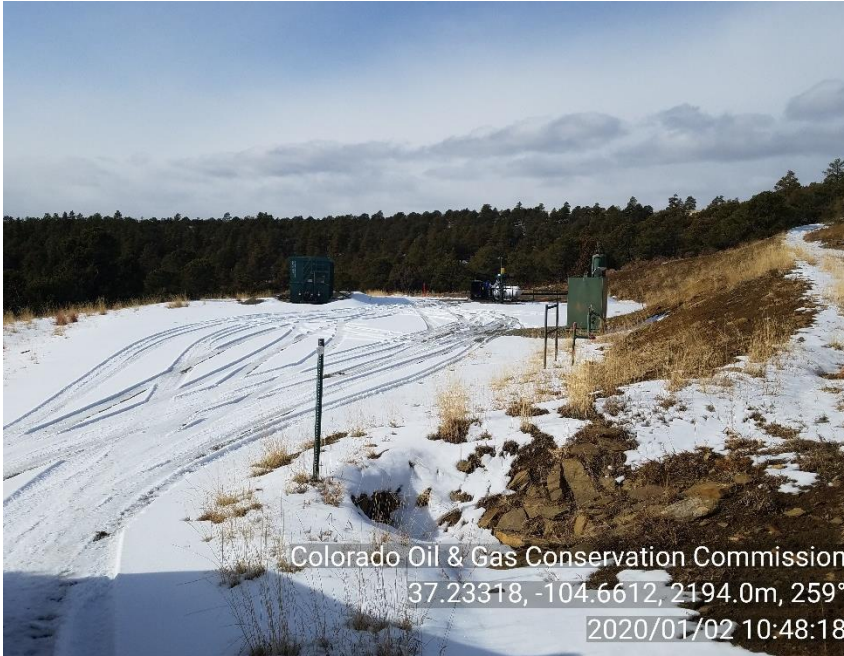
PHOTO 1: WELLHEAD

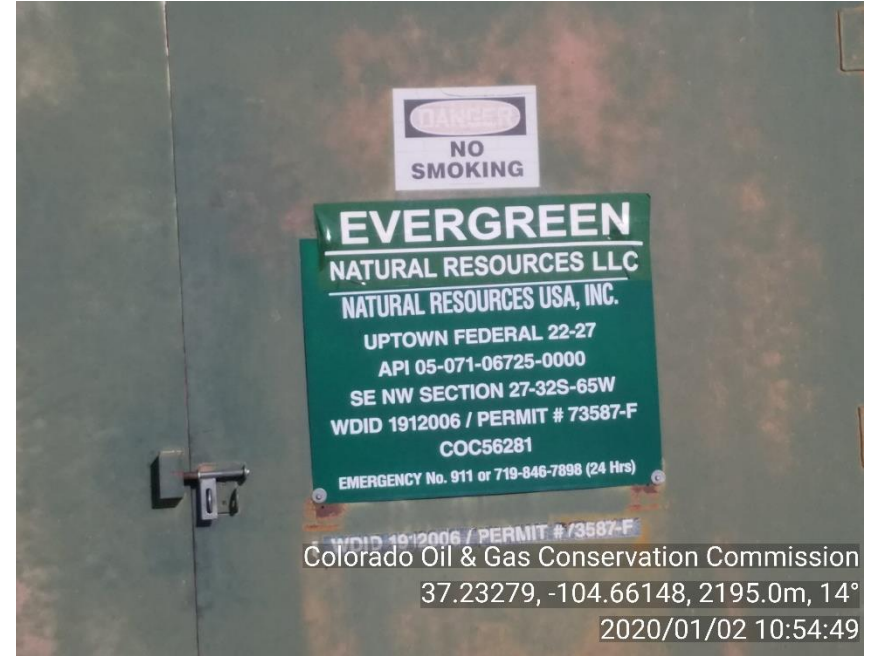
PHOTO 2: WELL SIGN

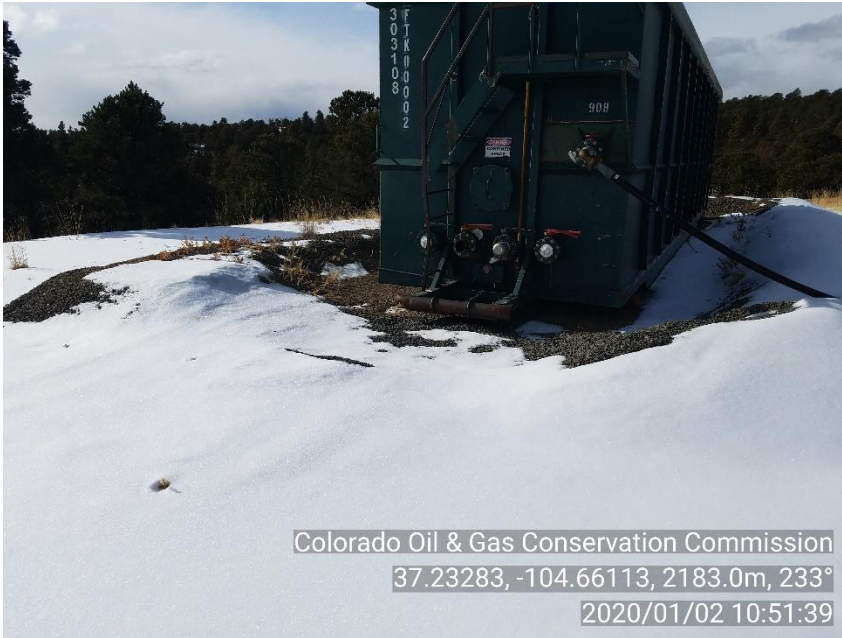
**PHOTO 3: IT APPEARS THAT BURN IN FRONT OF TANK HAS BEEN RAN OVER SEVERAL TIMES AND IS NO LONGER ADEQUATE. Repair or install berms or other secondary containment devices per Rule 605.a.(4). CA DATE 2/2/2020.**

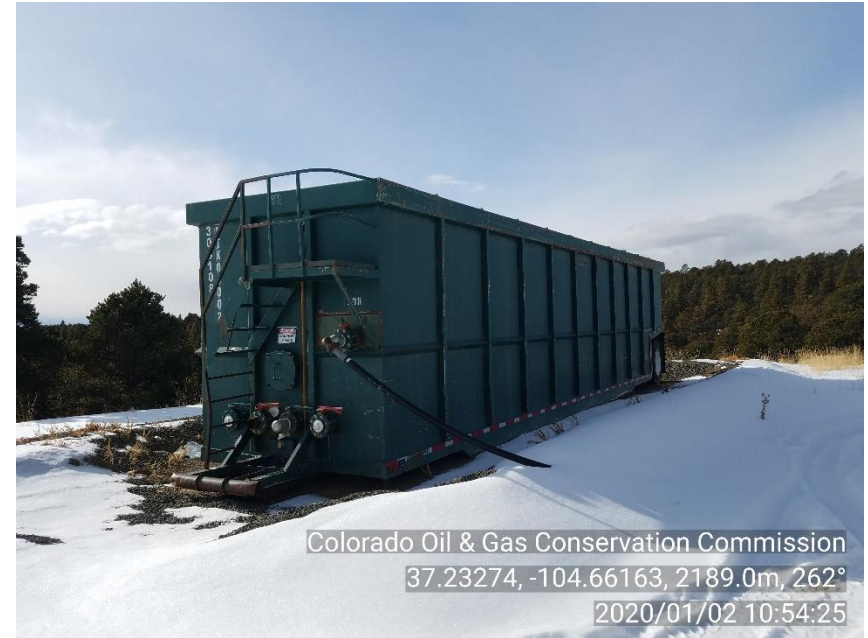
**PHOTO 4: NO NFPA STICKER POSTED ON TANK. TANK CAPACITY NOT POSTED ON TANK. INSTALL SIGN TO COMPLY WITH RULE 210.d. CA DATE 2/2/2020.**
