# Interim Reclamation and Stormwater Inspection

Operator: MALLARD EXPLORATION LLC- #10670

Location ID: 420020

Inspection Photos  
Location Name: Cass Farms #11-25H  
Location ID: 420020

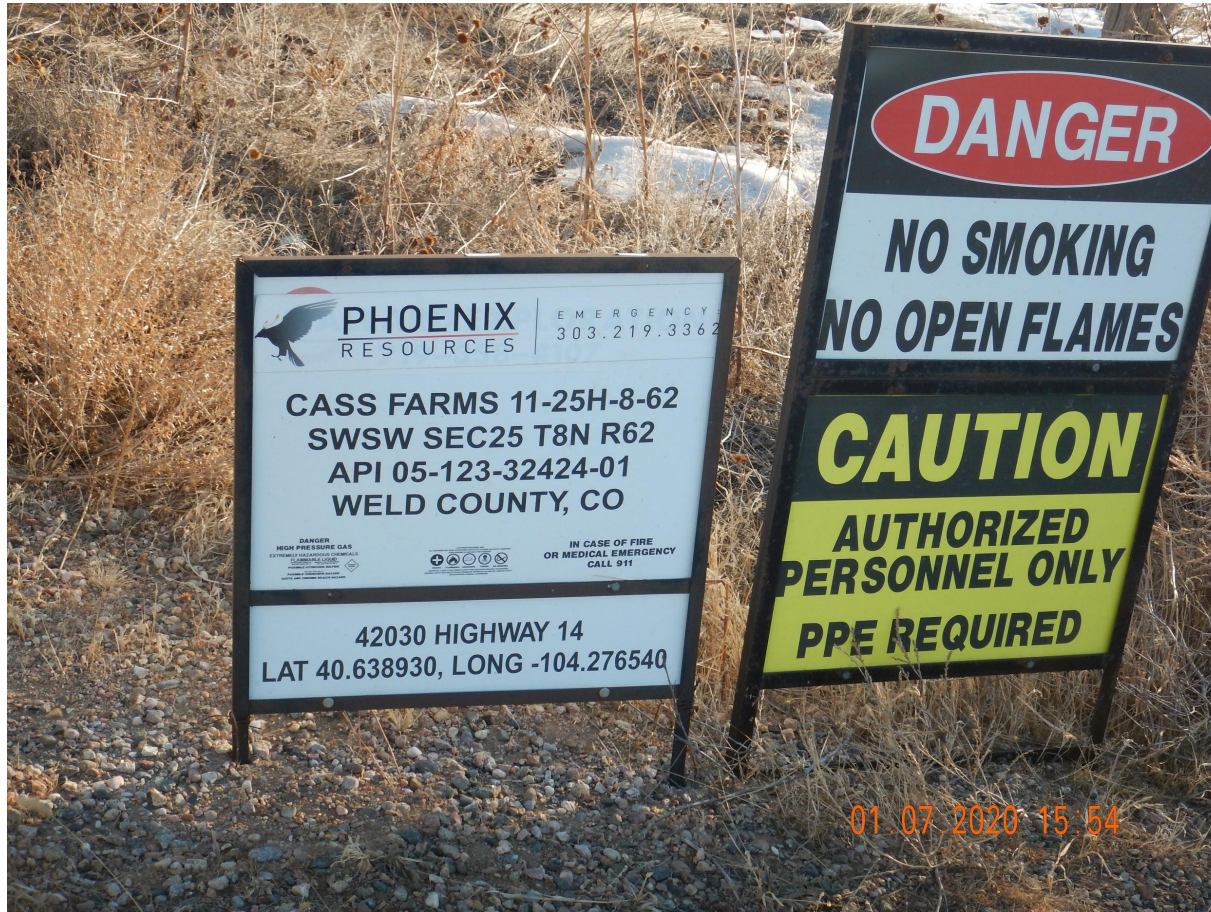
**Photo 1.** Photo taken from the entrance of location, facing South. Photo illustrates Operator sign.

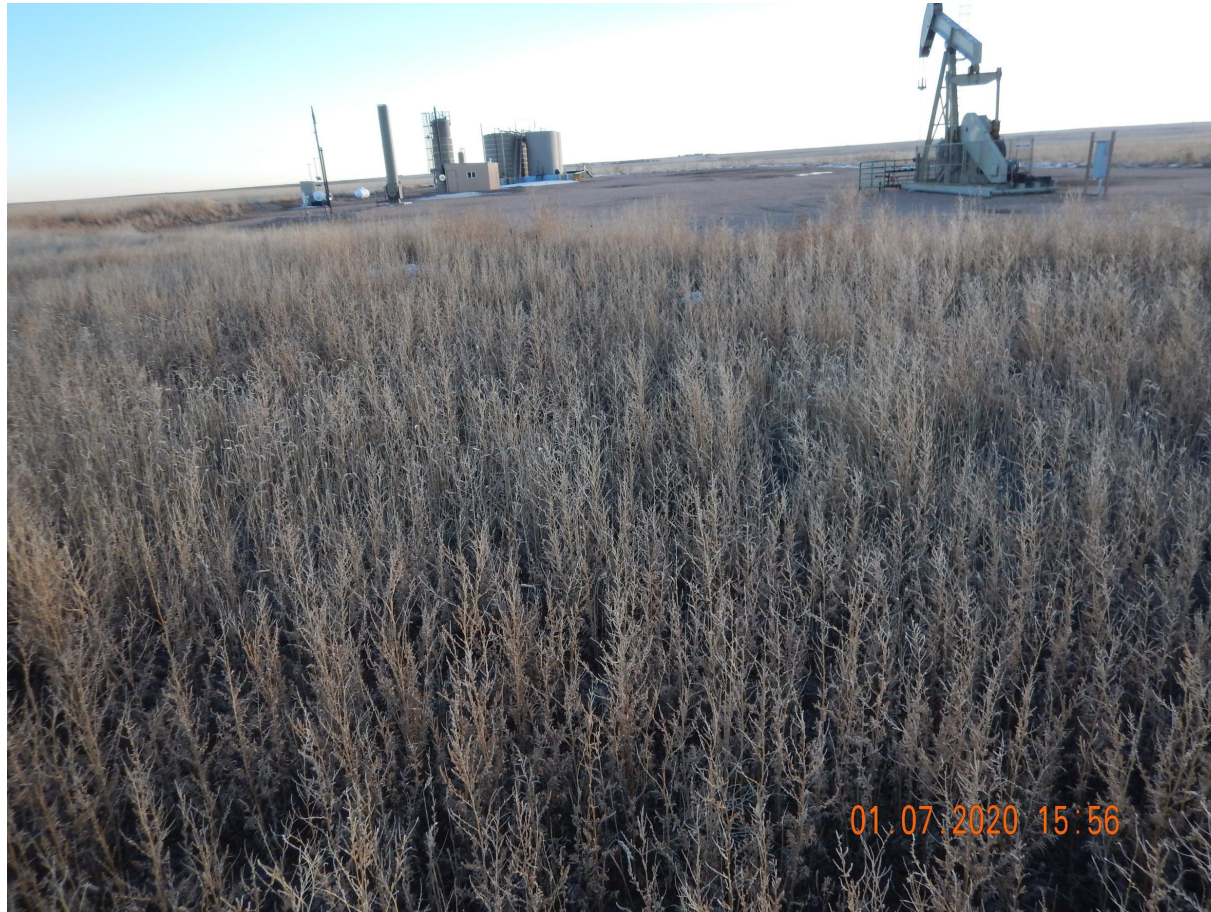
**Photo 2.** Photo taken from the northern interim reclamation area, facing South. Photo illustrates location has been reduced in size only needed for production operations; however, this location does not meet Rule 1003 vegetative standards. Photo also illustrates the high density of weedy annual vegetation, Kochia, which is not reflective of reference area vegetation.

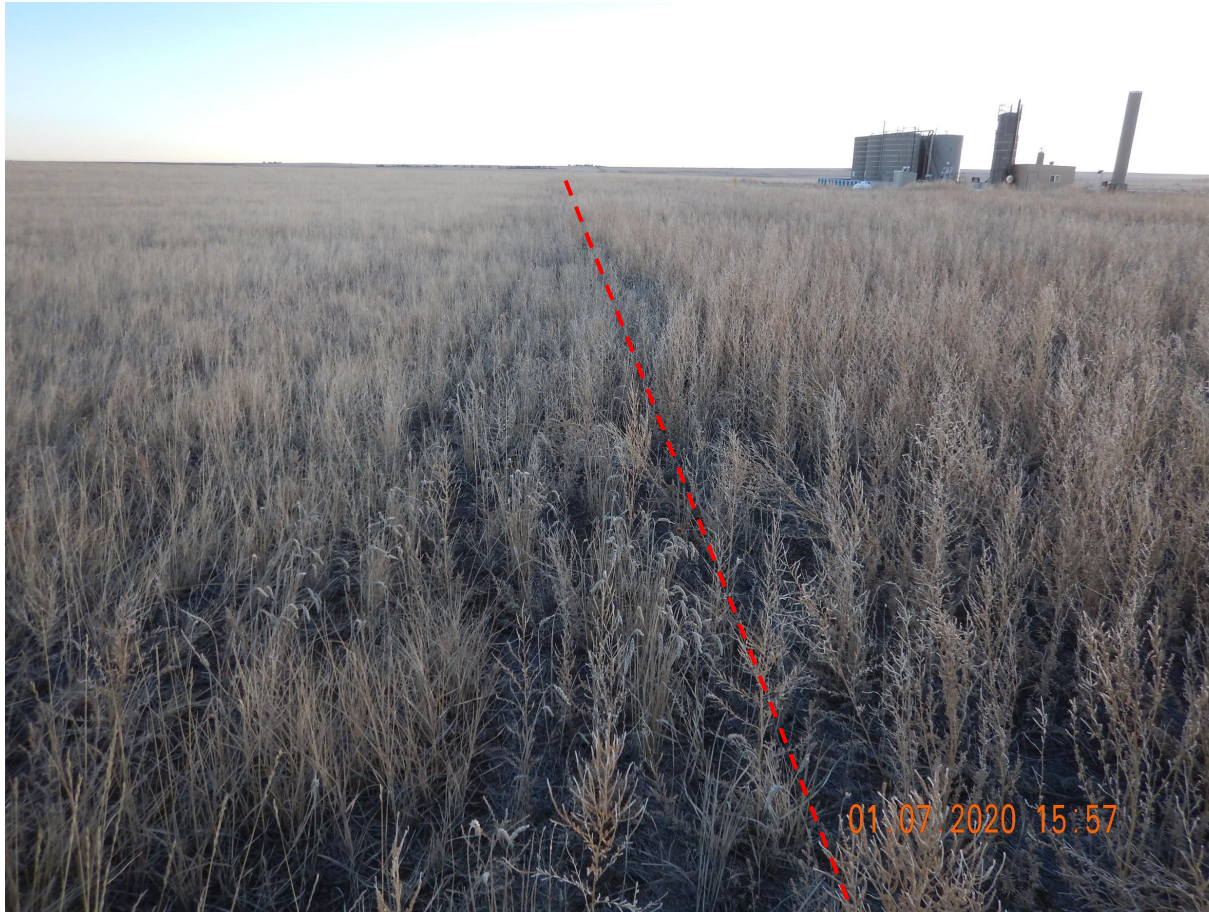
**Photo 3.** Photo taken from the northeastern interim reclamation area, facing South. Photo illustrates the high density of weedy annual vegetation, Kochia, and how that compares to the reference area vegetation. Interim reclamation area is to the right of the red-dashed line.

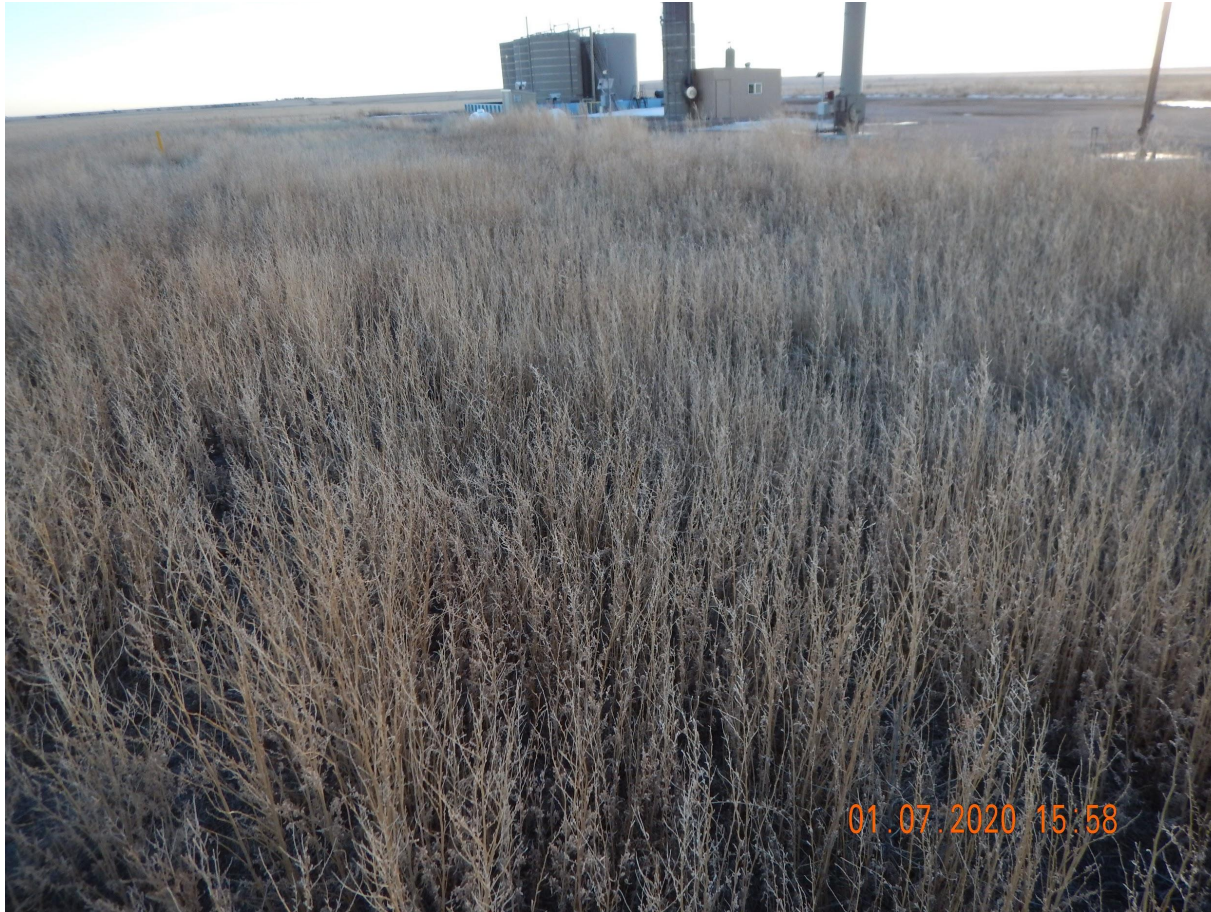
**Photo 4.** Photo taken from the eastern interim reclamation area, facing Southwest.  
See comments under Photo 2.
