Construction and Stormwater Inspection

January 8, 2020

Operator: RED HAWK PETROLEUM LLC - #10503

Inspection Photos
Location Name: L.E. Gerkin /9H
Location ID: 448913

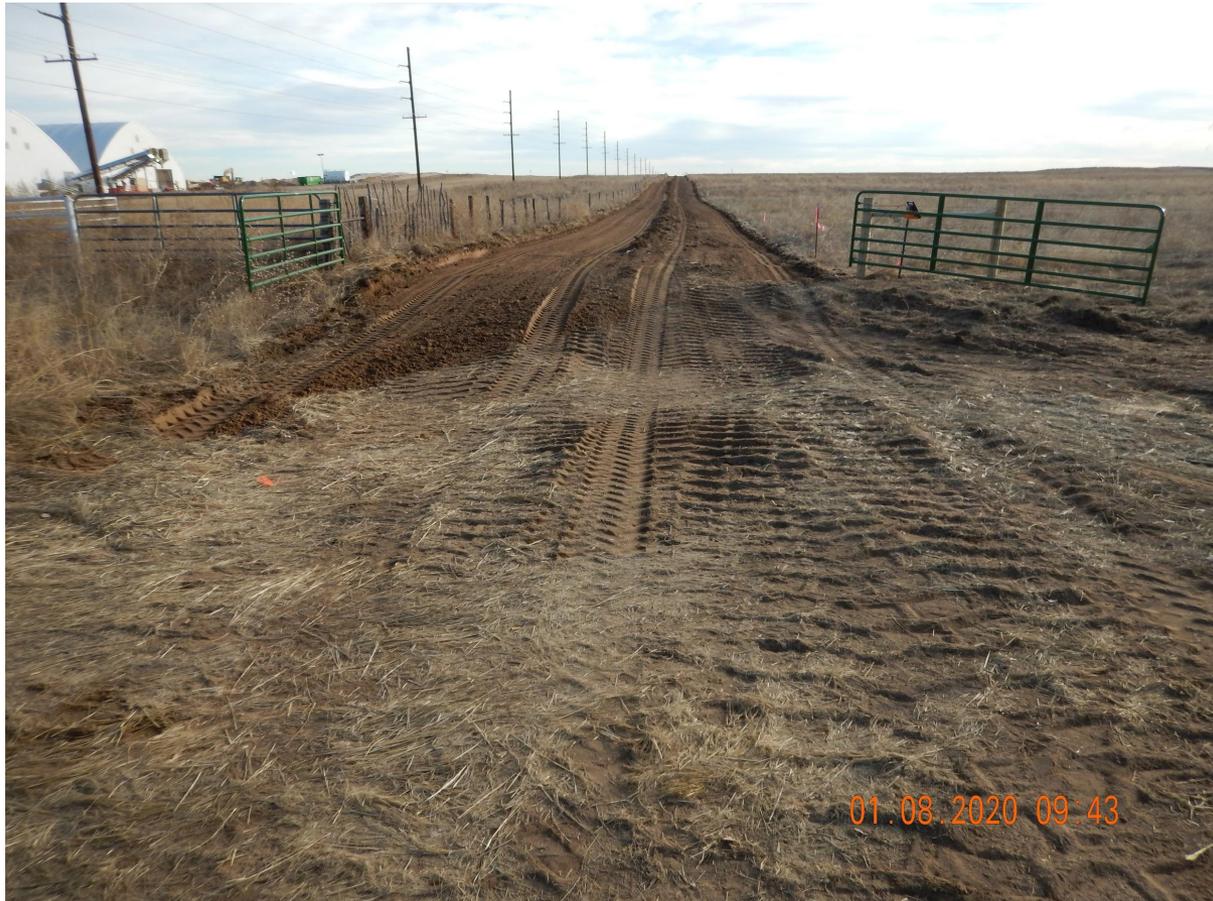
Photo 1. Photo taken from the entrance of location, facing East. Photo illustrates Operator has not yet installed vehicle tracking device BMPs. Operator should consider installing this as one of the first BMPs.

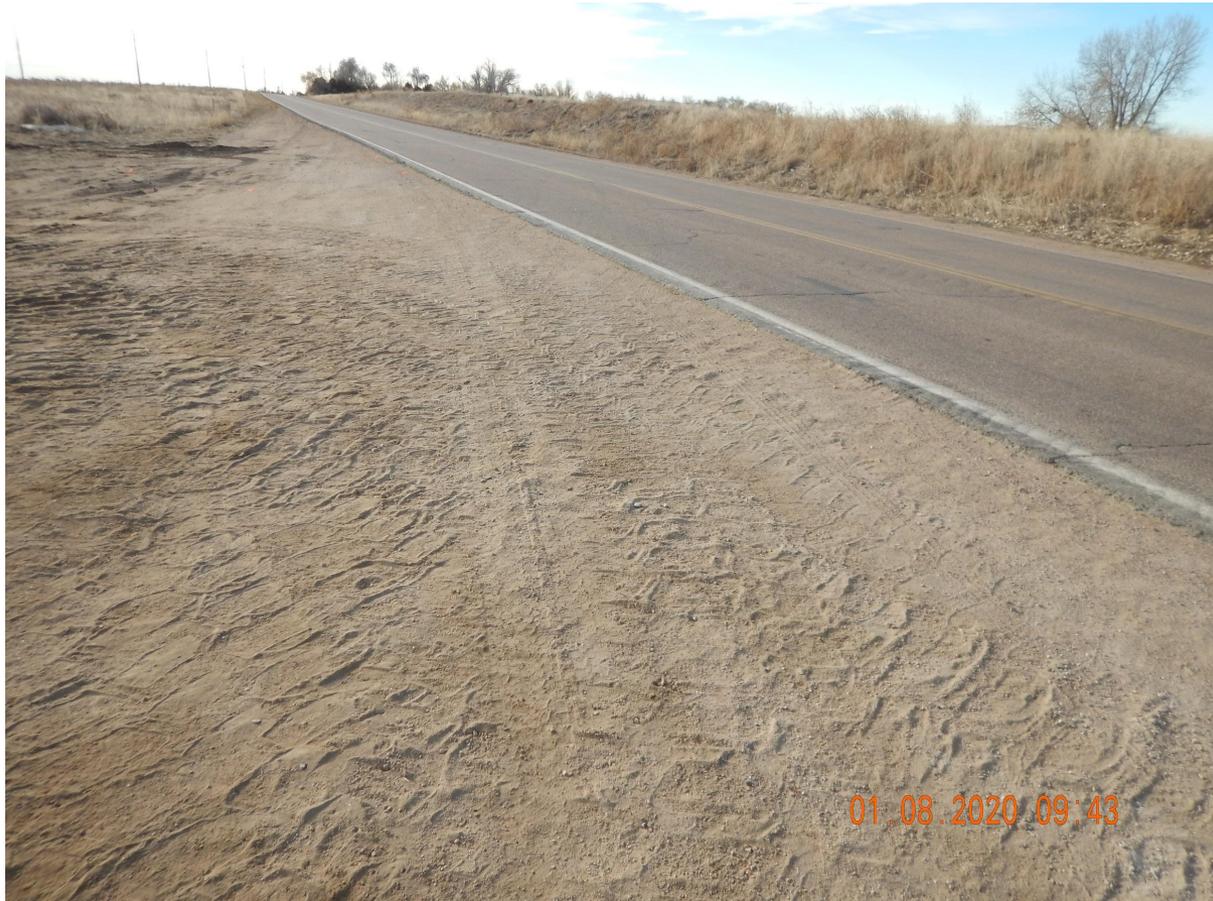
Photo 2. Photo taken from the entrance of location, facing South. Photo illustrates at the time of this inspection, there was no track out issues observed.

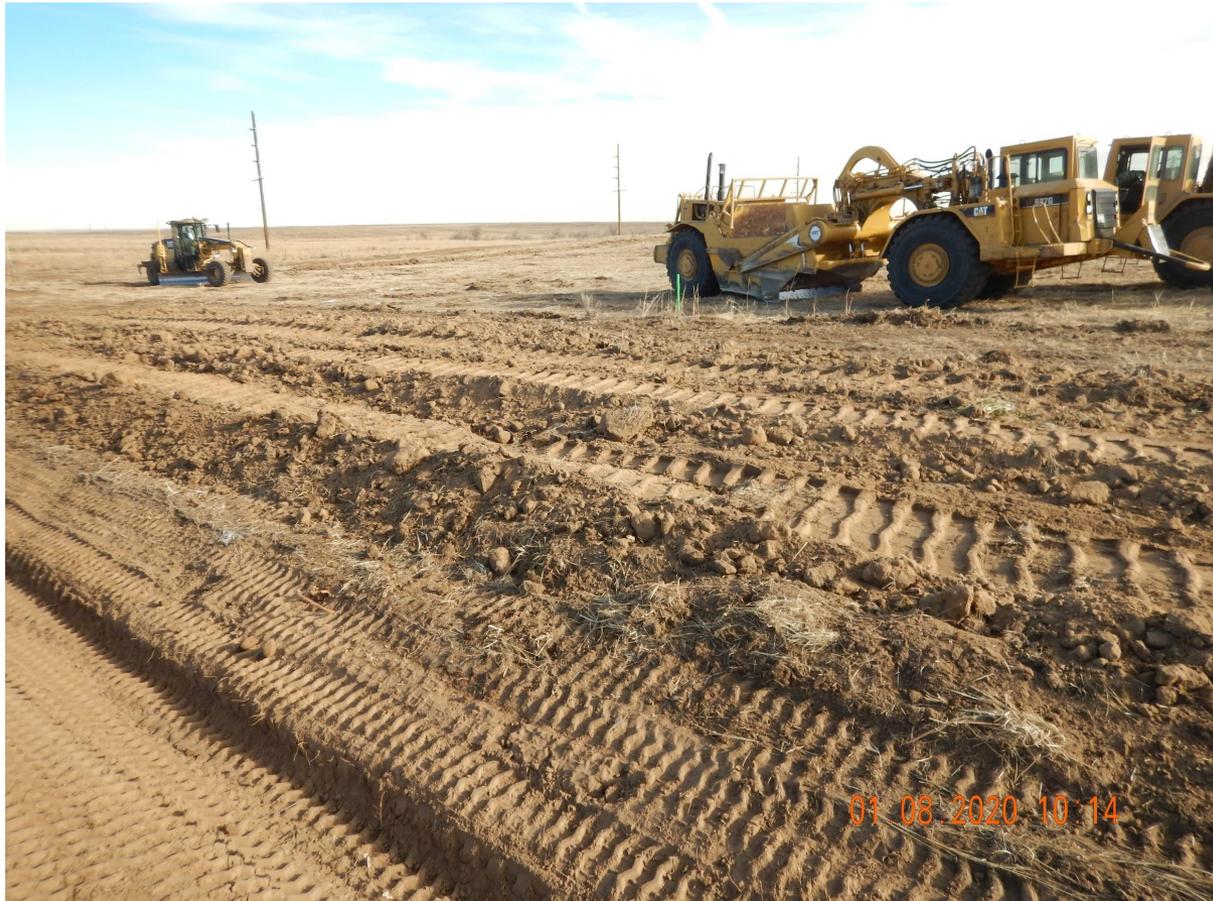
Photo 3. Photo taken from the western perimeter of location, facing Northeast. Photo illustrates topsoil is being salvaged and stored along the western perimeter of location.

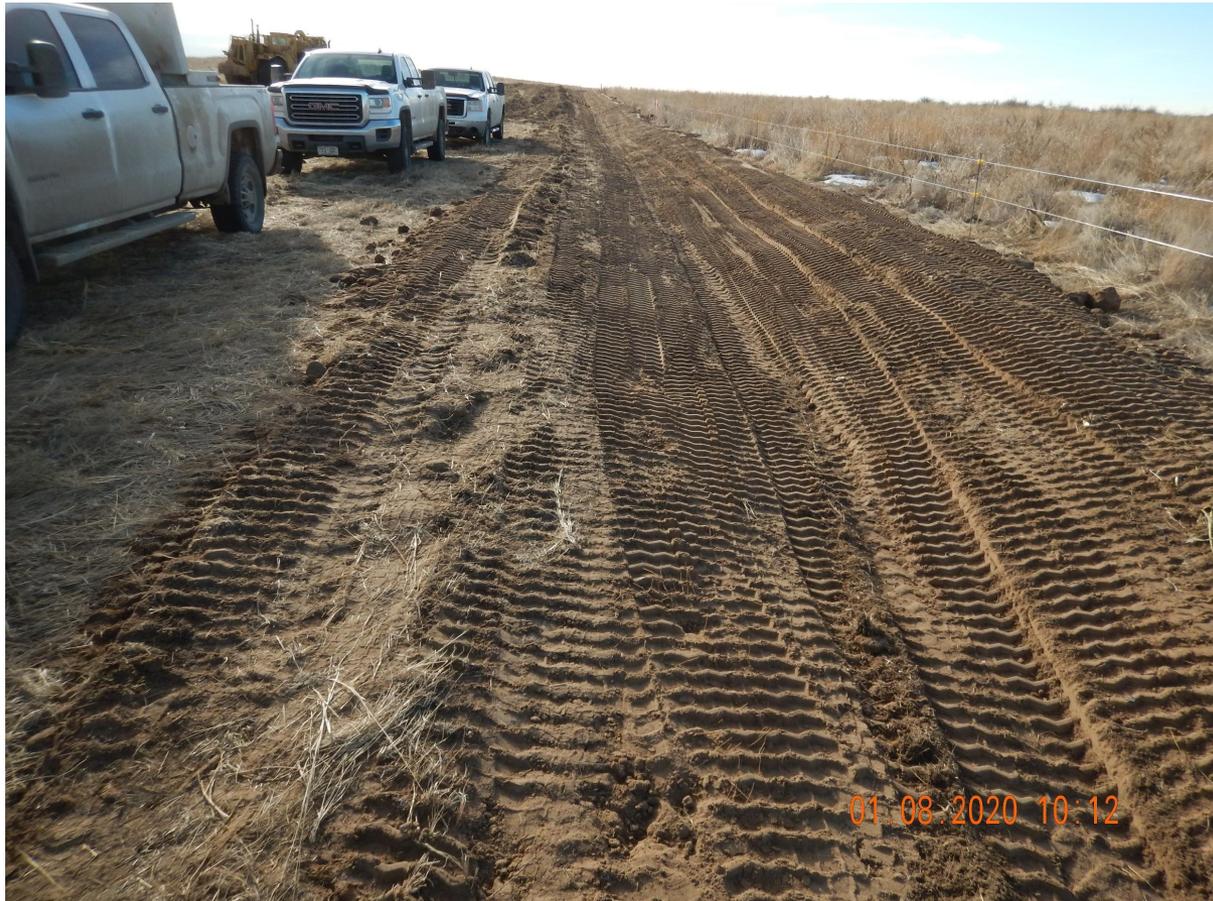
Photo 4. Photo taken from the northwestern perimeter of location, facing South. Photo illustrates a temporary BMP, ditch, that has been installed around the perimeter of location.

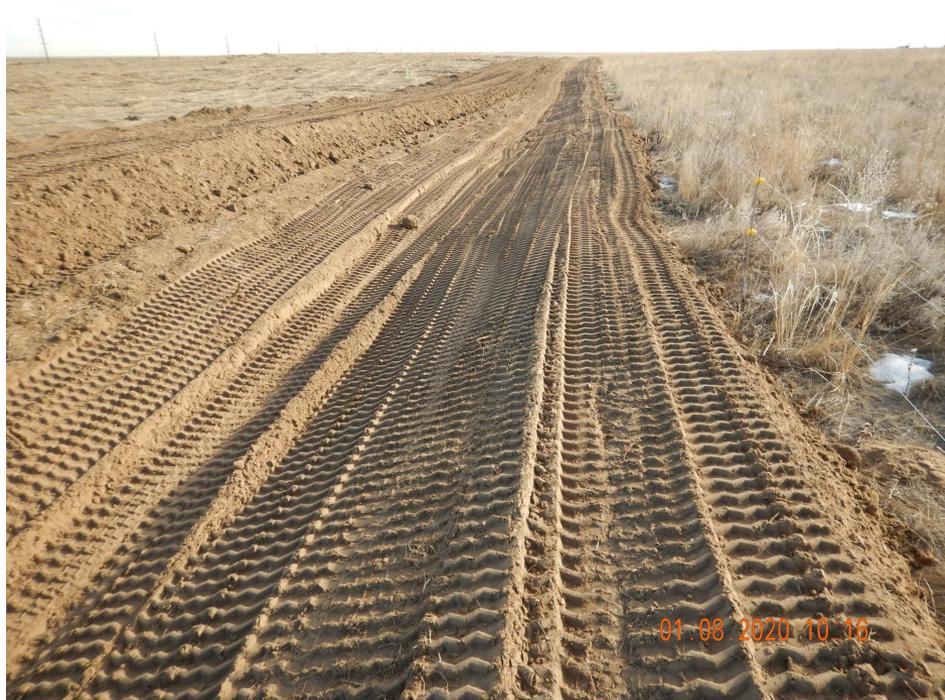
Photo 5. Photo taken from the southwestern perimeter of location, facing East. See comments under Photo 4.

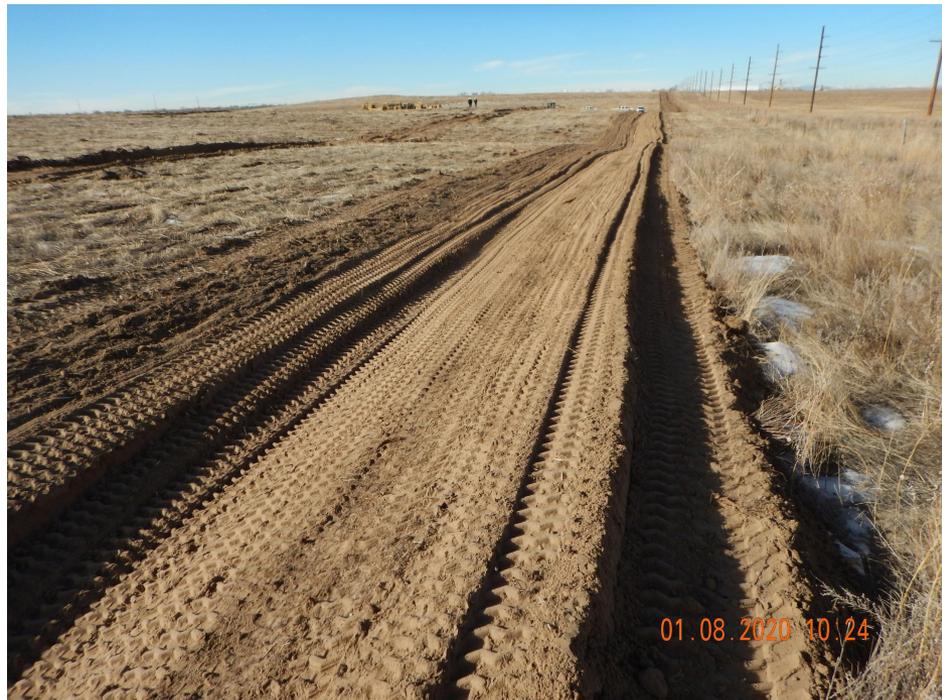
Photo 6. Photo taken from the northeastern perimeter of location, facing West. See comments under Photo 4.

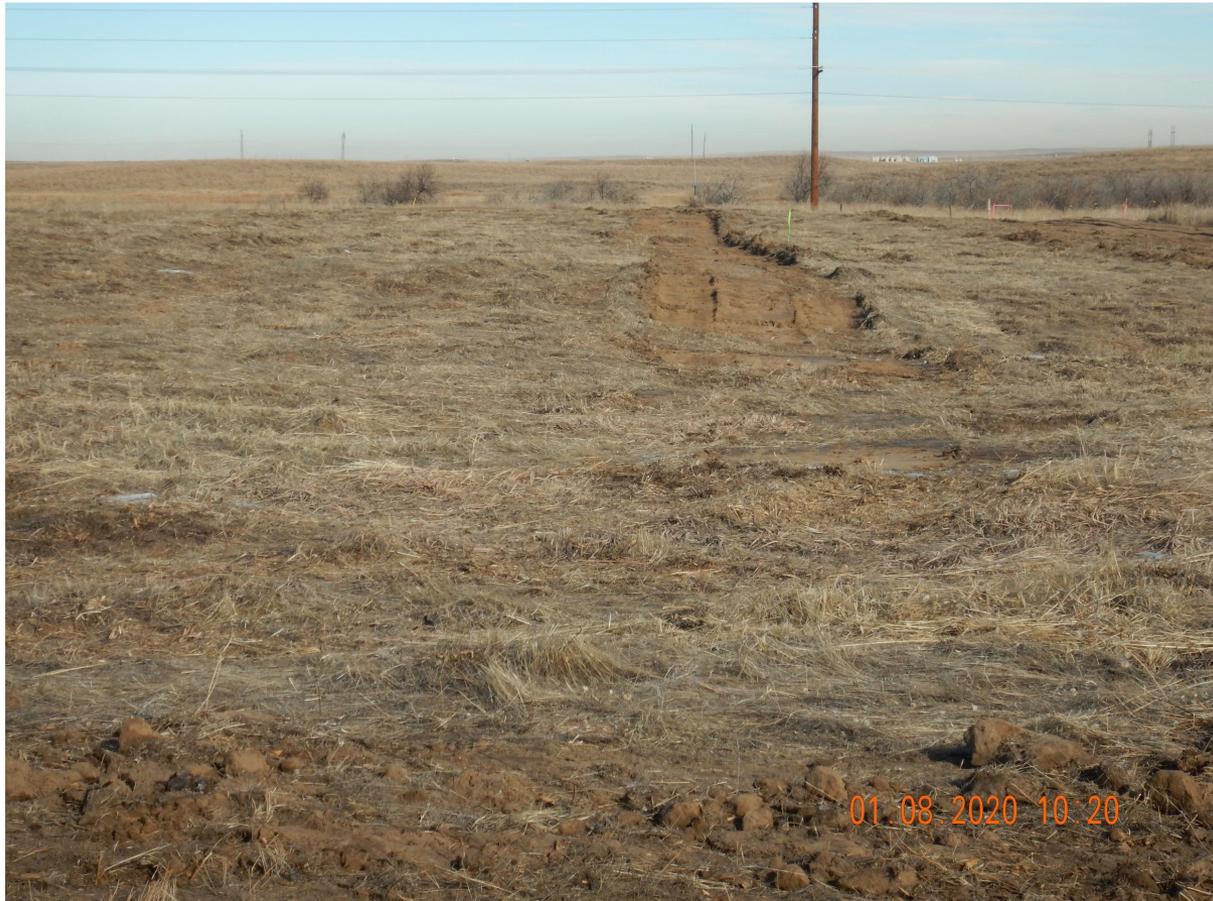
Photo 7. Photo taken from the southern perimeter of location, facing North. Photo illustrates Operator is in-process of performing topsoil salvage operations.
