Inspection Photos

Location Name: ZUESS FEDERAL 11-10 CA DATE 2-15-20

API#: 05-071-09529

INSP. #: 695102016

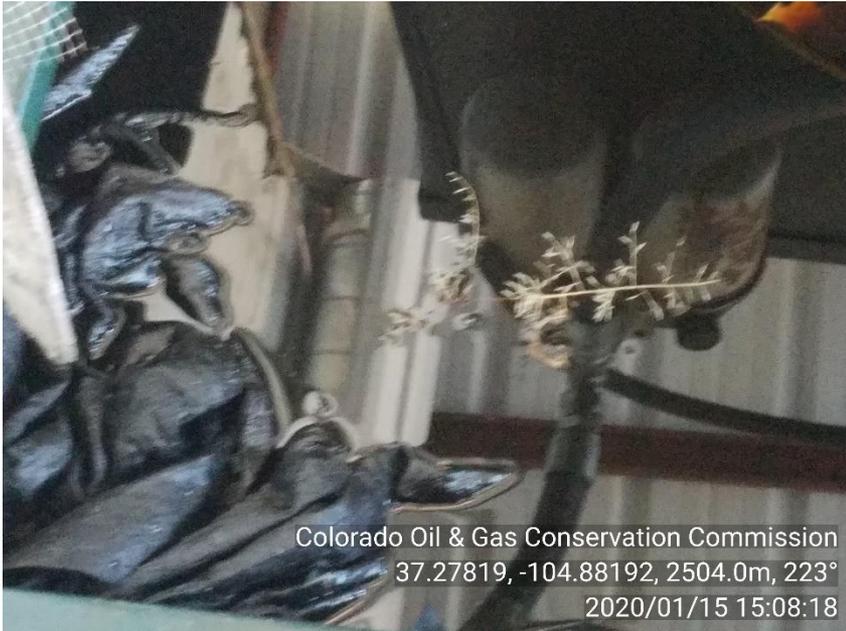
PHOTO 3: THERE IS APP. 1" TO 2" OF STANDING OIL INSIDE ENGINE SKID (ALTHOUGH ENGINE SKID IS INSIDE A BUILDING THE GARAGE STYLE DOOR IS FULL OPEN AT TIME OF INSPECTION ALLOWING WILDLIFE TO BE ABLE TO GET TO IT). Comply with general provisions of the oil and gas act for wildlife protection. CA DATE 1-20-20.
