## Inspection Photos

Location Name: RADISH 44-8 CA DATE 2-16-20

API#: 05-071-09376

INSP. #: 695102052

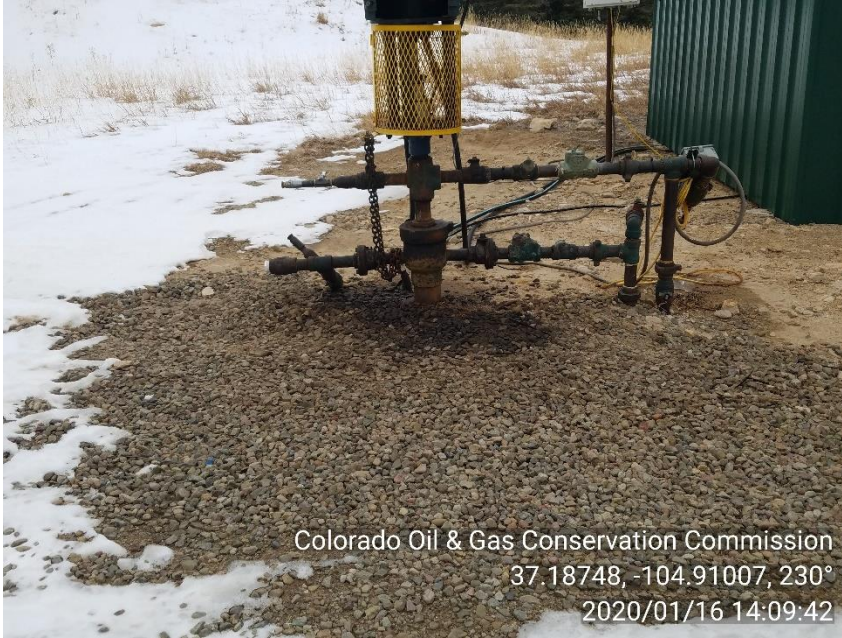
**PHOTO 3: AREA OF IMPACTED SOIL NEAR WELLHEAD  
APPEARS TO BE COMING FROM DRIVEHEAD. Non E&P Waste  
not properly stored, handled, transported, treated, or  
disposed per Rule 907A. CA DATE 2-16-20**
