Final Reclamation Inspection

Operator: BATES* JAMES EDWARD - 6575

API #: 05-005-06064

Inspection Photos
Location Name: PRICE #1
API #: 05-001-06796

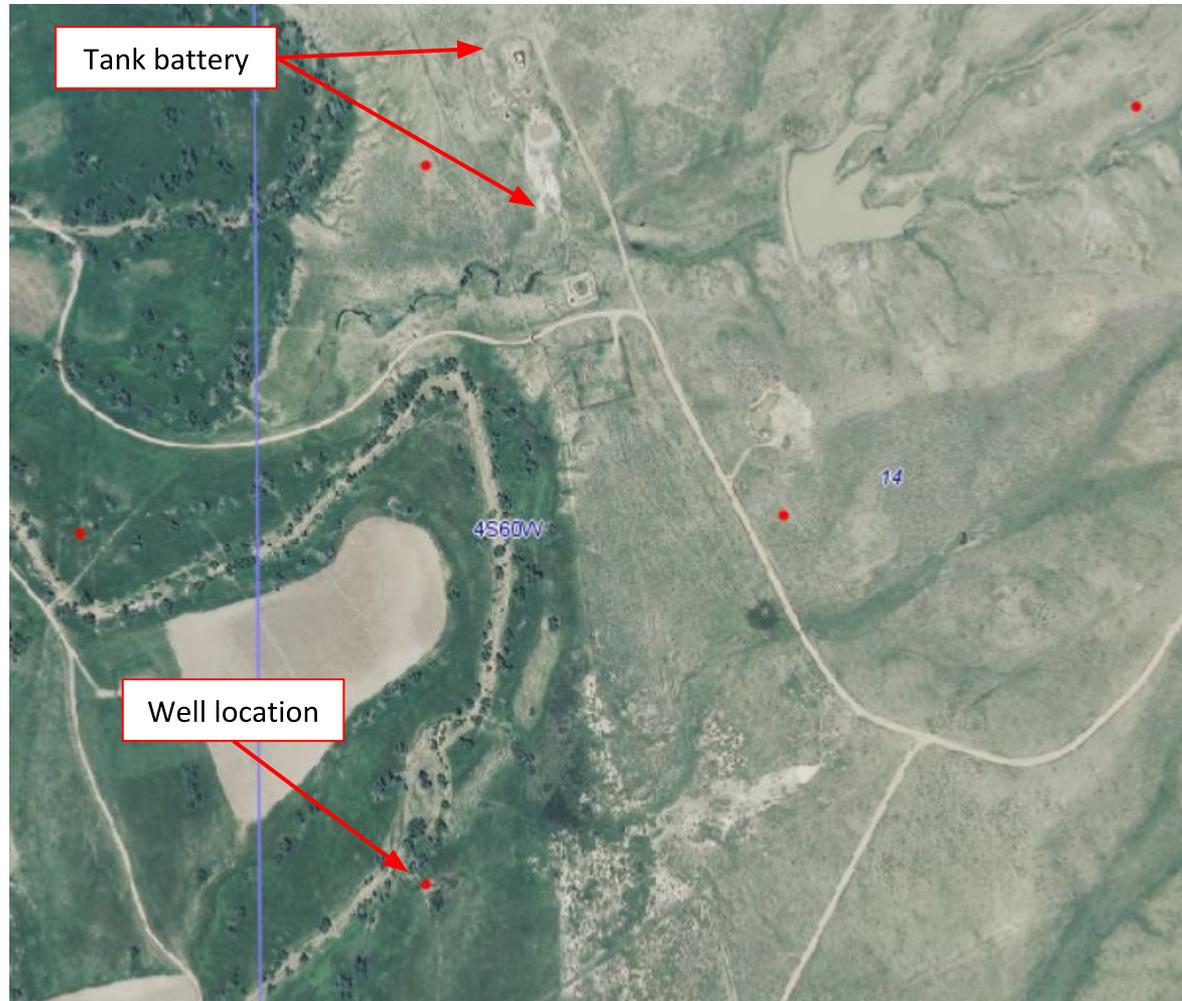
Photo 1. COGCC GISOnline aerial imagery from 2009 during active operations. Imagery illustrates the location of the well and the offsite tank battery.

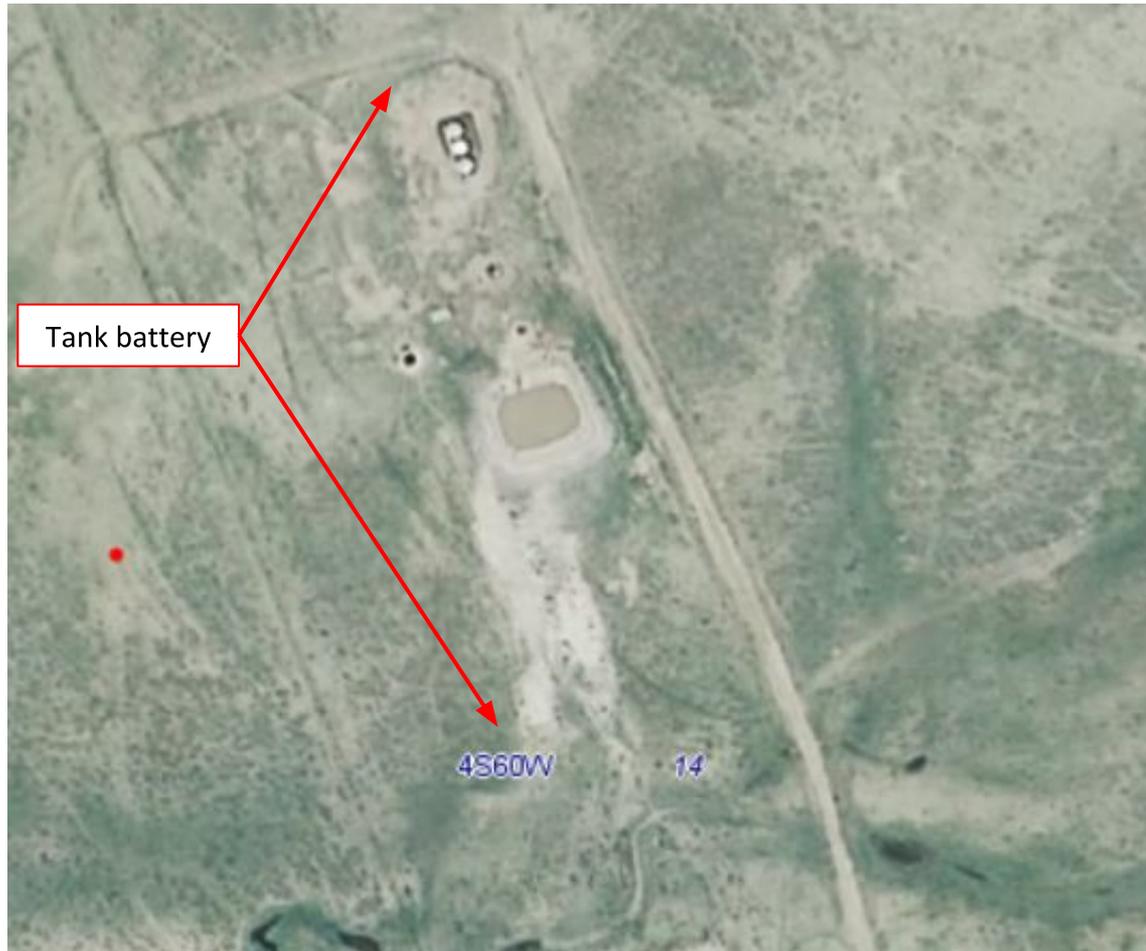
Photo 2. Zoomed in photo of the tank battery location. Photo illustrates the total disturbance including a produced water pit spill.

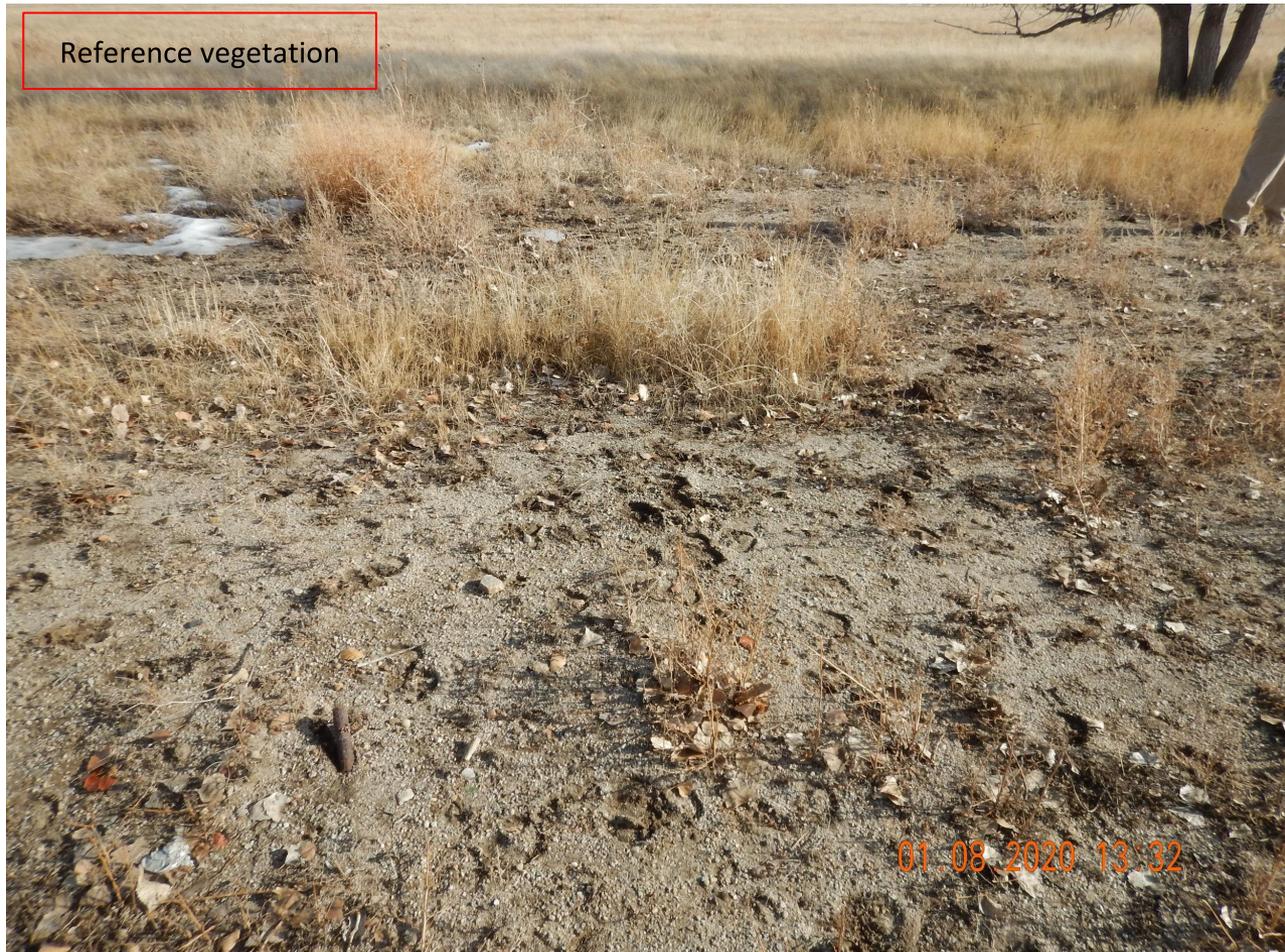
Photo 3. Photo taken from a well location, facing East. Photo illustrates an approximate 30' x 30' area does not meet Rule 1004 vegetative standards. Operator stated he never seeded the well location.

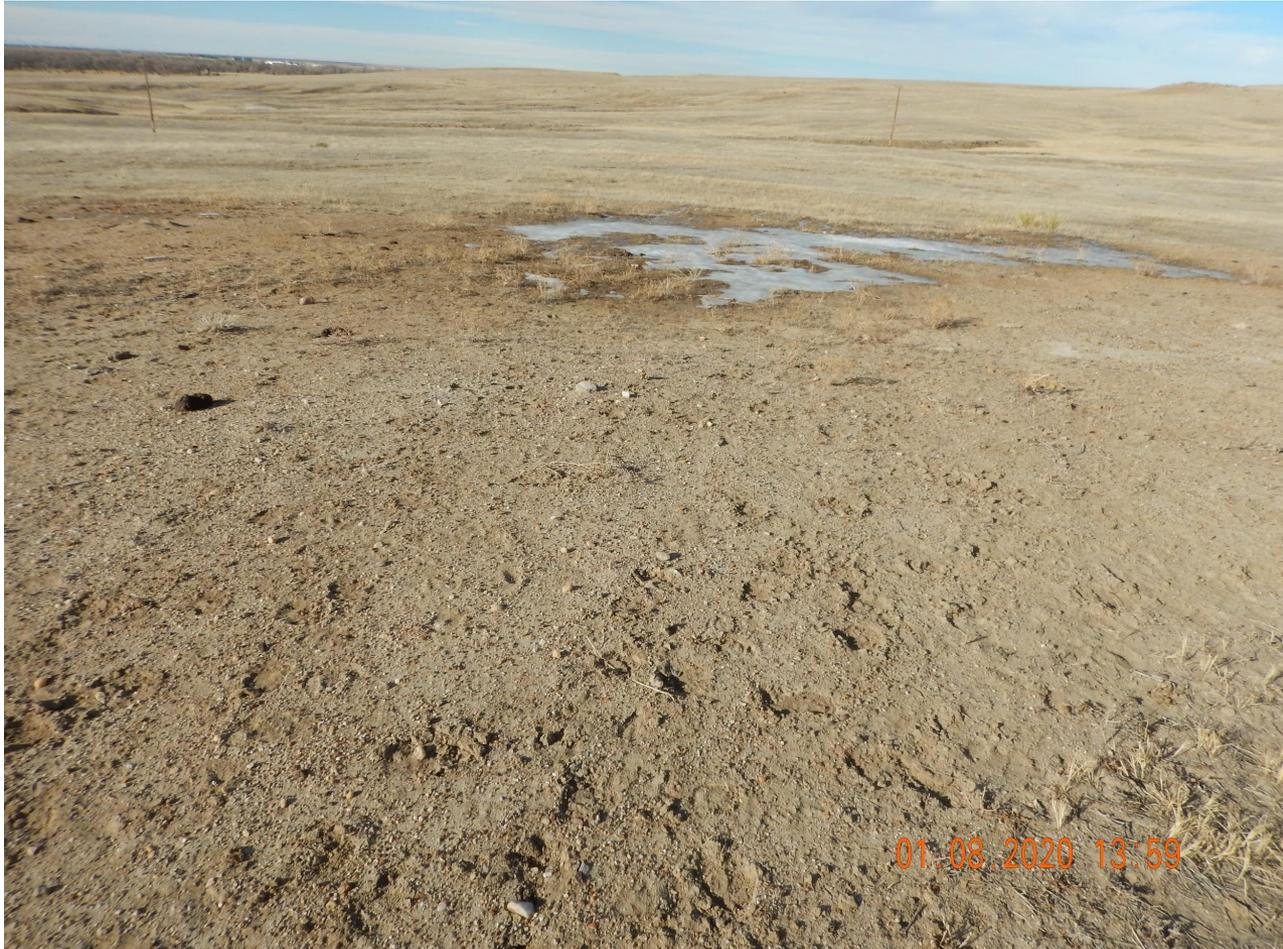
Photo 4. Photo taken from the northern tank battery, facing North. Photo illustrates minimal to no vegetative growth. Note: minimal to no vegetative growth was observed throughout any portion of the tank battery location. Operator stated he never seeded the tank battery location.

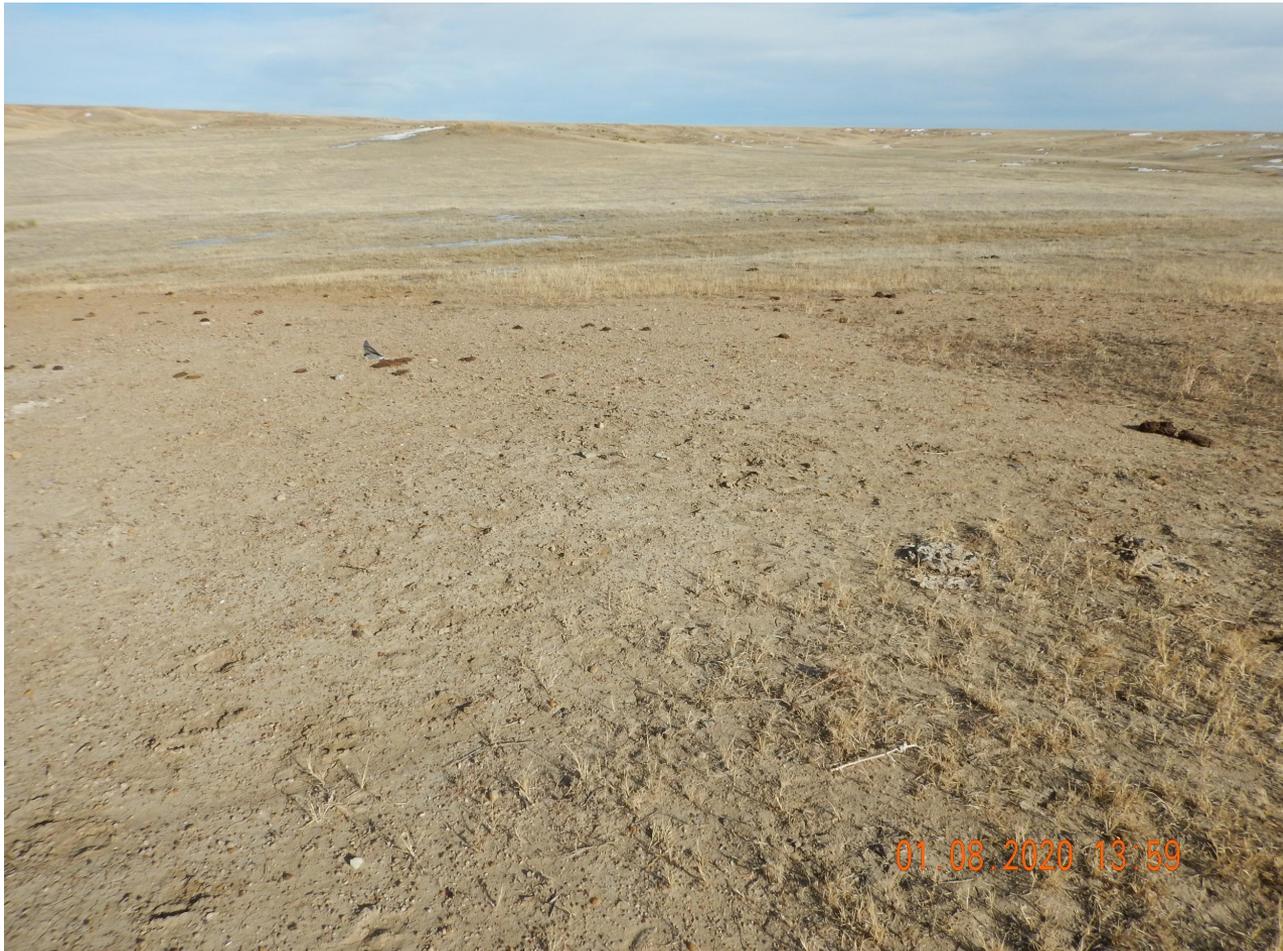
Photo 5. Photo taken from the northern tank battery, facing East. See comments under Photo 4.

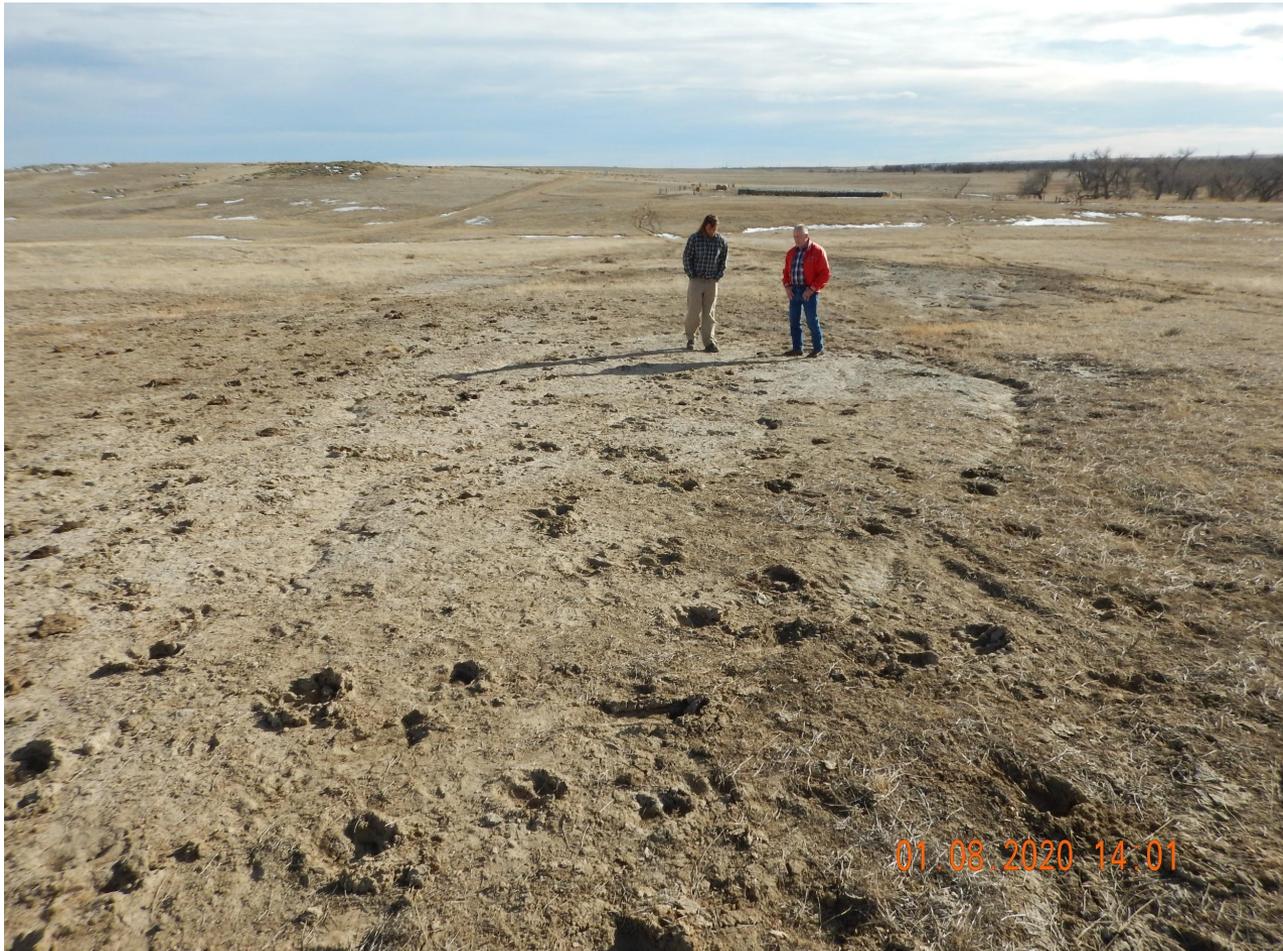
Photo 6. Photo taken from the southern tank battery, facing South. Erosion occurring along the southern tank battery and along portions of the produced water spill.

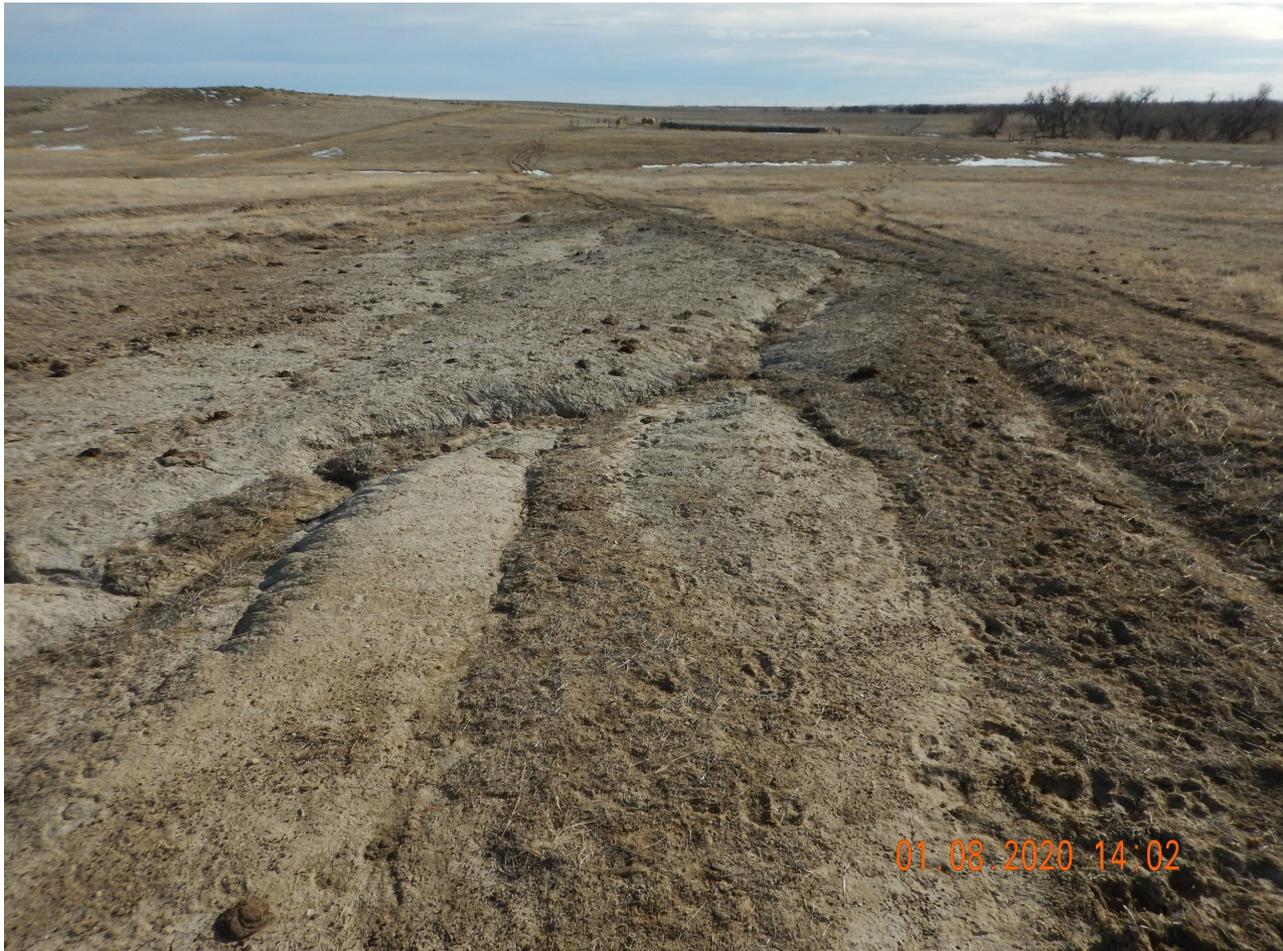
Photo 7. Photo taken from the southern tank battery, facing South. Photo illustrates erosion occurring along portions of the produced water spill.

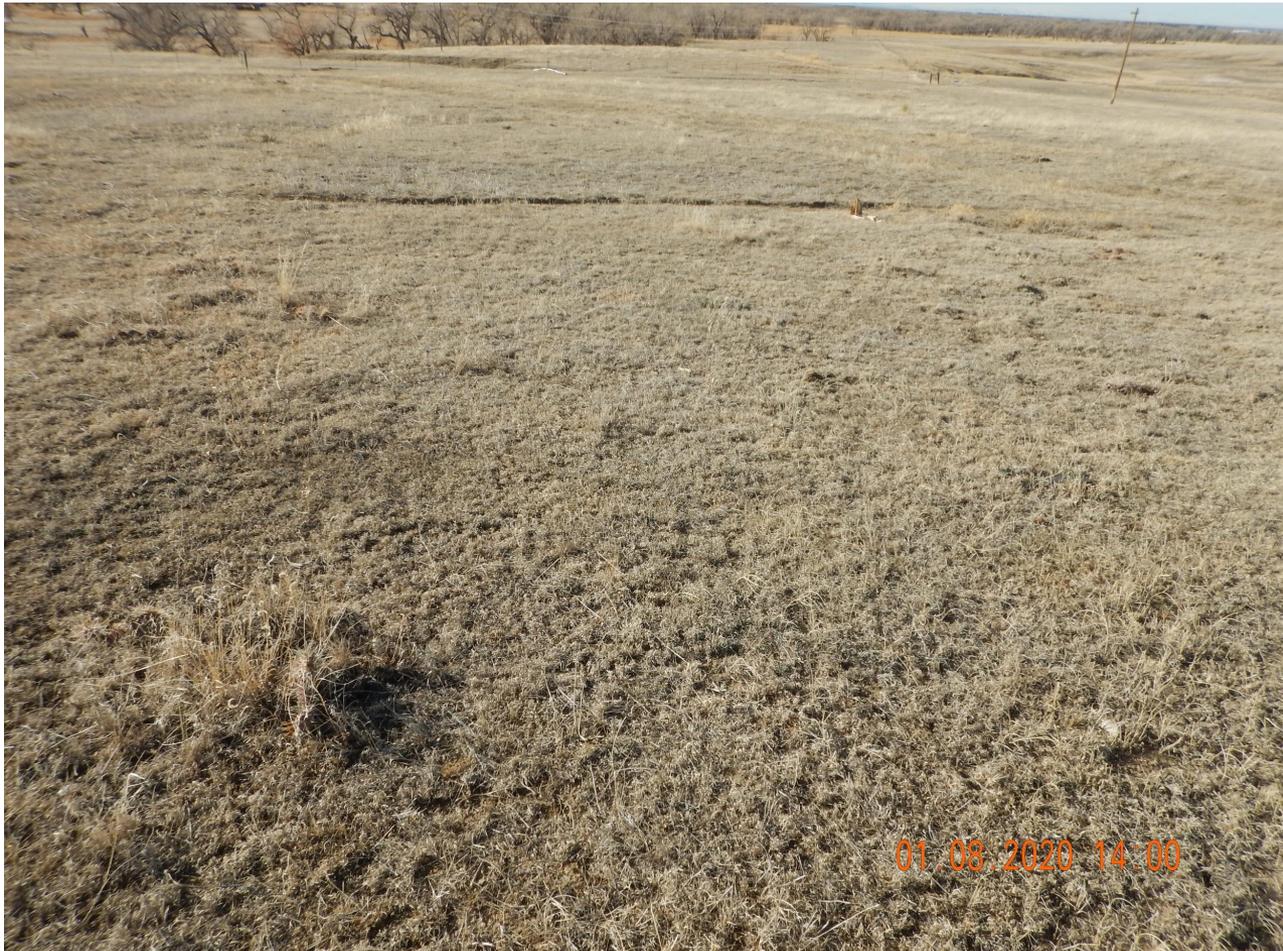
Photo 8. Tank battery reference photo taken northwest of the tank battery, facing West. Photo illustrates blue grama as the dominant vegetative cover.
