Inspection Photos

API: 05-071-07546

Operator: EVERGREEN NATURAL RESOURCES

Inspection Date: 1/22/2019

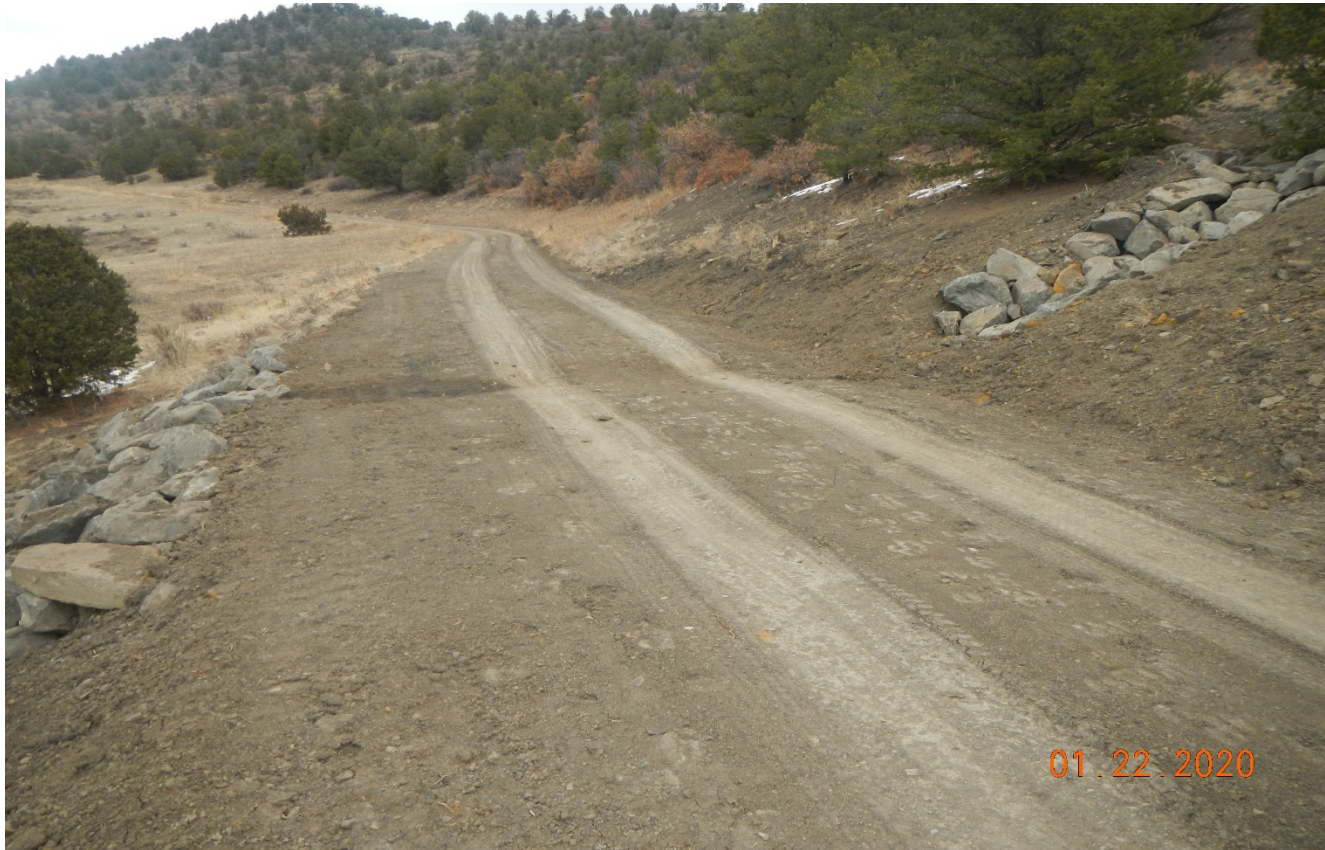
Photo 1. The area of erosion has been repaired along the main road. A channel has been installed across the road at this point. It is a concern that if not maintained the low area may create water pooling in the road.

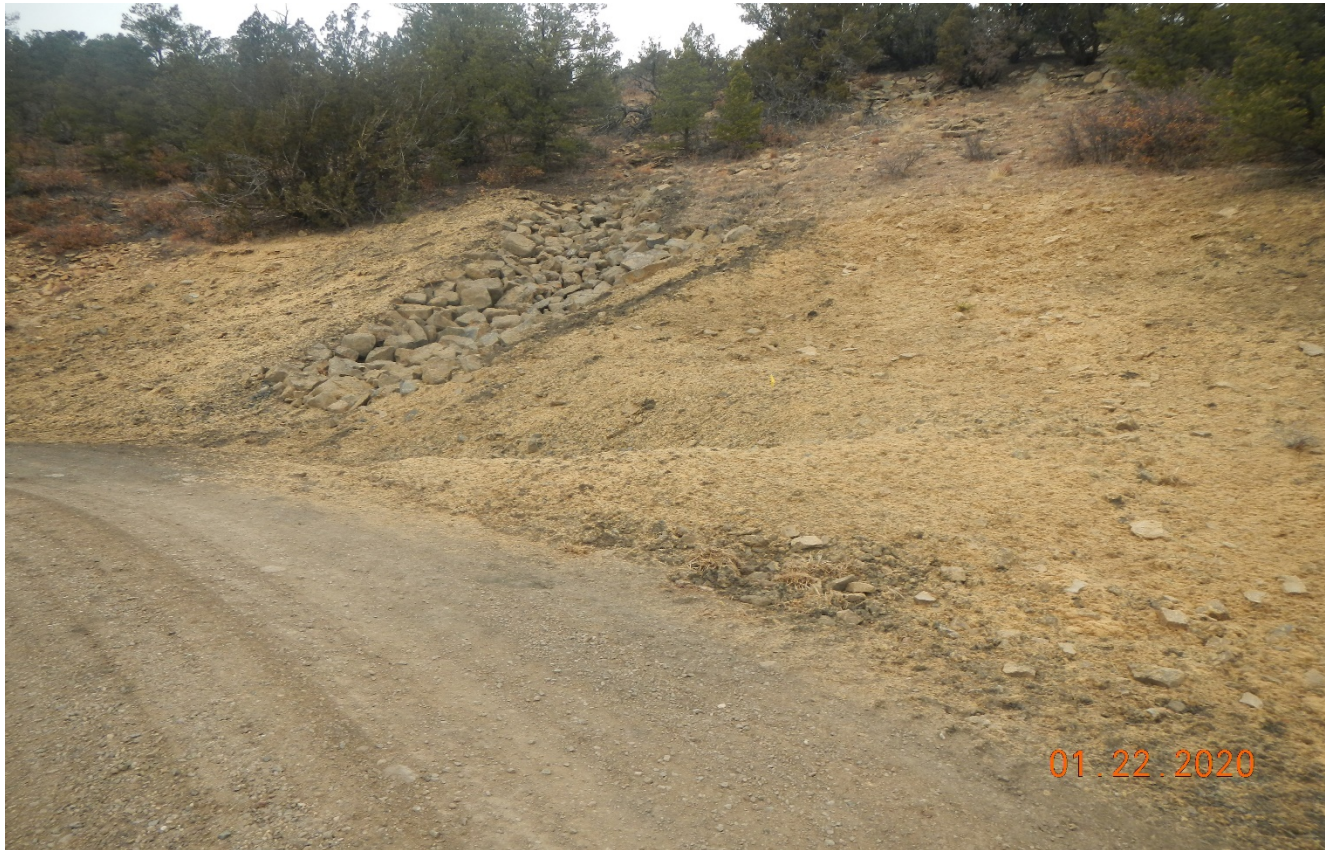
Photo 2. The area of erosion identified along the access road has been repaired. Rock rip/rap was installed and the cut slope is seeded and hydromulched.

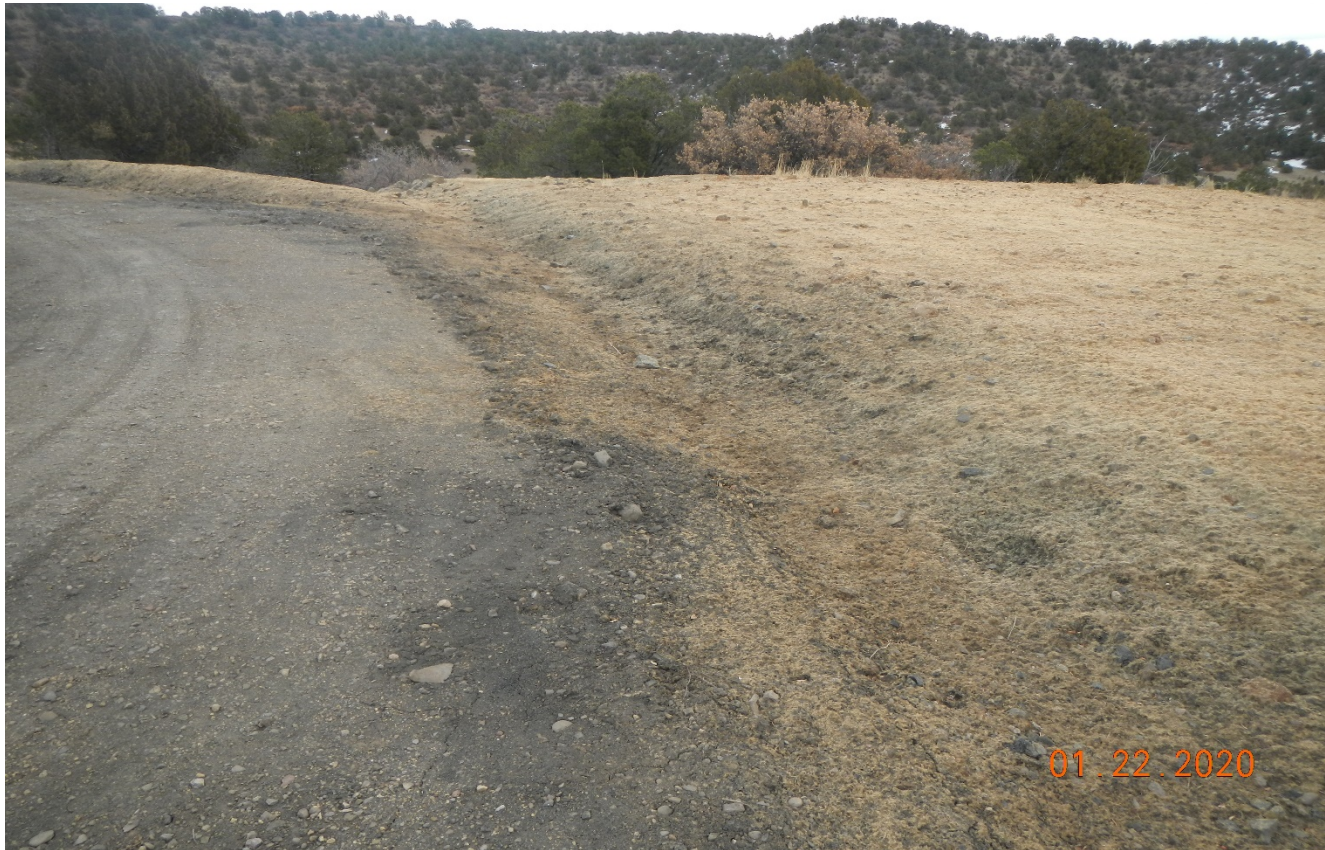
Photo 4. The south side of the location has been regraded, seeded, and hydromulched.
