Inspection Photos

Location Name: GOLDEN EAGLE 30-14 2-22-20

API#: 05-071-08650

INSP. #: 695102086

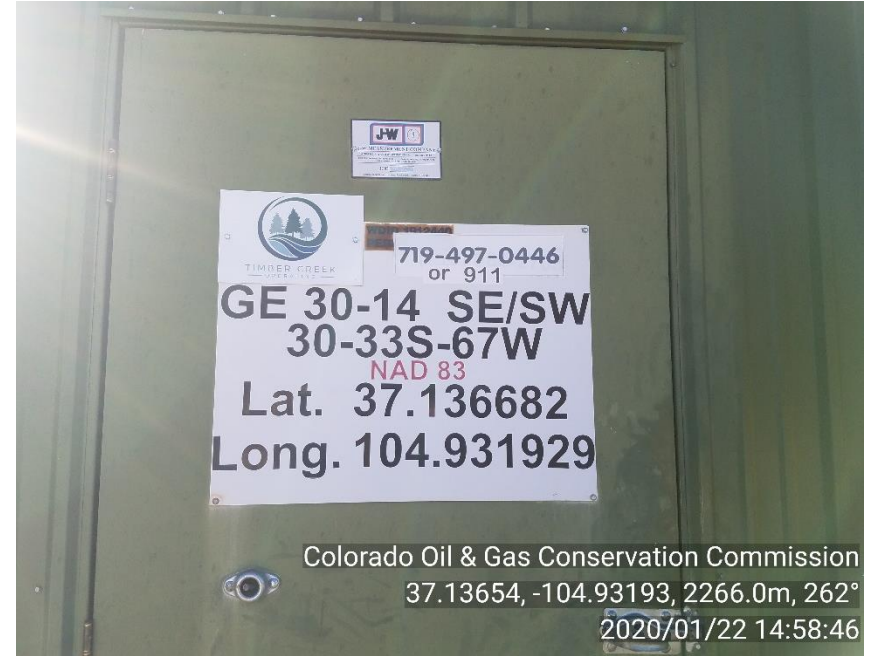
PHOTO 2: WELL SIGN

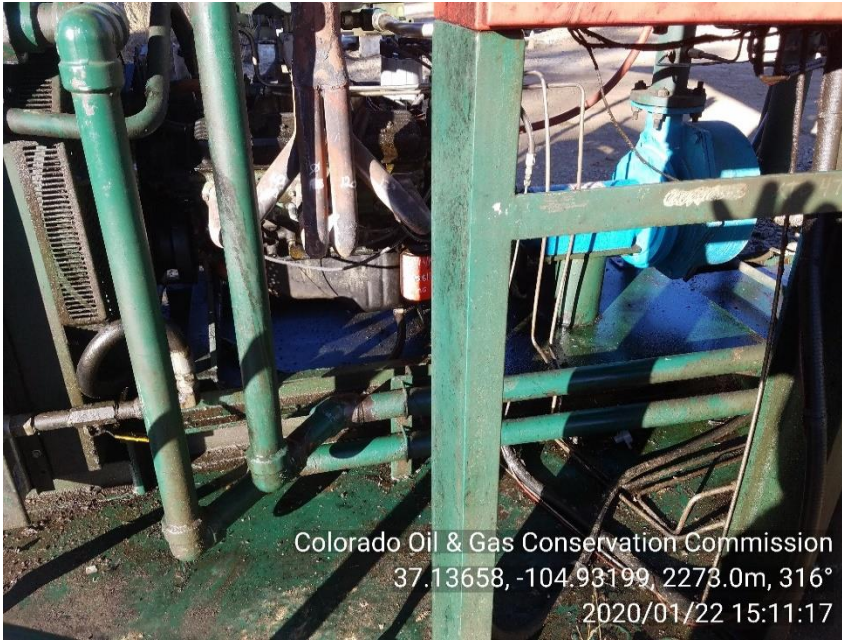
PHOTO 3: MECHANICAL CONDITION. **CLEAN COMPRESSOR AND REPAIR LEAKS (TO PREVENT FUTURE CONTAMINATION)**, Securely fasten all valves, pipes, and fittings to ensure good mechanical condition, inspect at regular intervals and maintain in good mechanical condition per Rule 605.d. CA DATE 2-23-20.

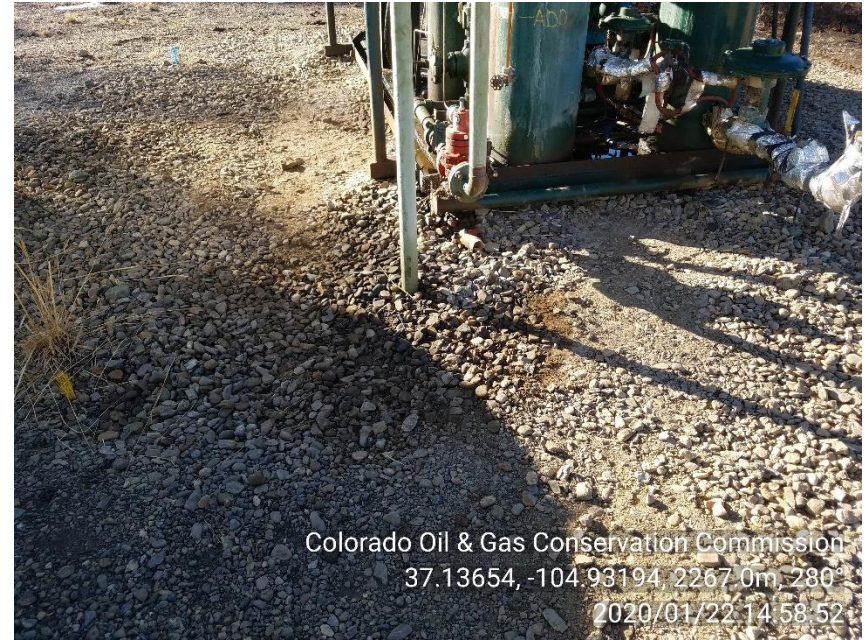
PHOTO 4: AREA OF IMPACTED SOIL NEAR LOWEST POINT OF COMPRESSOR SKID. **Conduct maintenance on equipment, cleanup stained material and review self inspection processes. CA DATE 1-28-20**

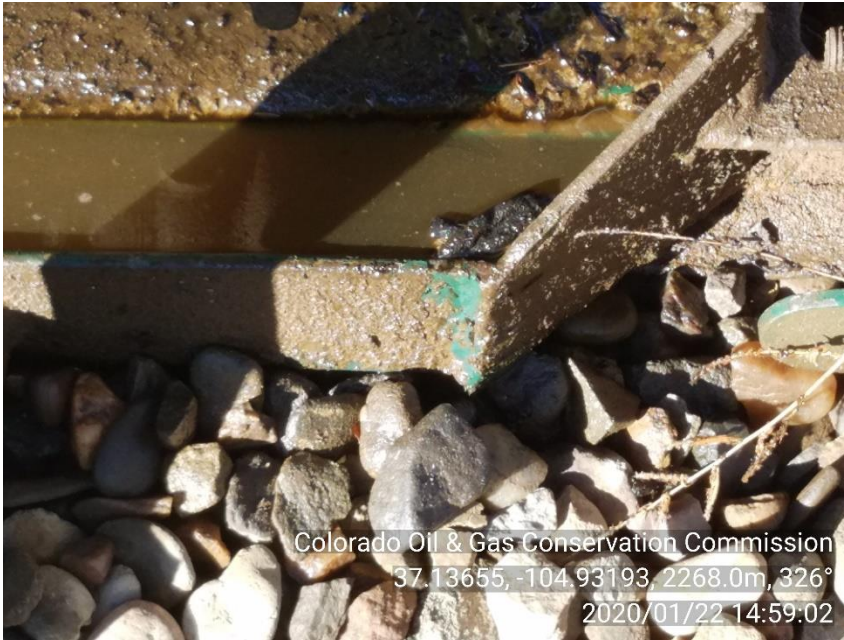
PHOTO 5: COMPRESSOR SKID IS FULL OF OILY WATER AND IT IS LEAKING ON THE LOCATION CONTAMINATING THE SOIL AND POTENTIALLY MIXING WITH STORM WATER. **Comply with general provisions of the oil and gas act for wildlife protection. 1-28-20**

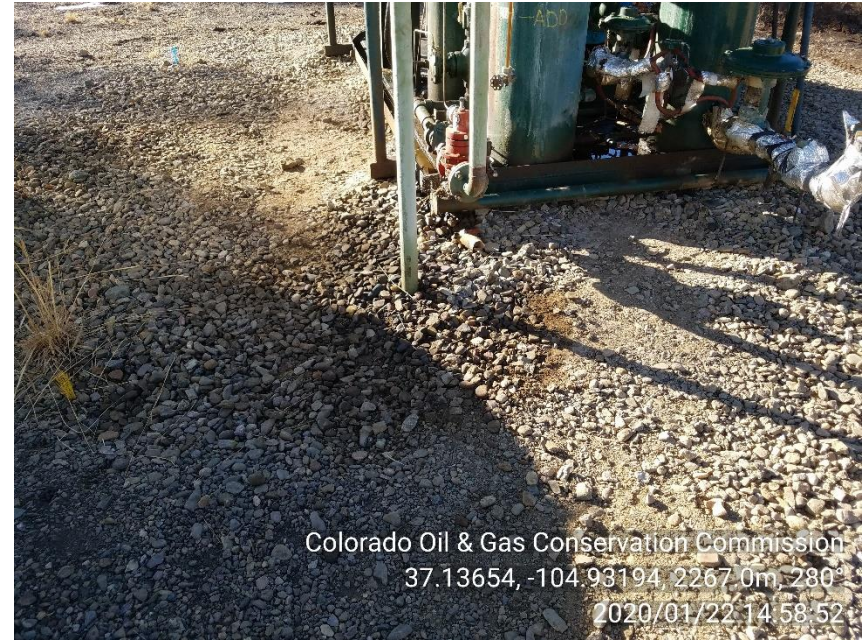
PHOTO 4: AREA OF IMPACTED SOIL NEAR LOWEST POINT OF COMPRESSOR SKID. **Non E&P Waste not properly stored, handled, transported, treated, or disposed per Rule 907A. CA DATE 1-28-20**
