Inspection Photos

Location Name: CORDILLERA 34-7 CA DATE 2-11-20

API#: 05-071-09150

INSP. #: 695102110

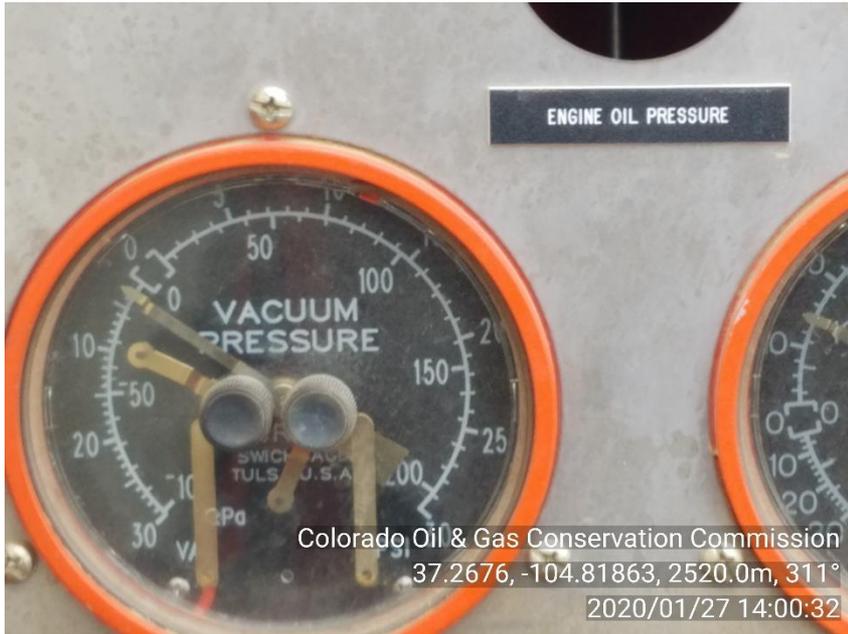
PHOTO 3: Vacuum pump observed on well without COGCC approval. Provide COGCC with documentation showing approval of use of vacuum pump. CA DATE 2-11-20.

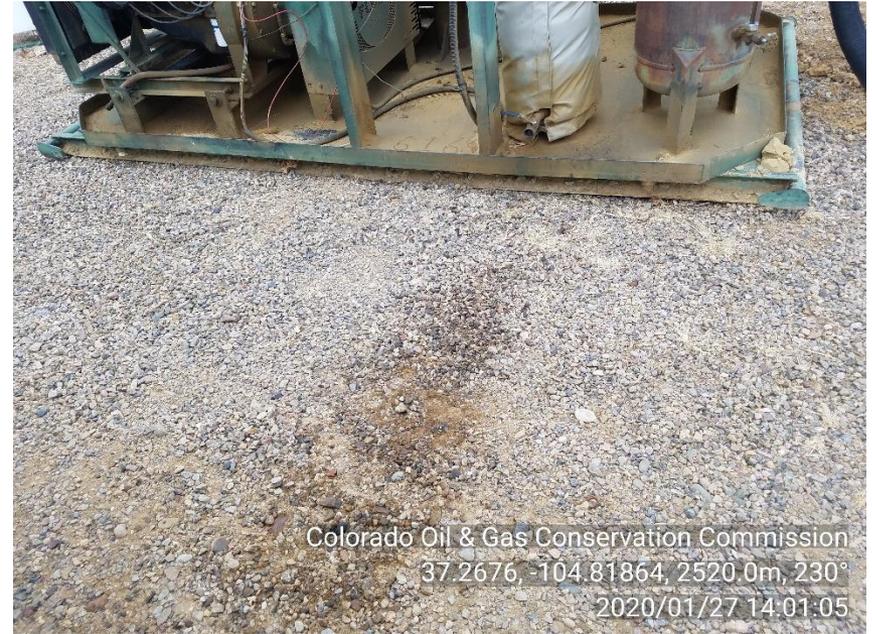
PHOTO 4: APPEARS THAT FUEL GAS SEPARATOR IS BEING DRAINED ON LOCATION LEAVING AN AREA OF IMPACTED SOIL NEAR COMPRESSOR. CAPTURE AND PROPERLY DISPOSE OF ANY OILY WASTE FROM FUEL GAS SEPARATOR WHEN IT IS DRAINED. PROPERLY DISPOSE OF IMPACTED SOIL CA DATE 2-1-20
