# Final Reclamation Inspection

Operator: NOBLE ENERGY INC - #100322

Location ID: 319134

Inspection Photos  
Location Name: MURPHY #1  
Location ID: 319134

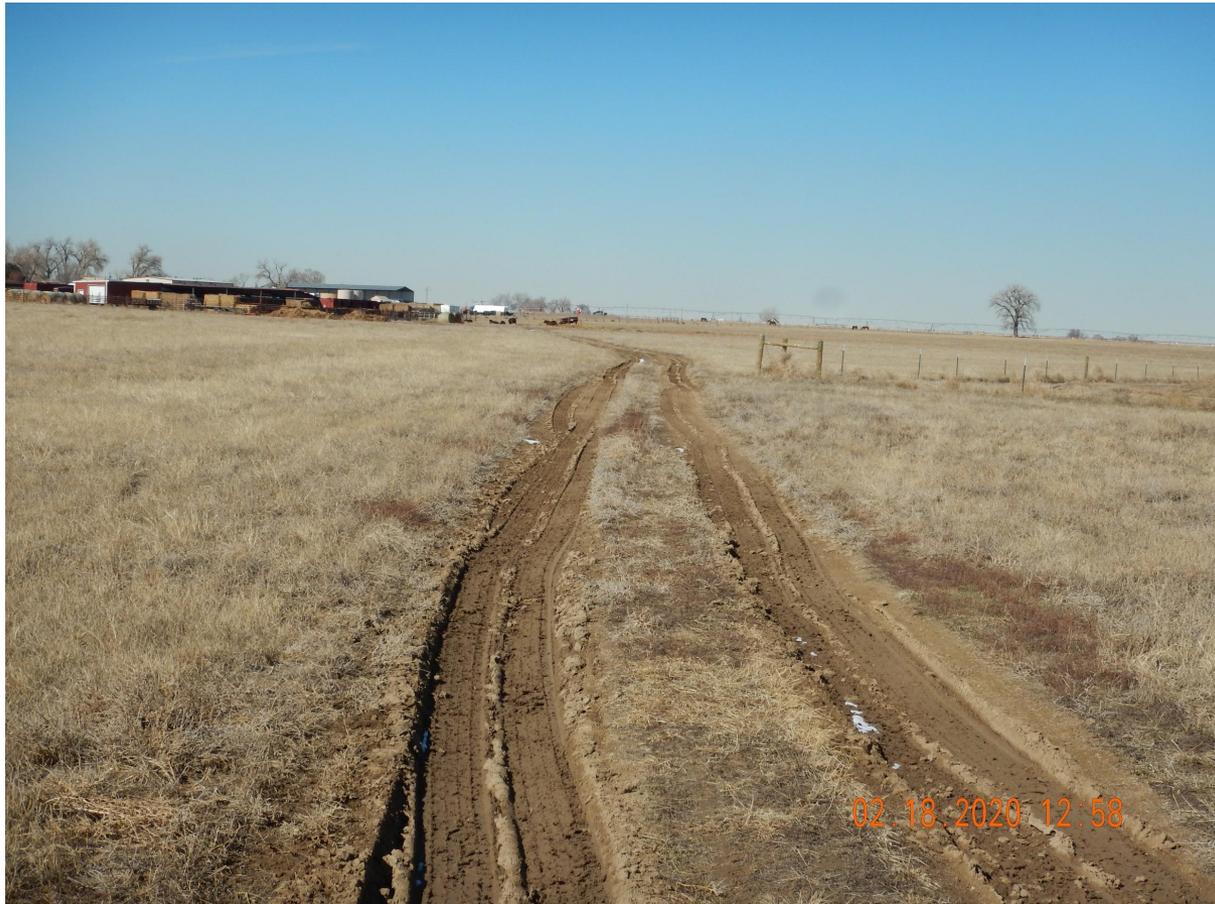
**Photo 1.** Photo taken from the PA well location, facing Northwest. Photo illustrates PA access road is still in use for a temporarily abandoned well.

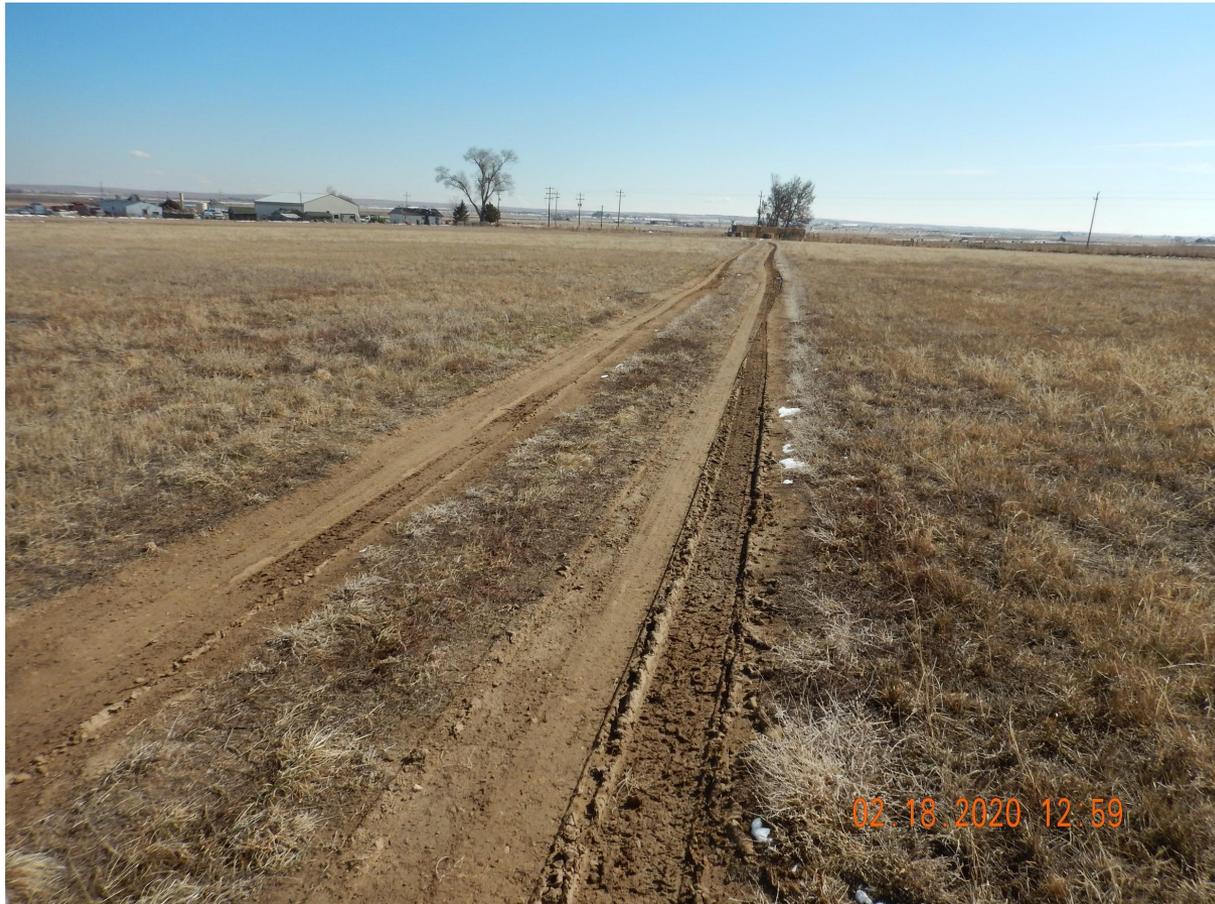
**Photo 2.** Photo taken from the PA well location, facing Southeast. See comments under Photo 1.

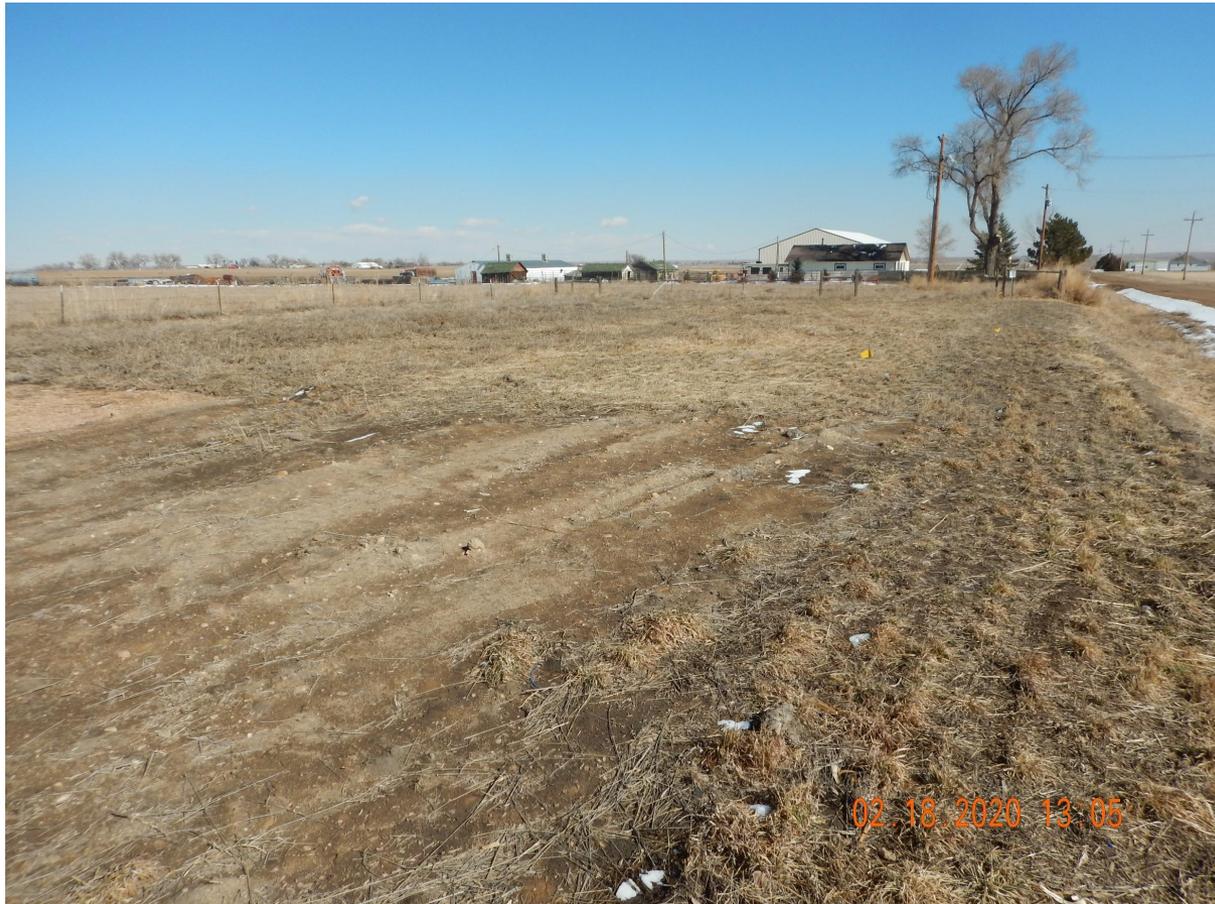
**Photo 3.** Photo taken from the tank battery location, facing East. Photo illustrates portions of the tank battery have been reclaimed but equipment remains.

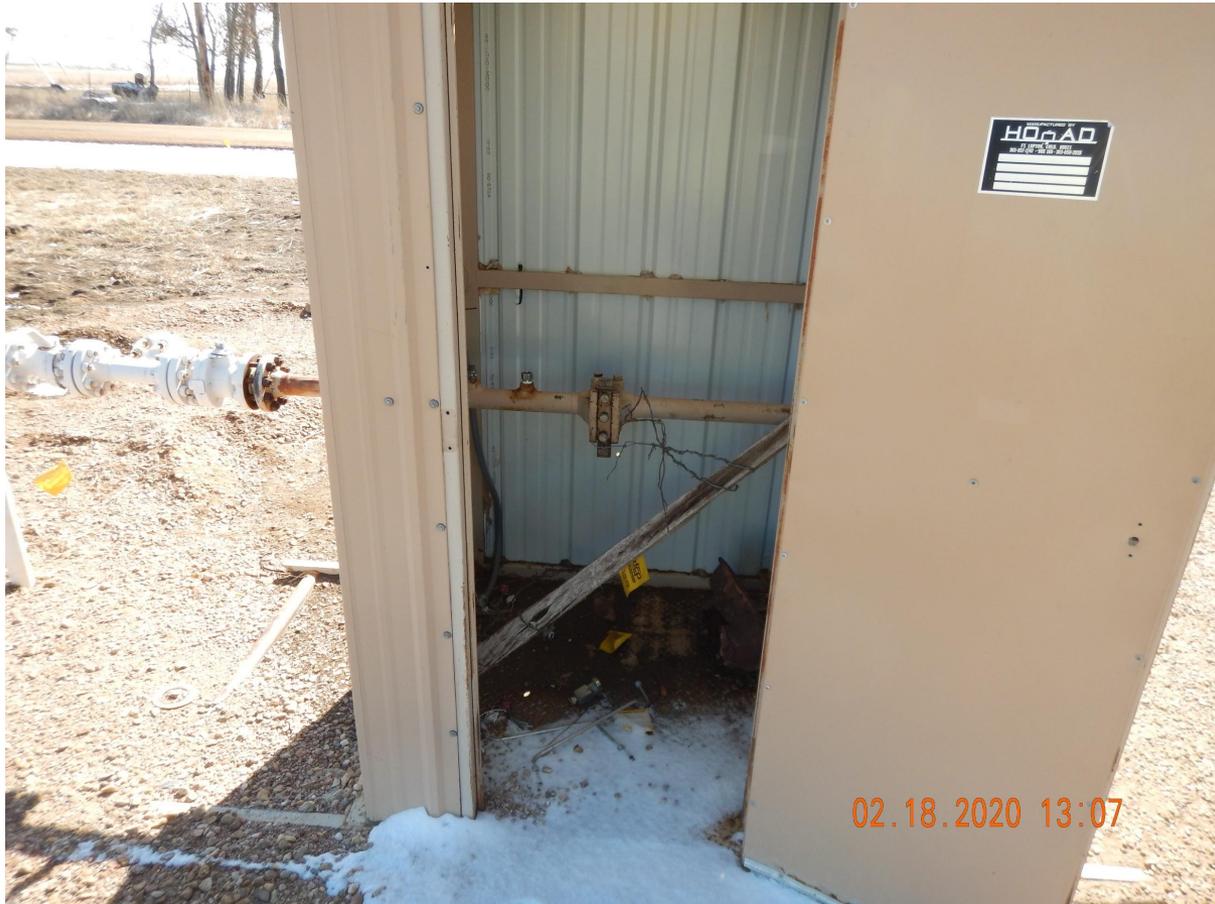
**Photo 4.** Photo taken from the tank battery location. Photo illustrates a meter house no longer in use.

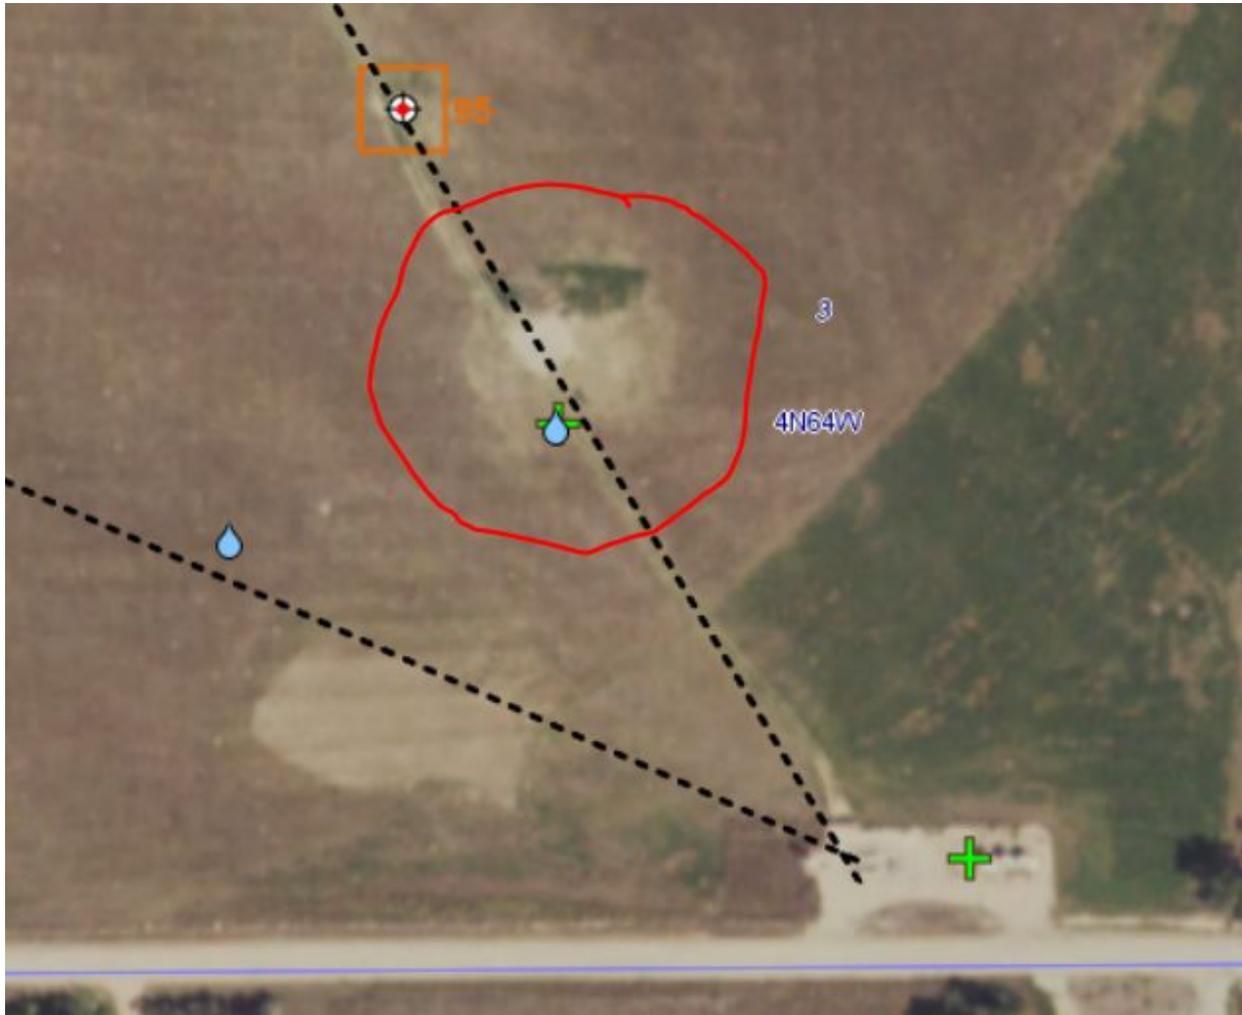
**Photo 5.** COGCC COGIS Online aerial imagery from 2017 illustrates a spill area circled in red. COGCC staff will have to perform a follow up inspection to ensure spill area meet Rule 1004 vegetation standards.
