Inspection Photos
Operator: Kinder Morgan
Location #: 313480
Date: 2/20/2020

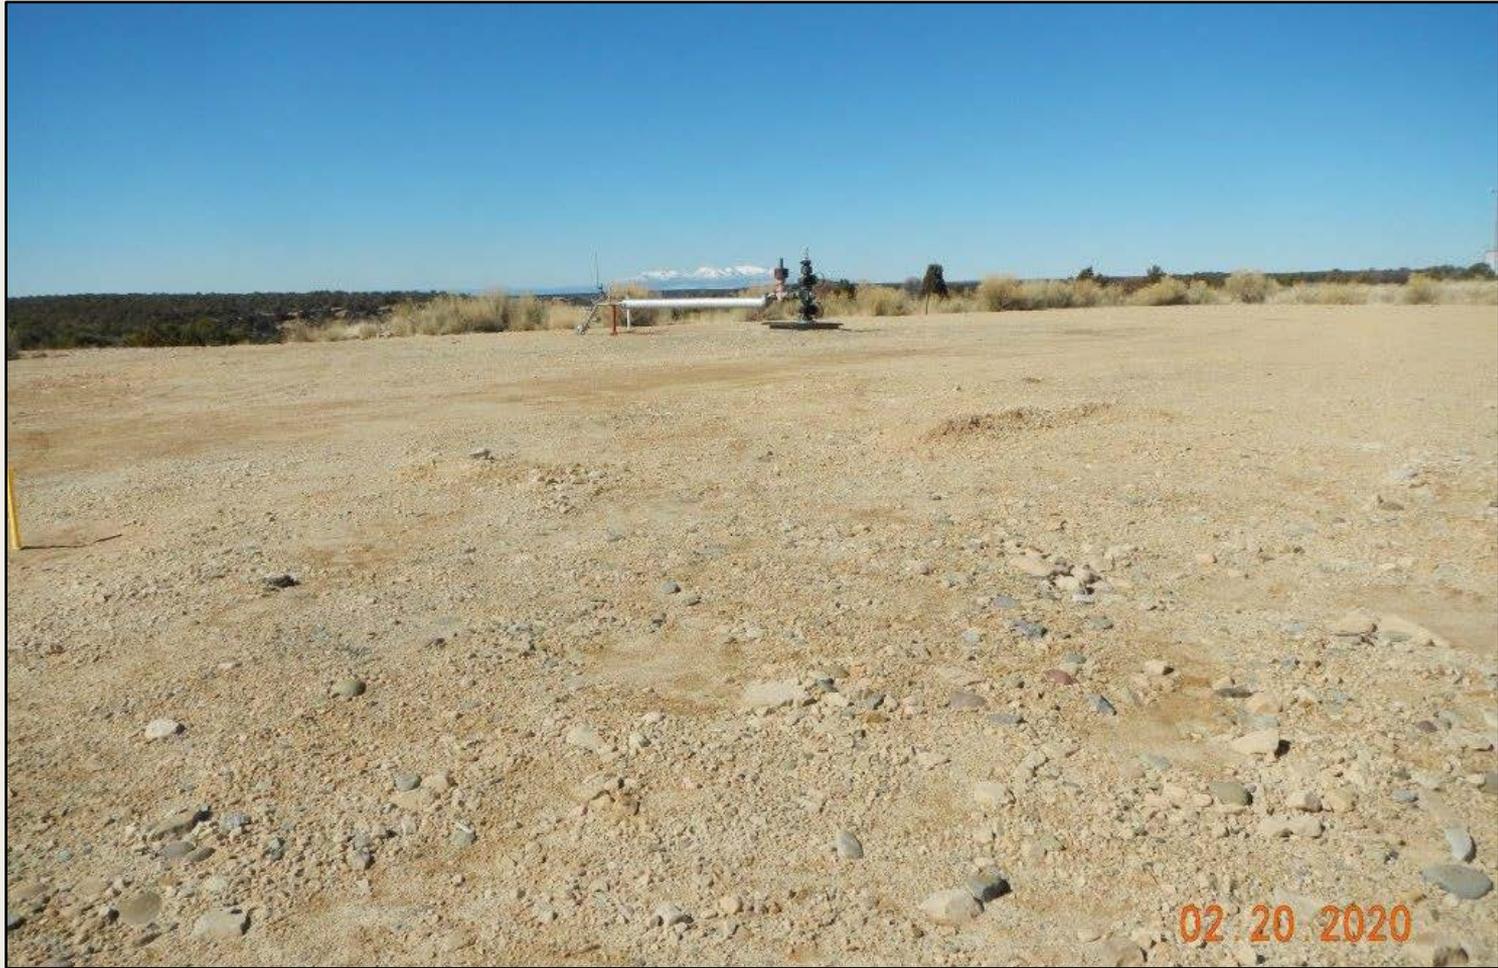
Photo 1. View of the project area from the southeastern corner of the working area facing center.

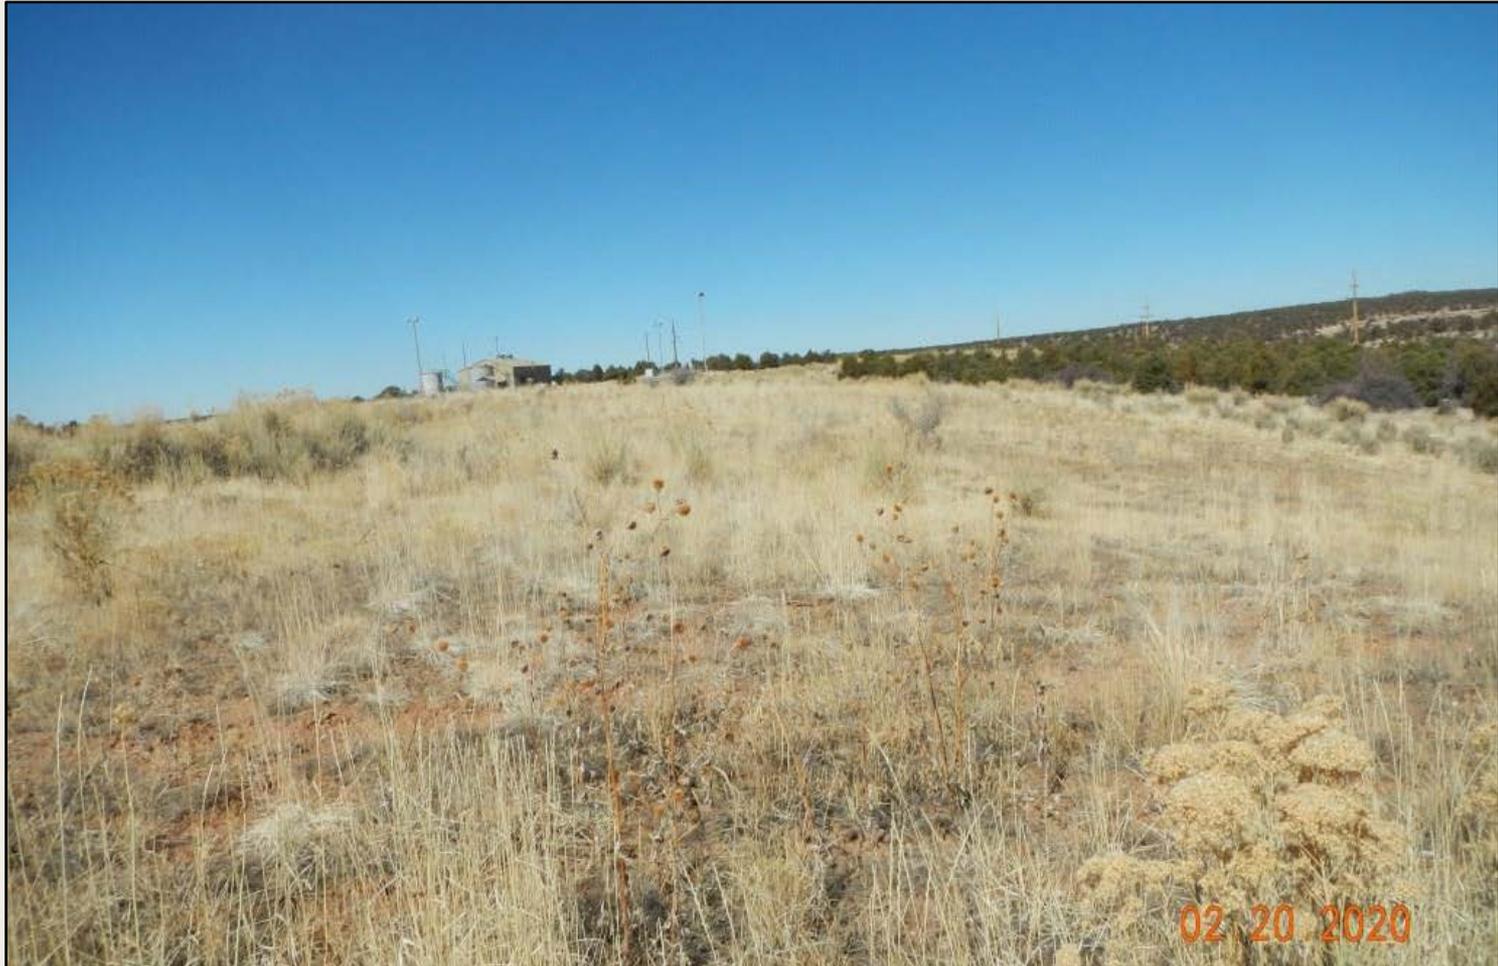
Photo 2. View of the eastern project area from the southeastern edge facing northward. Revegetation is progressing with grasses such as western wheatgrass, James galleta, and sand dropseed.

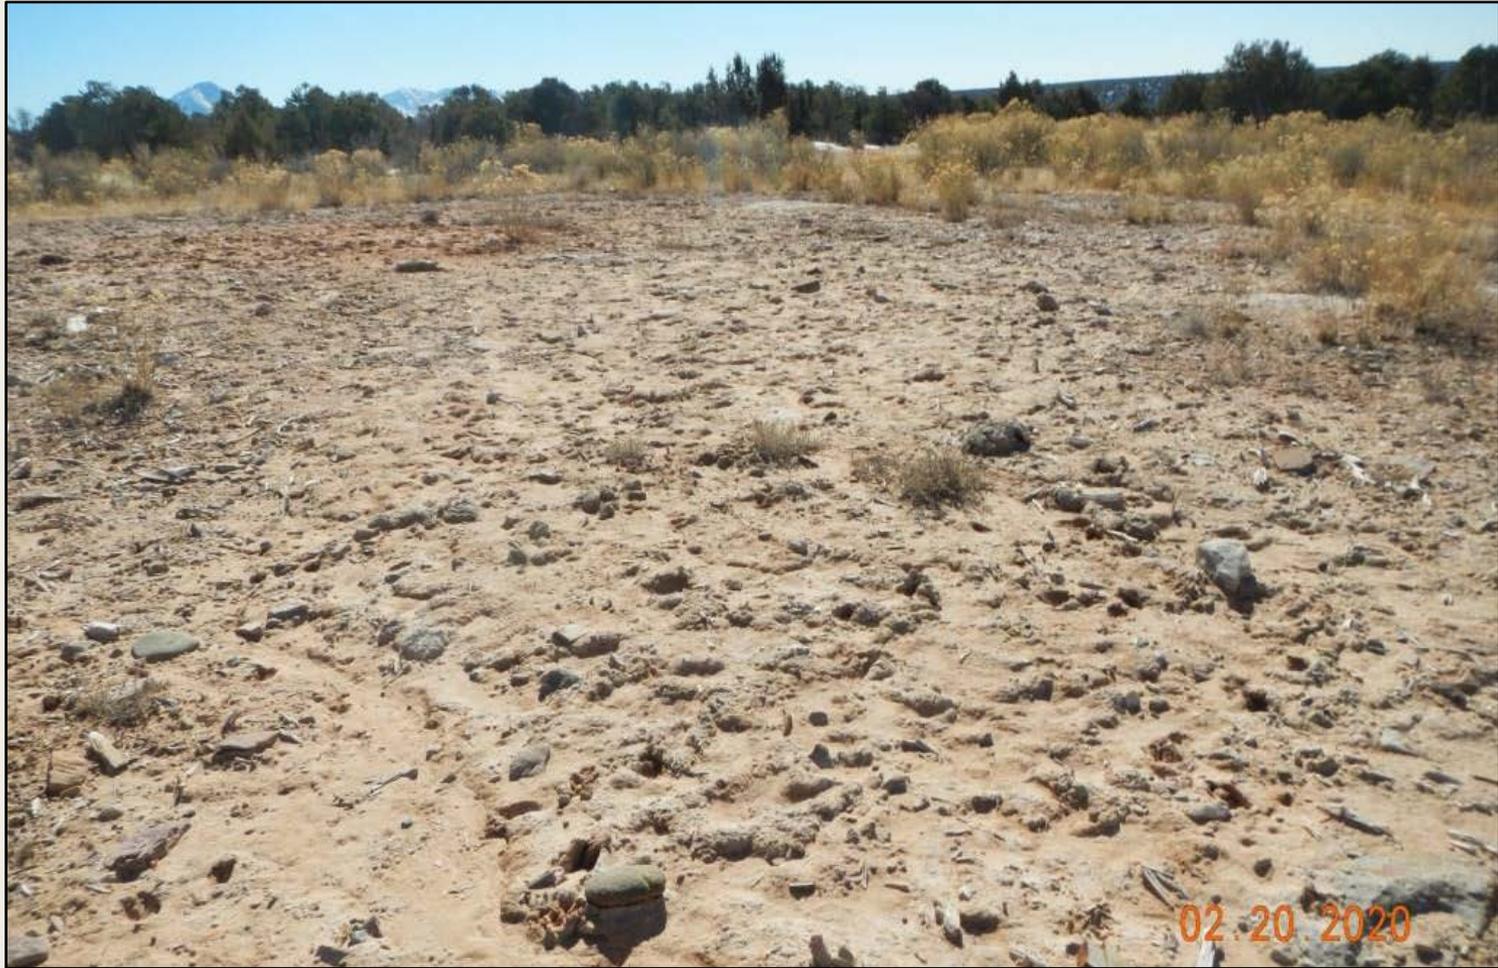
Photo 3. View of area in the western project area with bare soils that appears to be salt-impacted. Soils will likely need testing and amendment for successful revegetation.

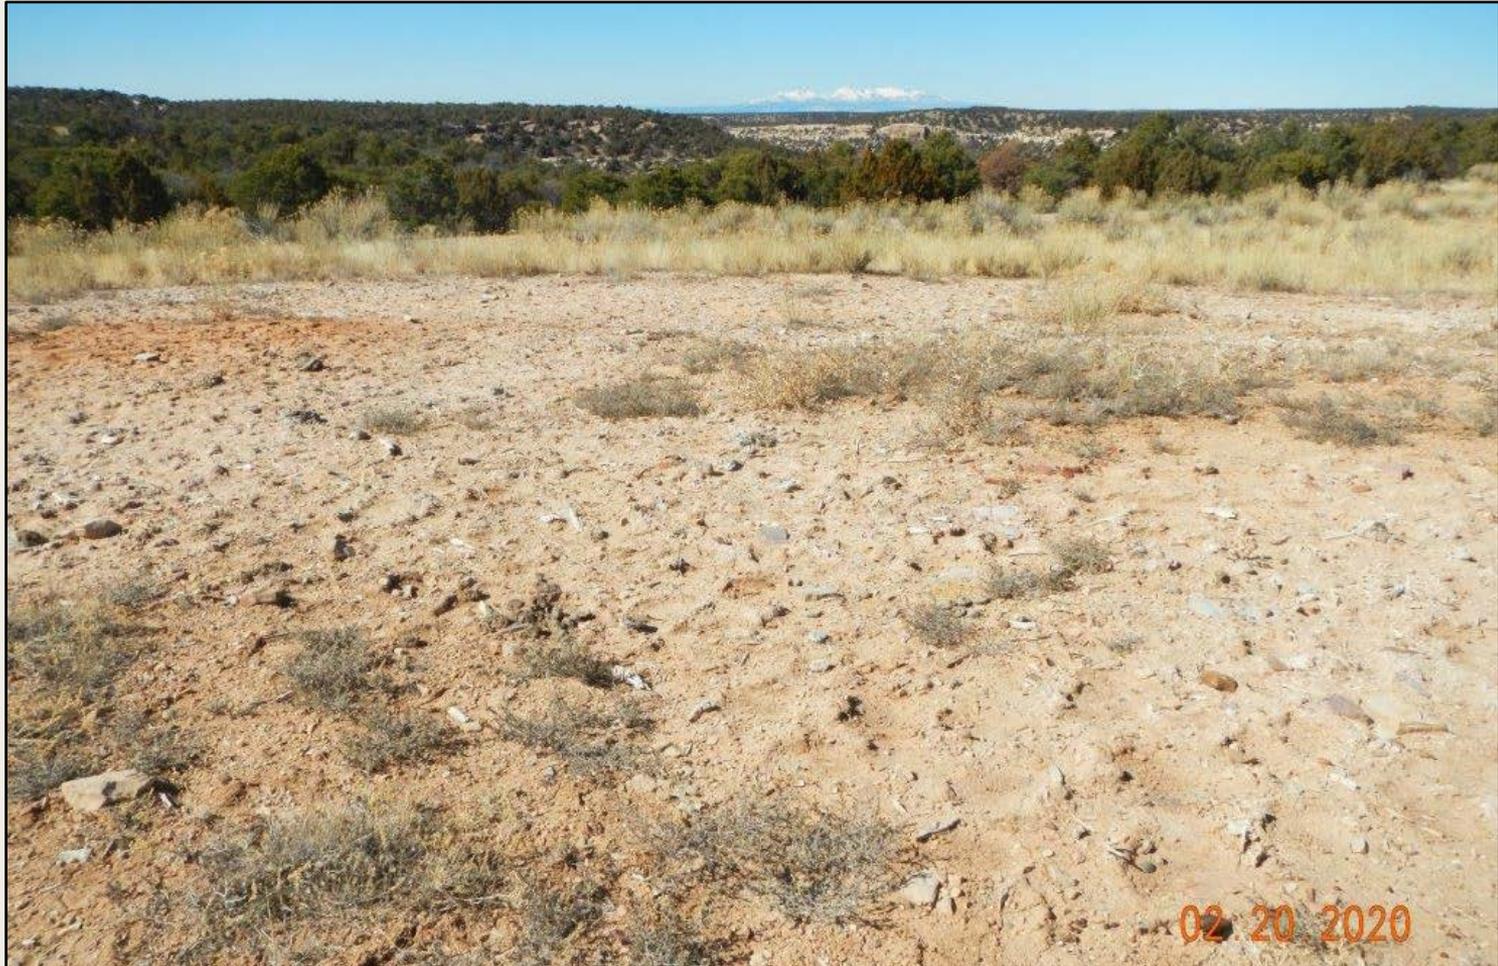
Photo 4. Another view of bare and sparse vegetation on soils within the western project area.

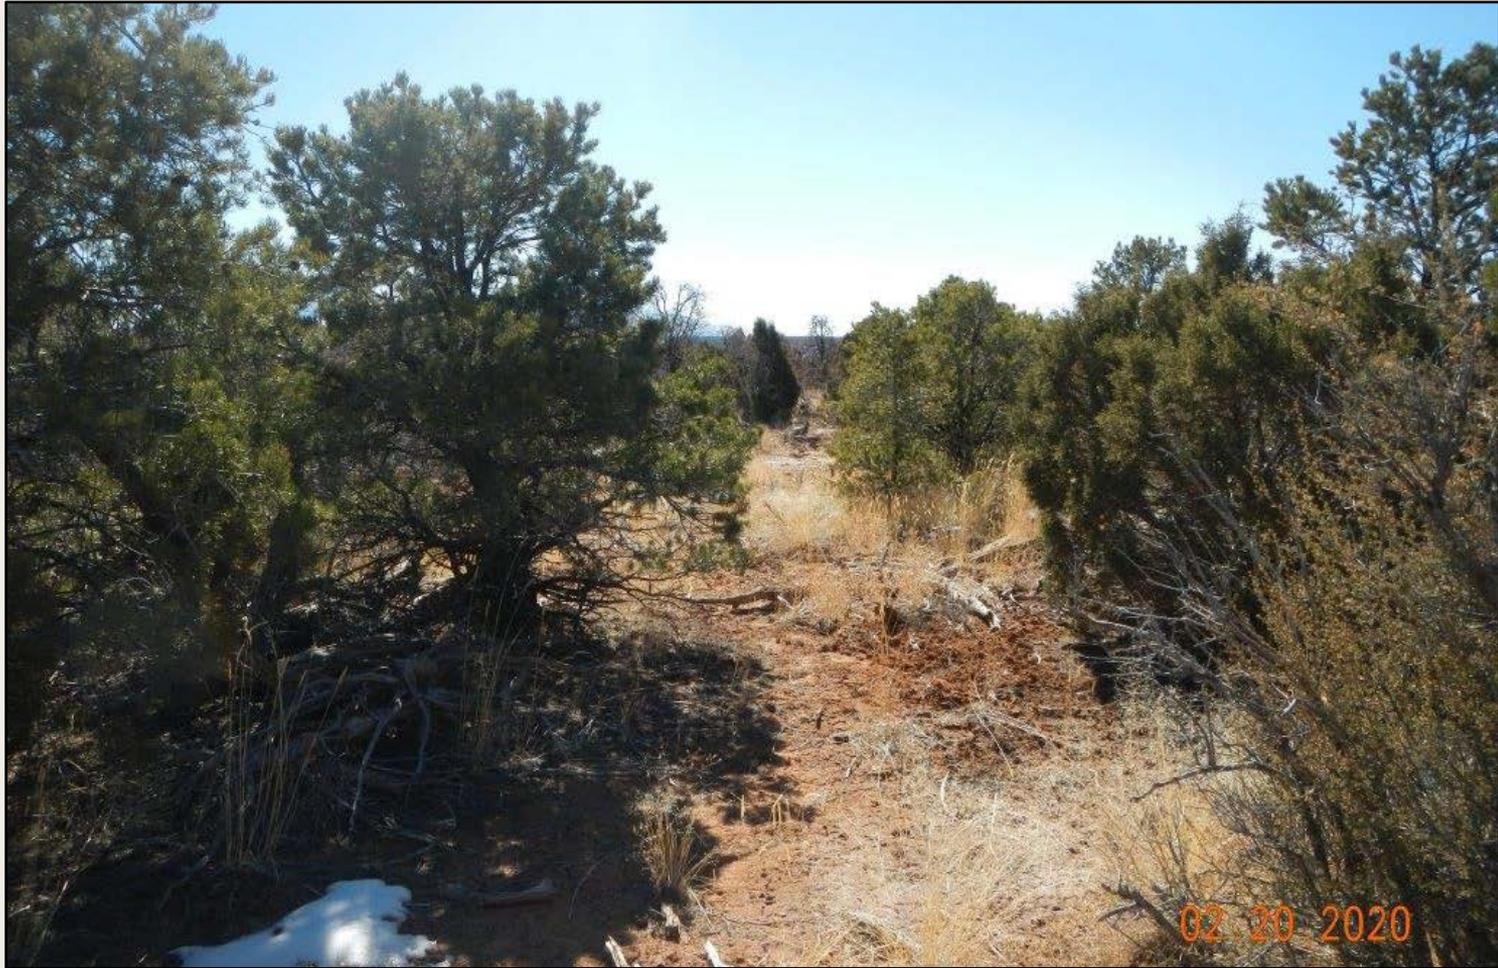
Photo 5. View of the reference area, comprised of pinyon juniper woodland, mixed cliffrose shrubland, and grasses such as Indian ricegrass and sand dropseed in the understory.
