Inspection Photos
Operator: Kinder Morgan
Location #: 428397
Date: 2/20/2020

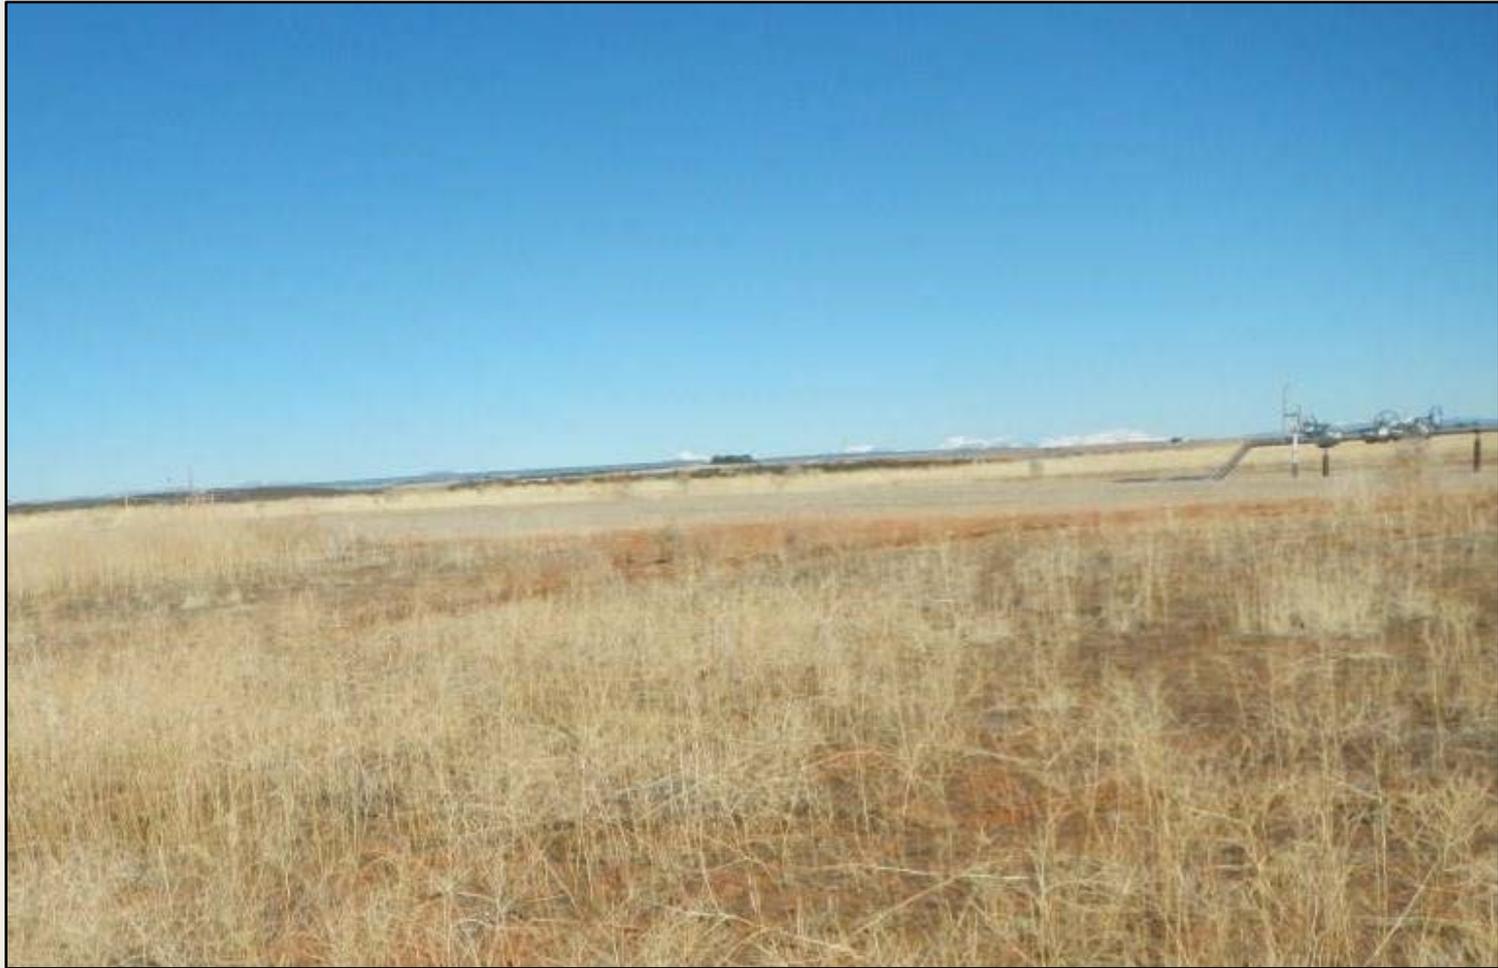
Photo 1. View of the project area from the southwestern corner facing center.

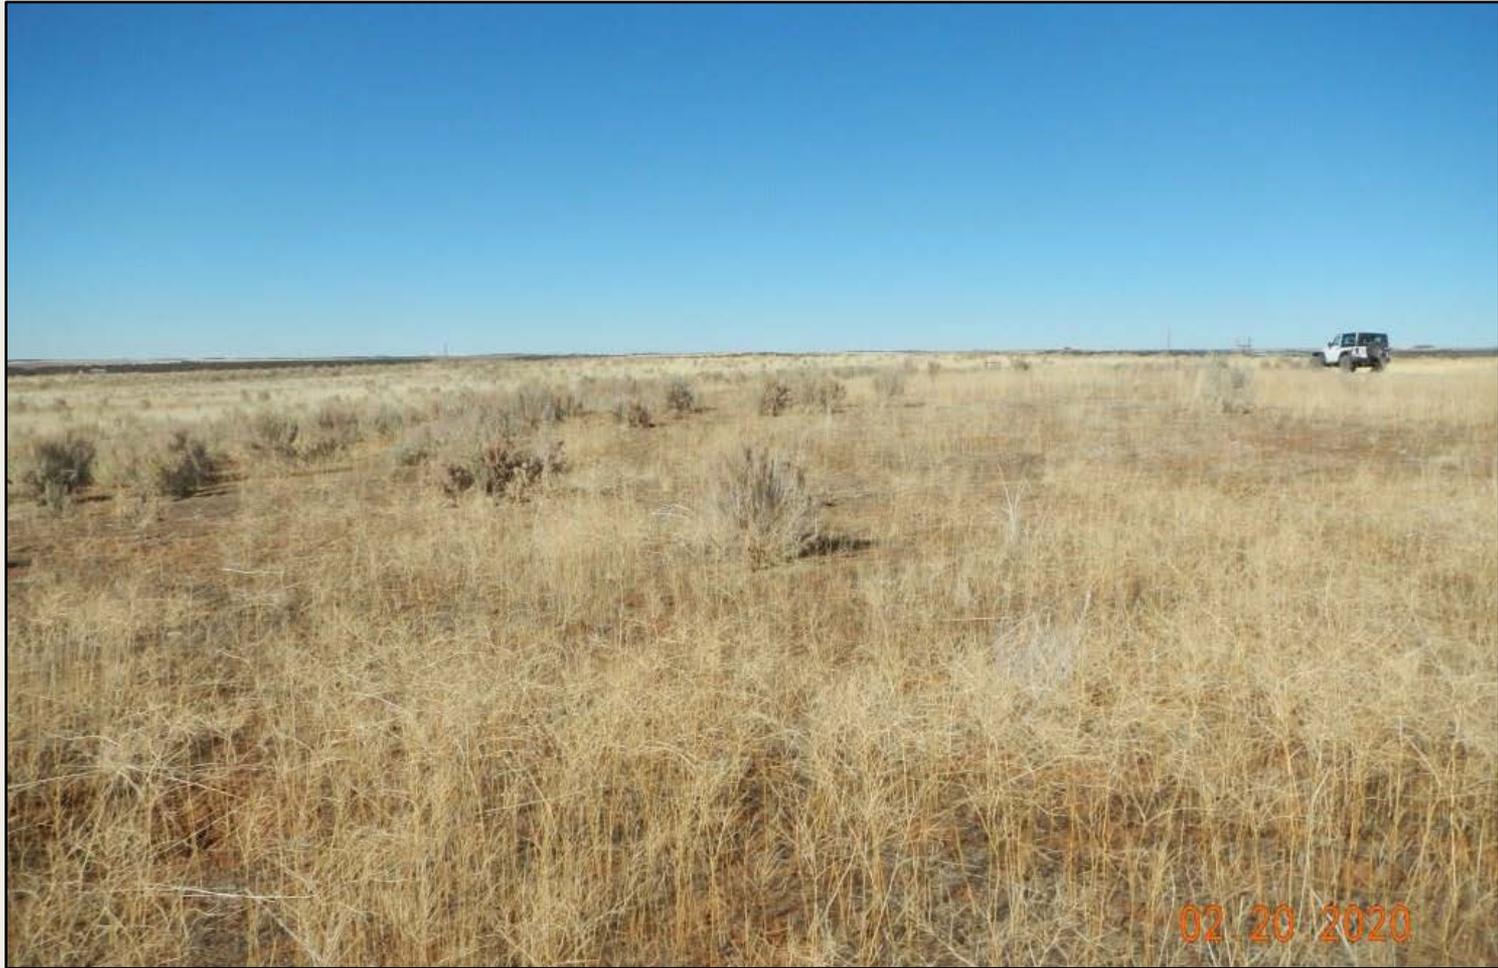
Photo 2. View of the western project area from the southwestern corner facing northward. Revegetation is weedy, largely supporting annual weeds such as mustard and cheatgrass.

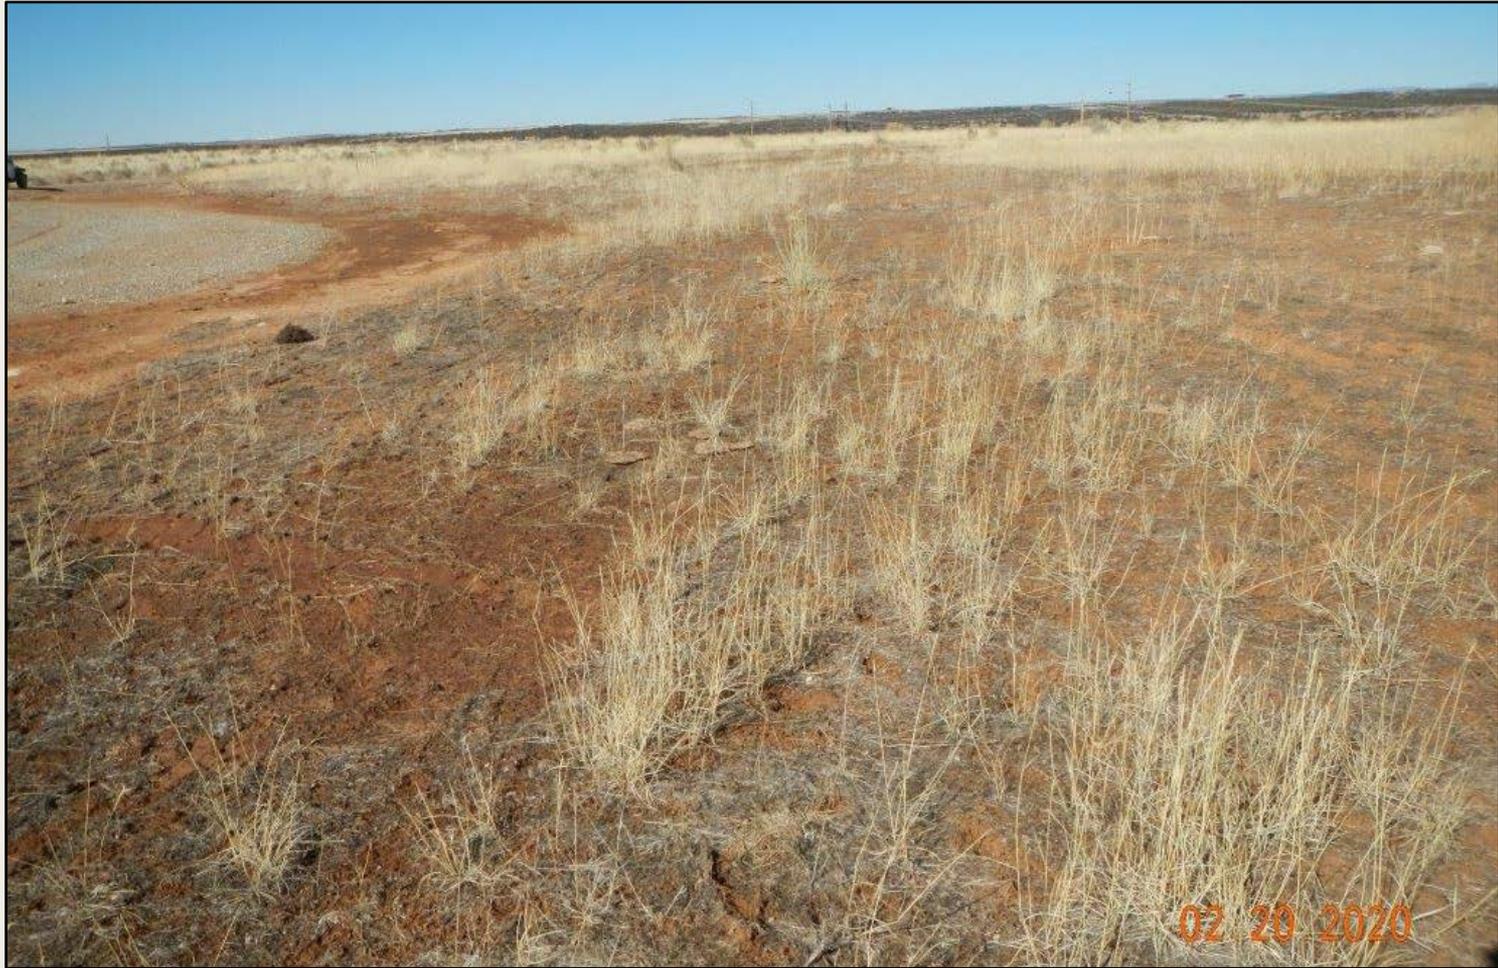
Photo 2. View of the eastern project area from the southeastern corner facing northward. Revegetation is sparse with significant areas supporting little desirable vegetation. Scattered perennial grasses observed.

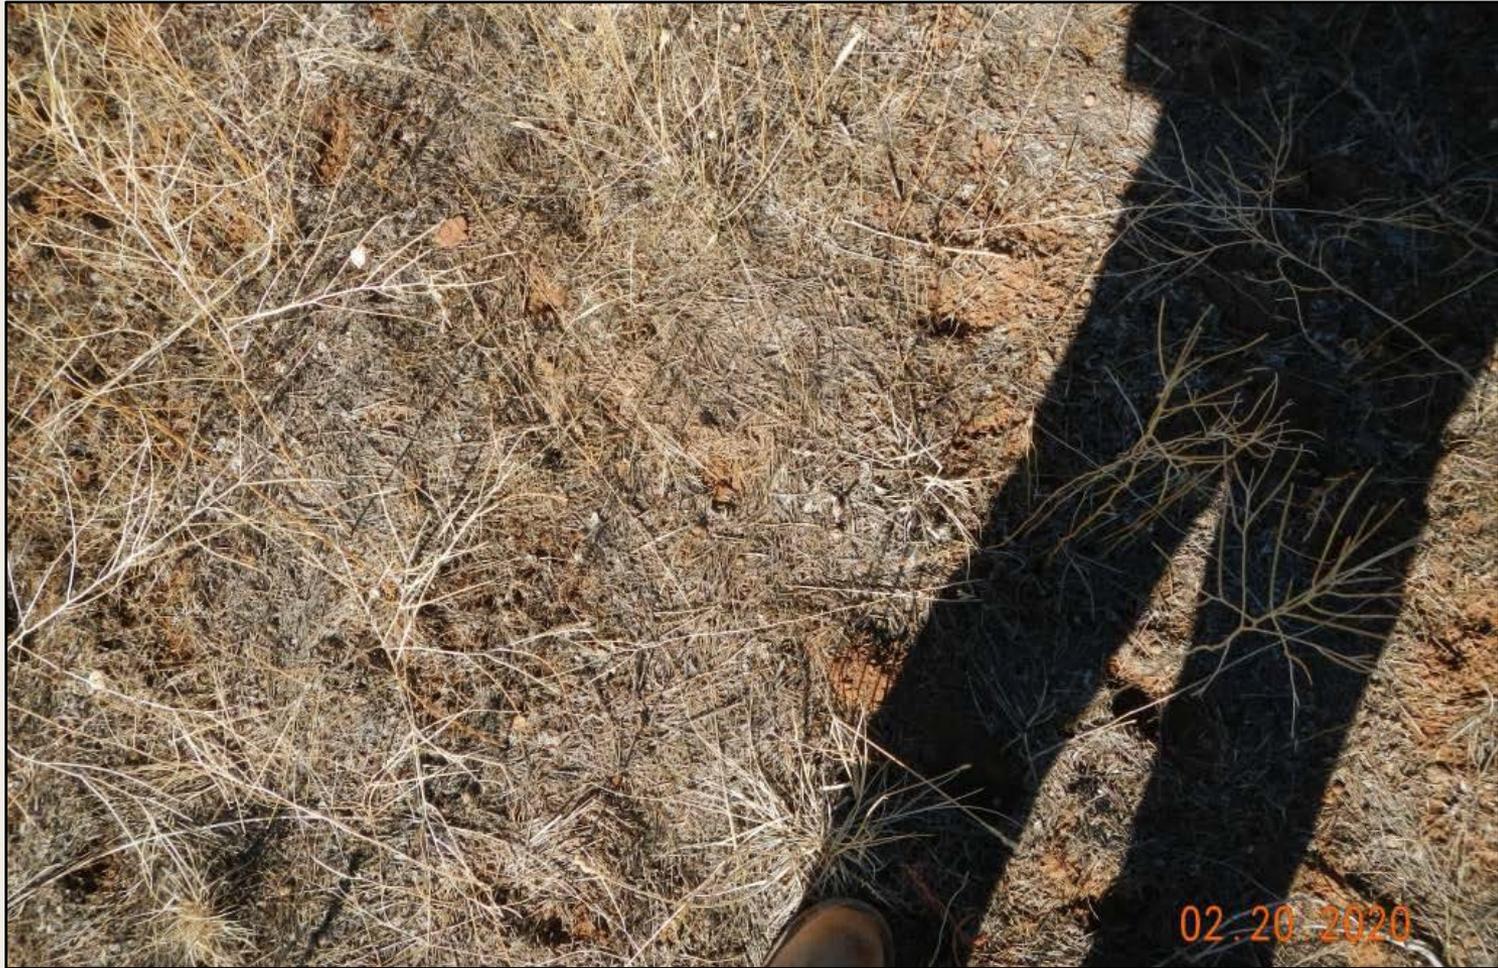
Photo 4. Birdseye view of typical vegetative cover within the interim reclamation area. Observed vegetation is largely annual weeds such as cheatgrass and mustard spp.

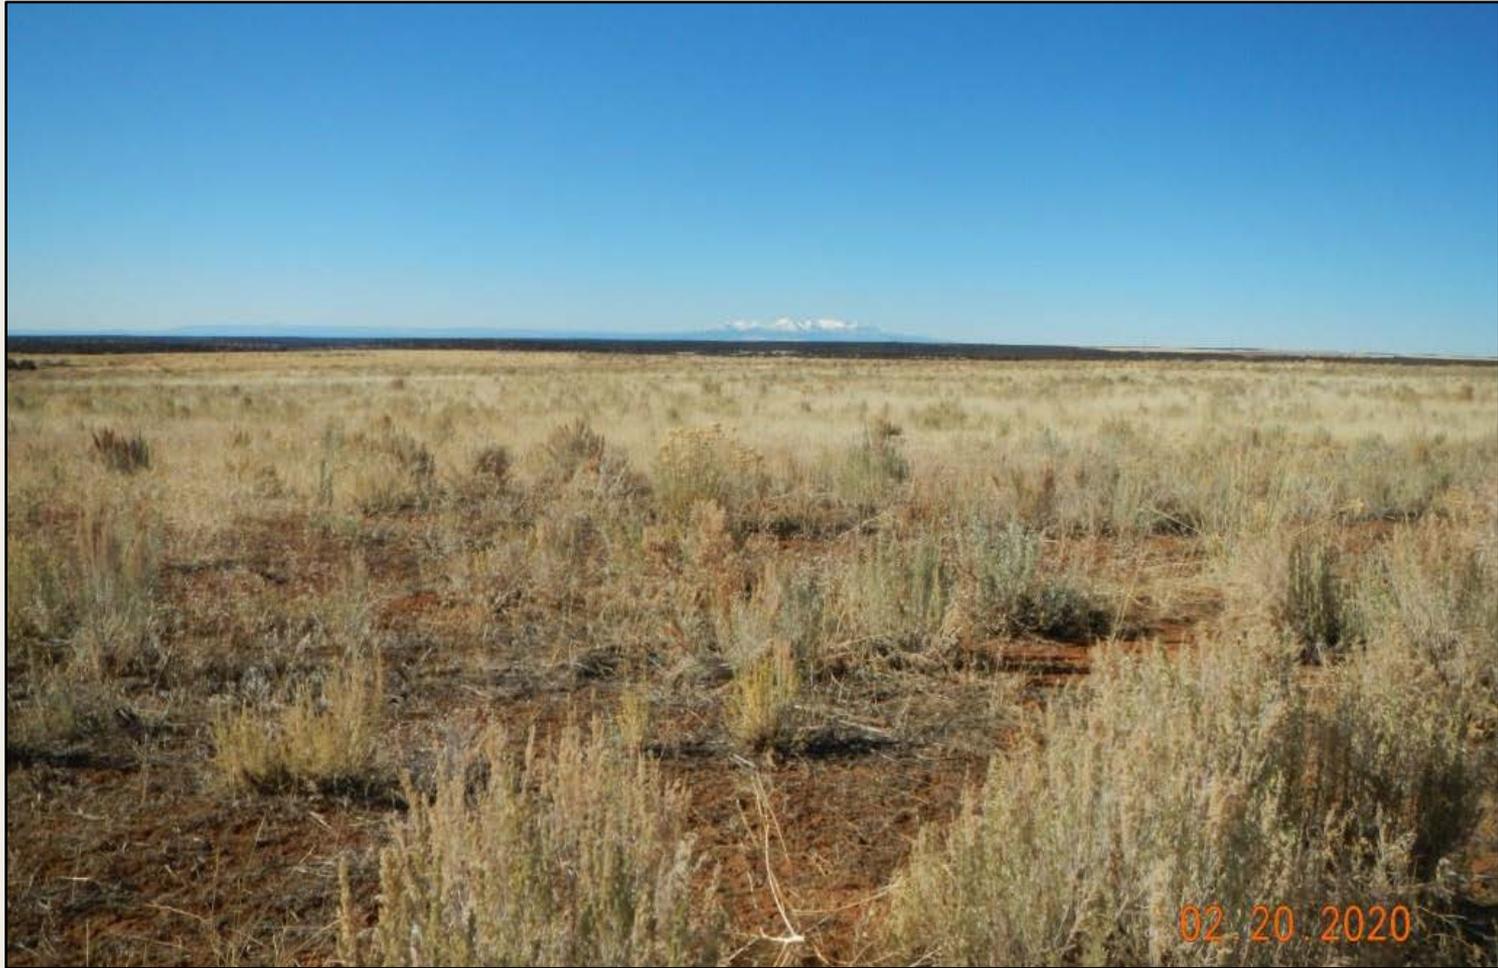
Photo 5. View of the reference area, comprised of sagebrush shrubland and grass field vegetation.
