Final Reclamation and Stormwater Inspection

Operator: PDC ENERGY INC - 69175

Location ID: 333249

Weld County, CO

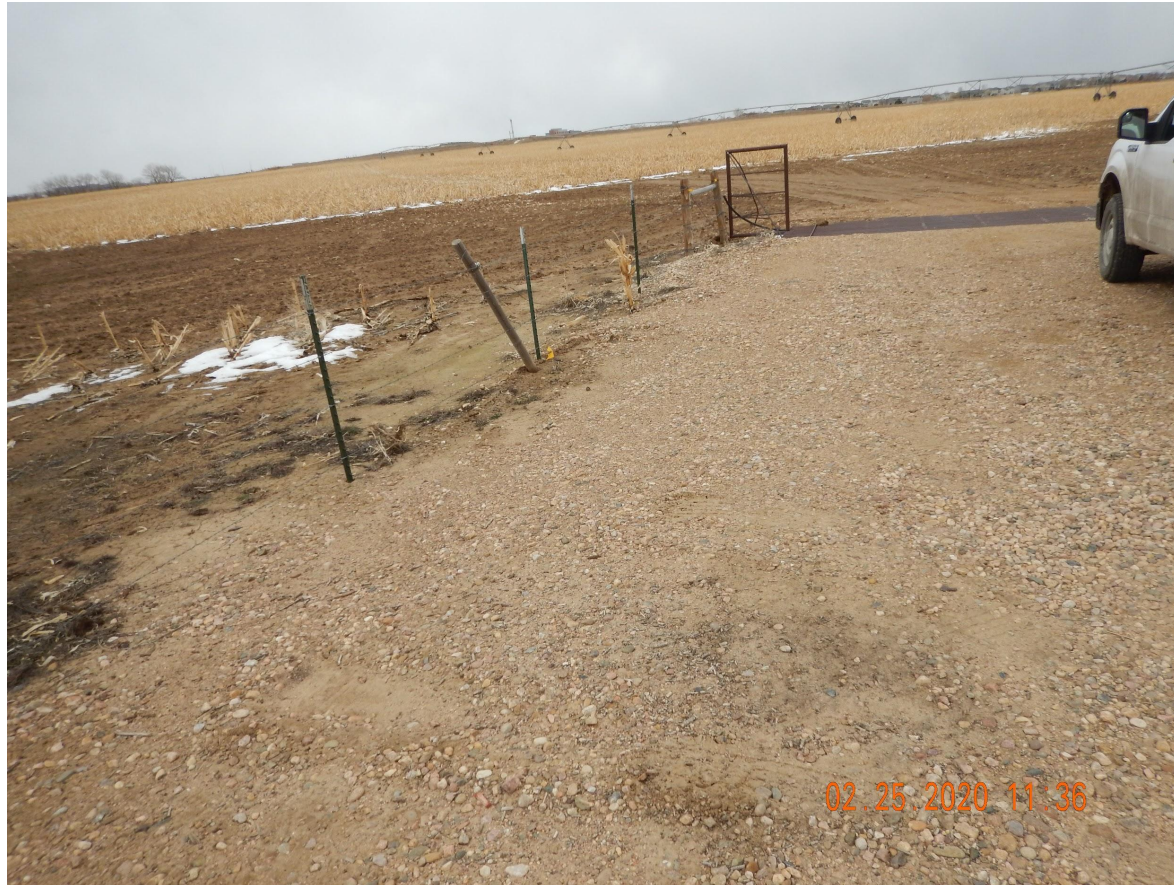
Photo 1. Photo taken from the entrance of the well location access road, facing West. Photo illustrates the culvert and access road point have not been removed per Rule 1004.

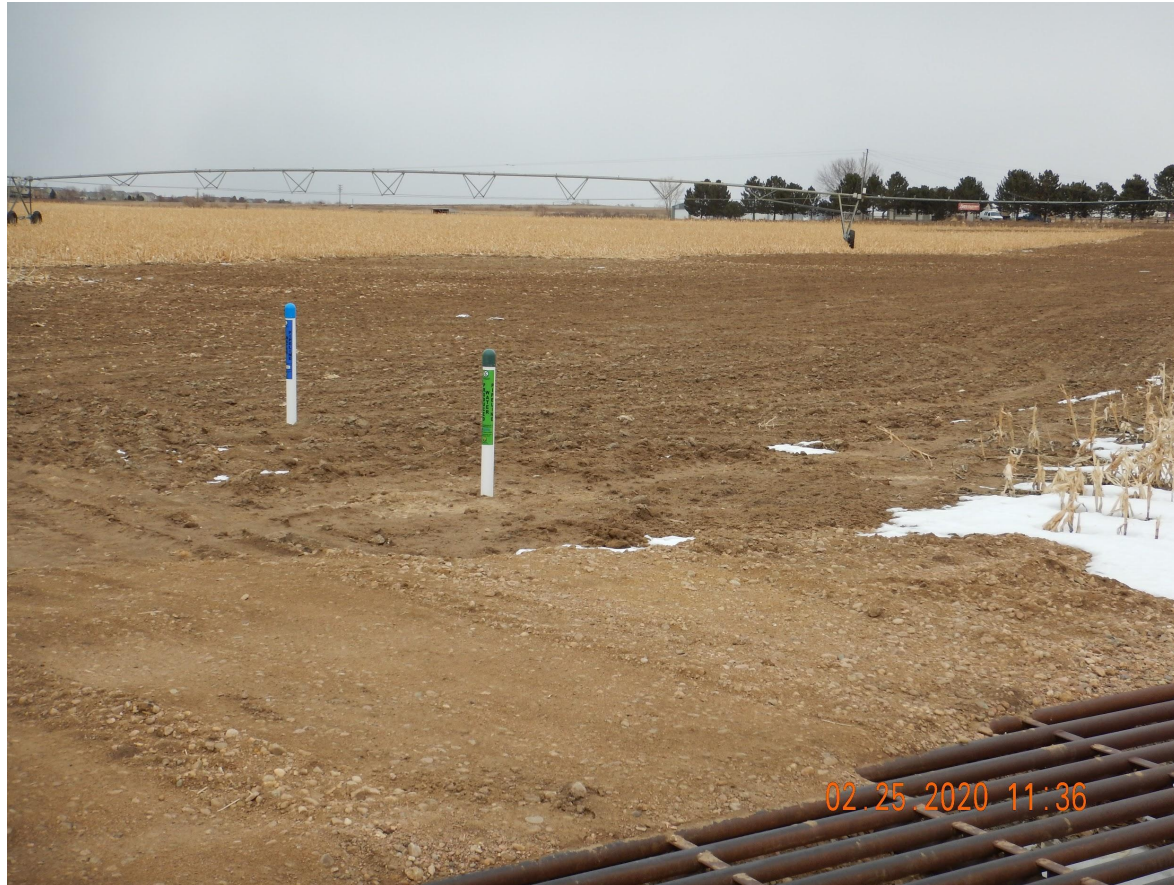
Photo 2. Photo taken from the entrance of the well location access road, facing Northwest. Photo illustrates portions of the access road have been recently disturbed from a pipeline. COGCC staff will have to make a future inspection during the next active growing season to evaluate vegetative compliance.

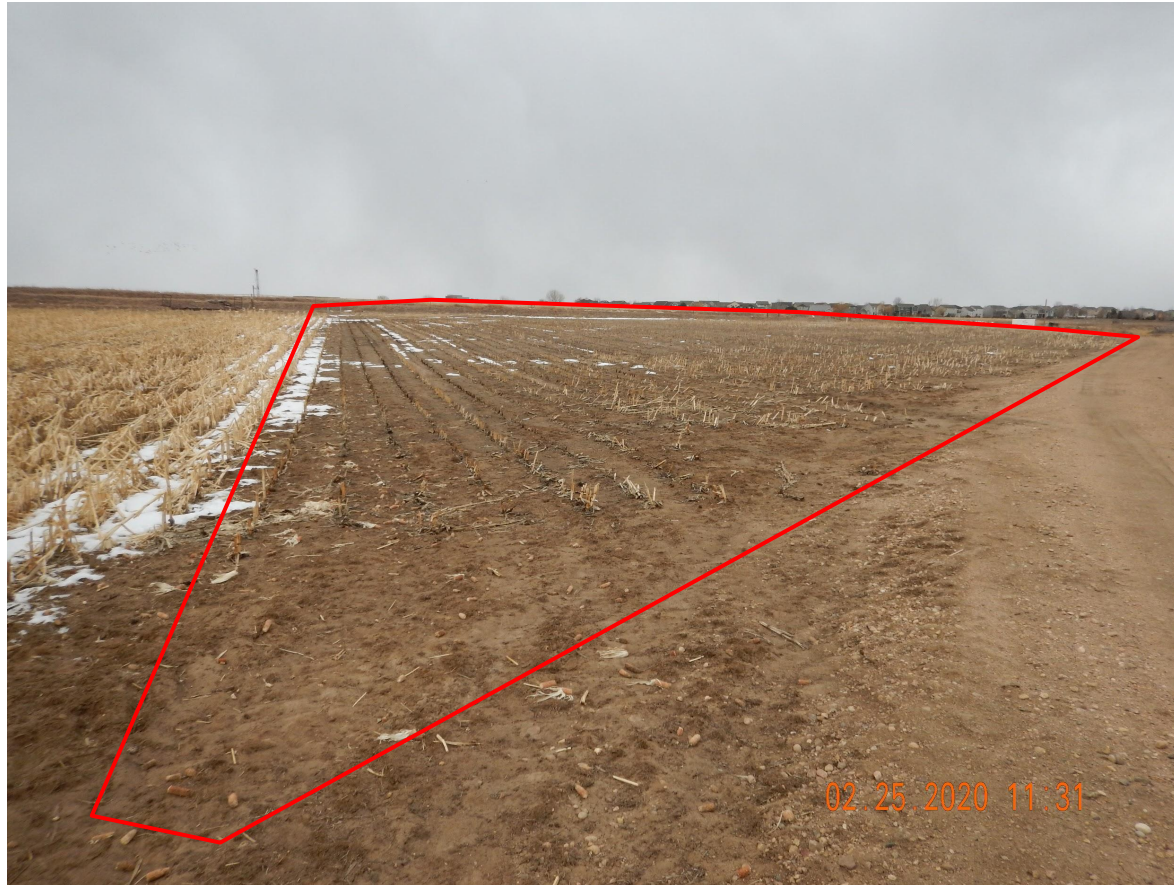
Photo 3. Photo taken from the southern location, facing Northwest. Photo illustrates that crop do not appear to be reflective of reference area crop levels. COGCC staff will have to make a future inspection during the next active growing season to evaluate vegetative compliance.

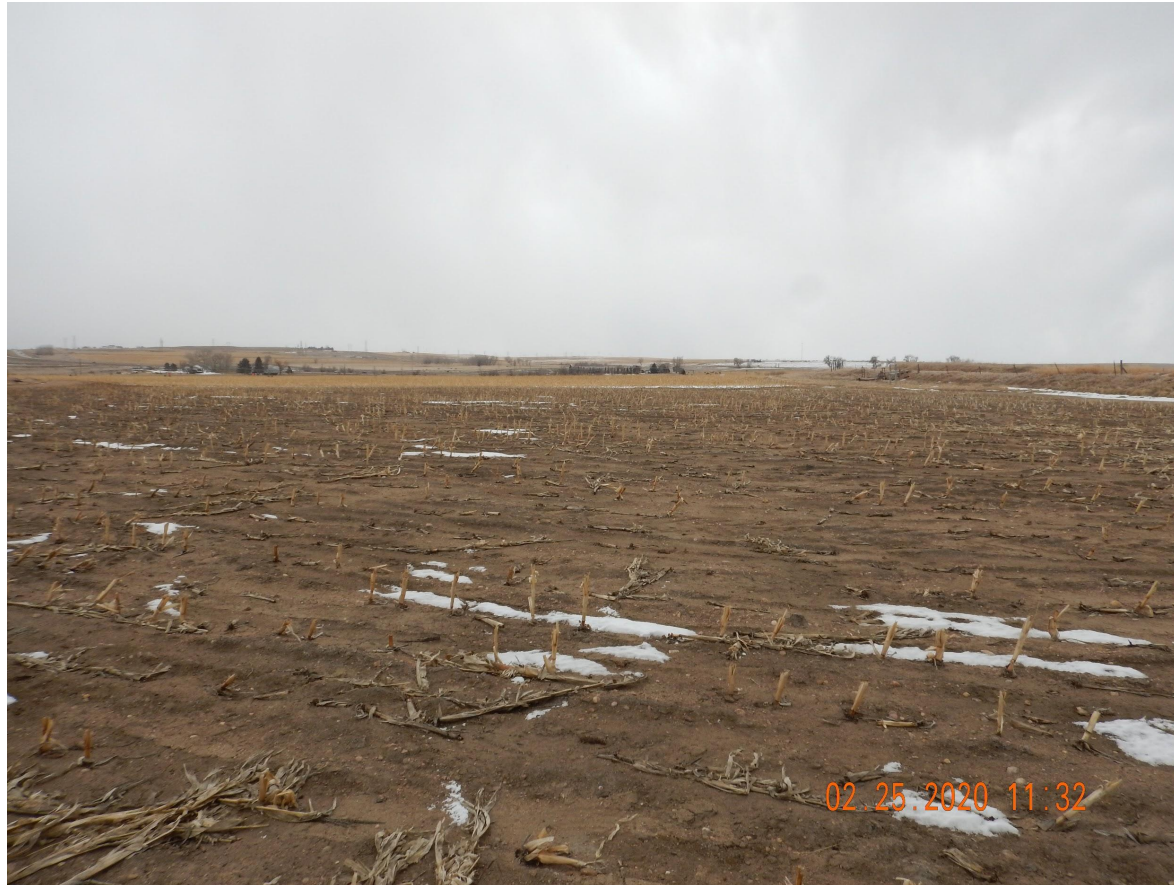
Photo 4. Photo taken from the northern location, facing South. See comments under Photo 3.
