Inspection Photos

Operator: CHEVRON USA INC - 16700

Location ID: 314838

Rio Blanco County, CO

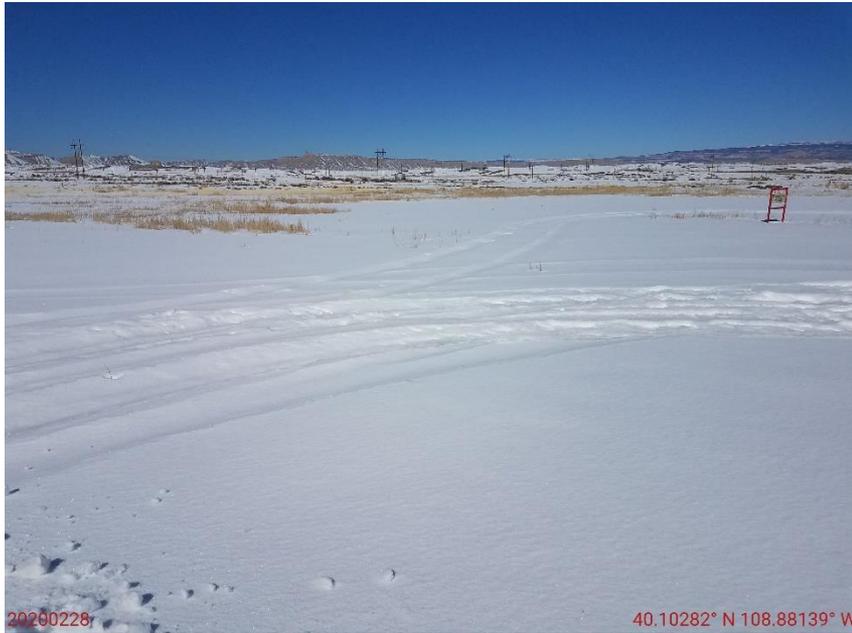
Photo 1: Photo taken from the south end of the Location facing northwest. Photos 1-2 provide an overview of the Location from northwest to northeast. Surface equipment/signage observed on the Location and needs to be removed. Snow cover on the surface of the Location prevented reclamation specialist from conducting an accurate assessment of the reclamation/revegetation of the Location. A followup inspection will be conducted in the future growing seasons to determine compliance with Rule 1004.c.(2).

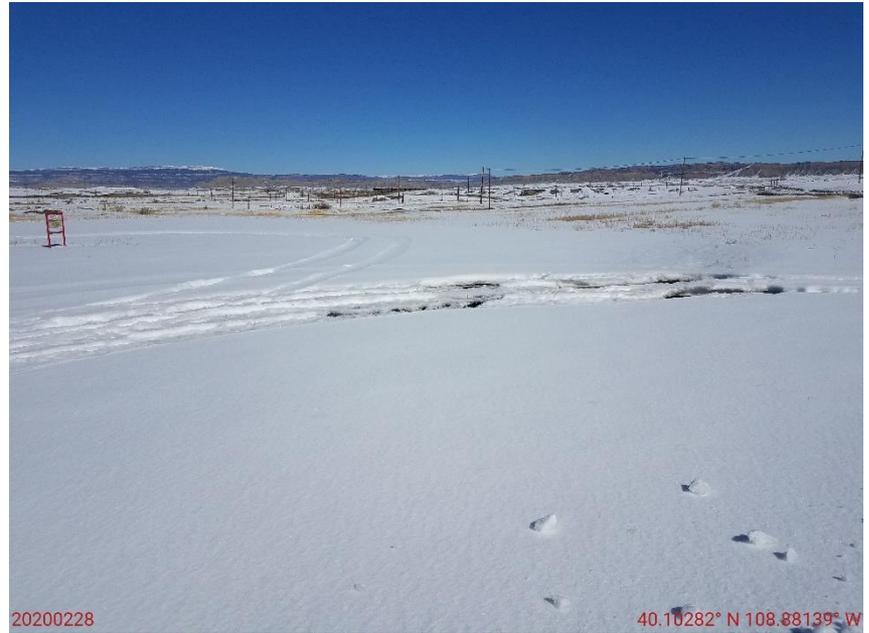
Photo 2: See comments under photo 1.

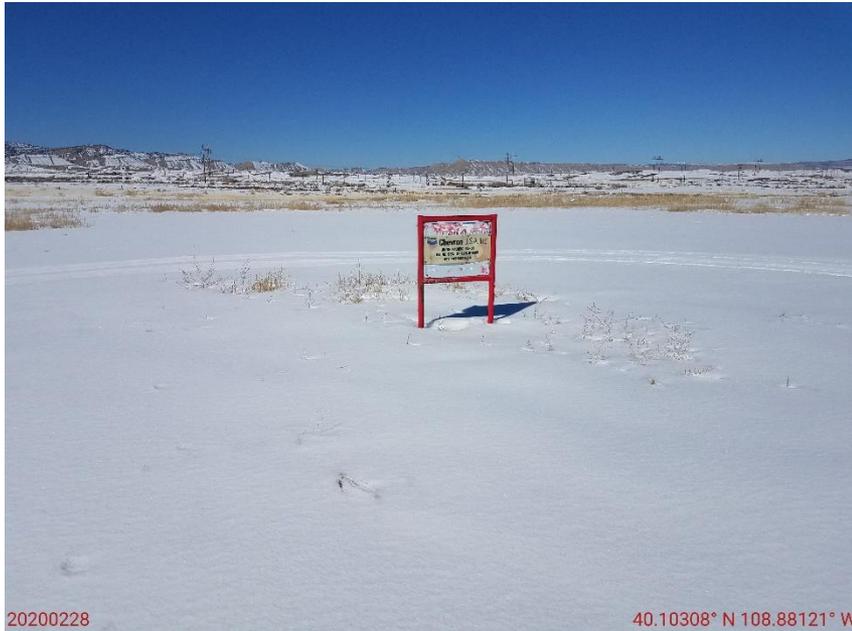
Photo 3: Photo of sign left at wellhead. .

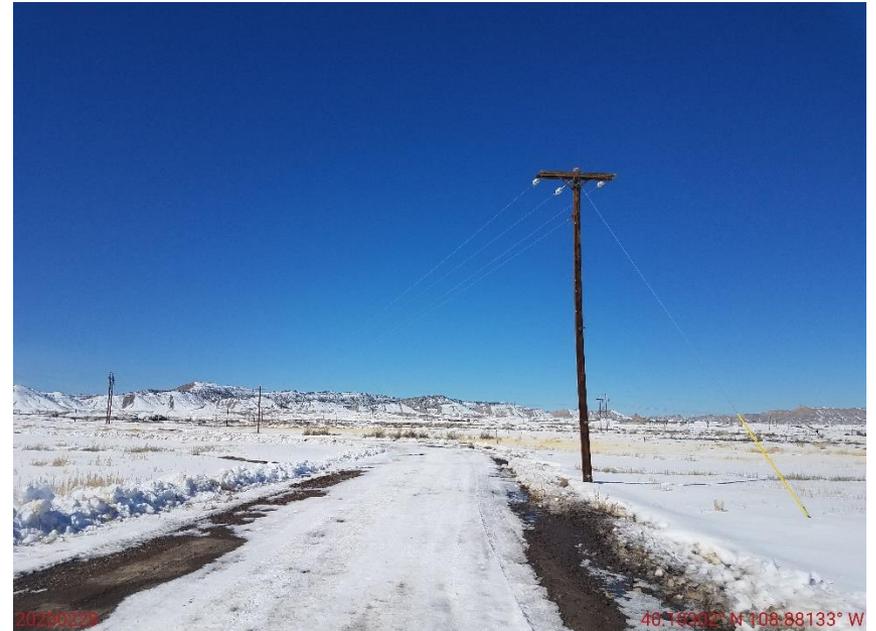
Photo 4: Photo taken from the west end of the Location, facing west. Photo shows the Oil and Gas utility pole on Location, and poles leading to the Location, have not been removed pursuant to Rule 1004.a
