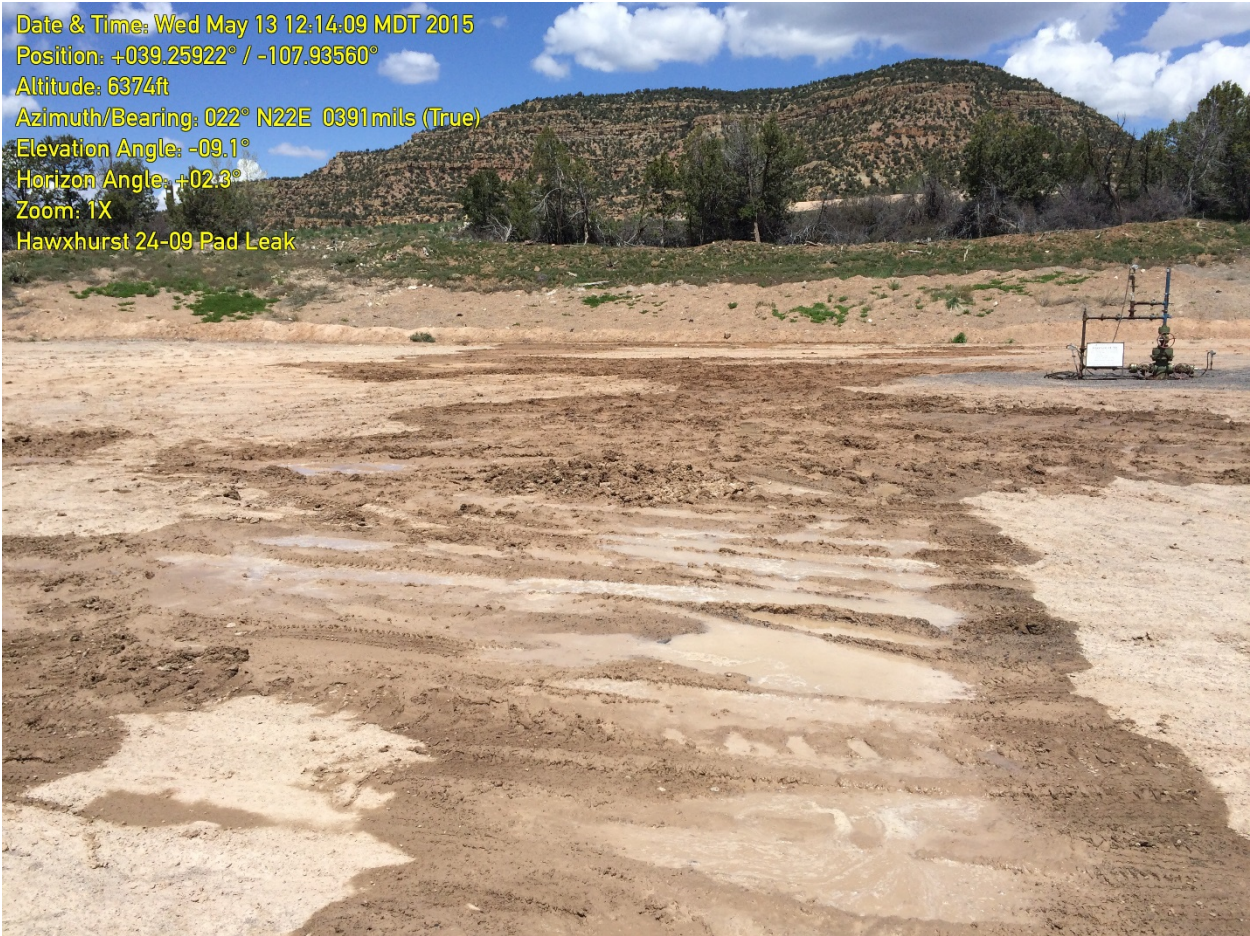
Date & Time: Wed May 13 12:14:09 MDT 2015  
Position: +039.25922° / -107.93560°  
Altitude: 6374ft  
Azimuth/Bearing: 022° N22E 0391mils (True)  
Elevation Angle: -09.1°  
Horizon Angle: +02.3°  
Zoom: 1X  
Hawxhurst 24-09 Pad Leak

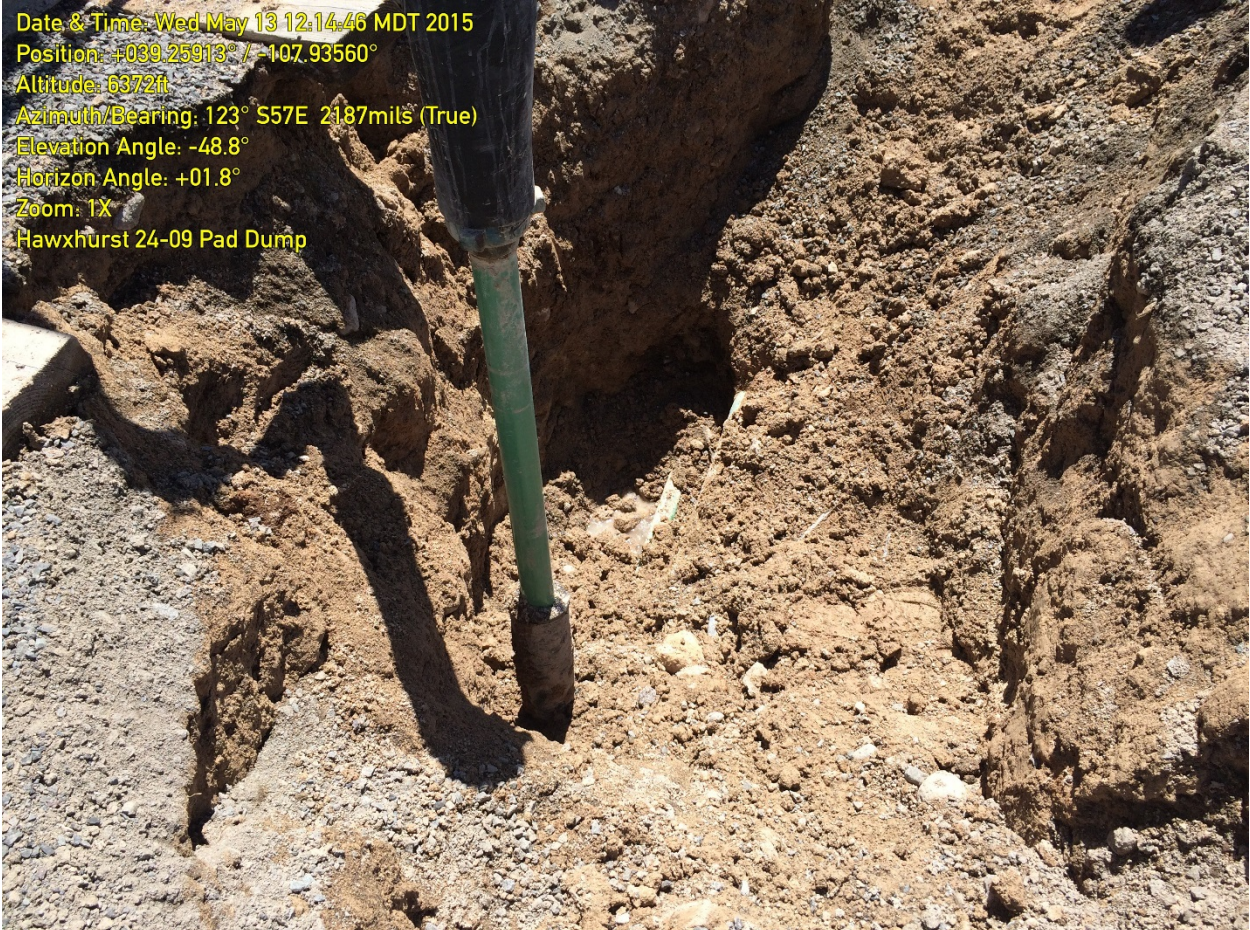
Date & Time: Wed May 13 12:14:46 MDT 2015  
Position: +039.25913° / -107.93560°  
Altitude: 6372ft  
Azimuth/Bearing: 123° S57E 2187mils (True)  
Elevation Angle: -48.8°  
Horizon Angle: +01.8°  
Zoom: 1X  
Hawxhurst 24-09 Pad Dump

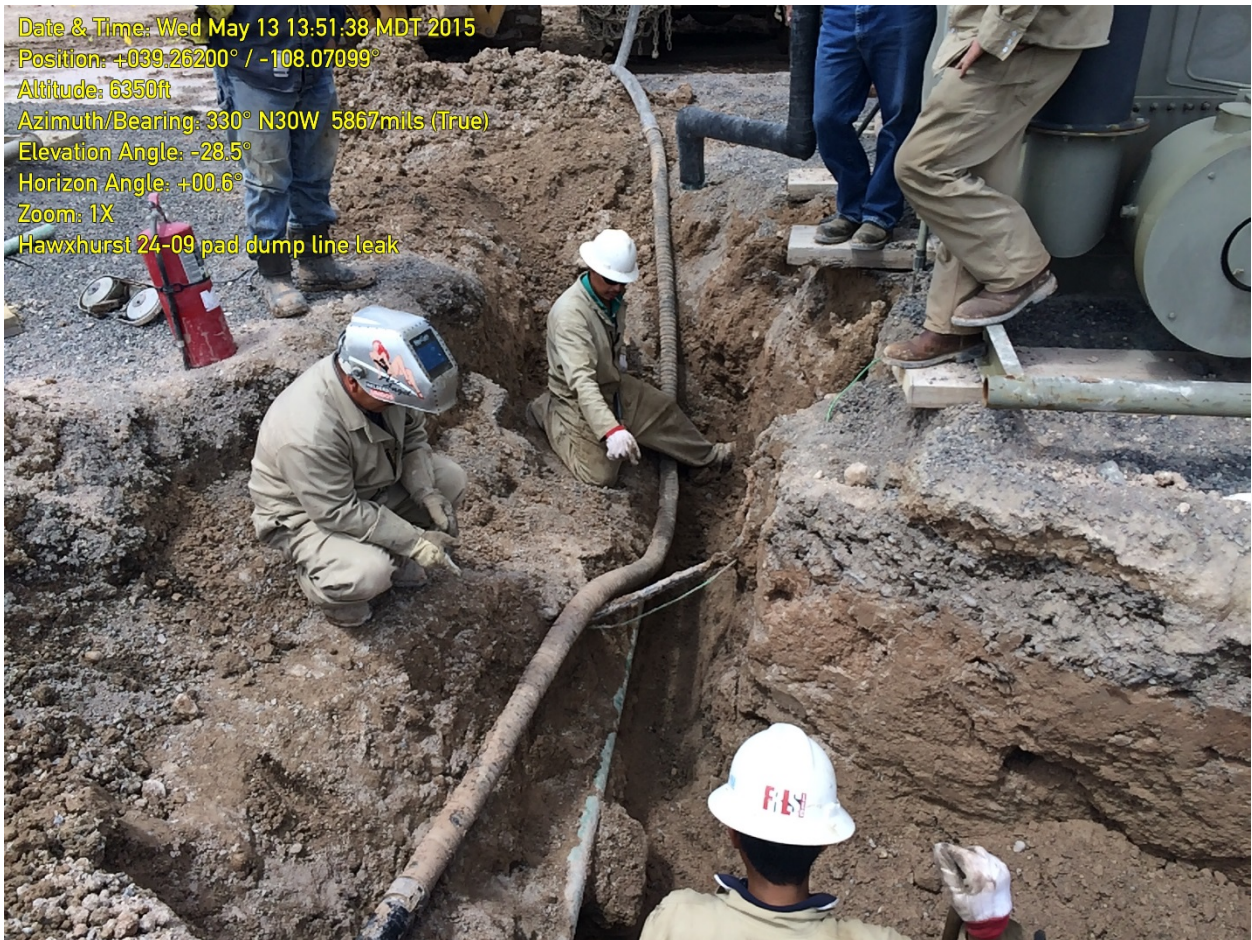
Date & Time: Wed May 13 13:51:38 MDT 2015  
Position: +039.26200° / -108.07099°  
Altitude: 6350ft  
Azimuth/Bearing: 330° N30W 5867mils (True)  
Elevation Angle: -28.5°  
Horizon Angle: +00.6°  
Zoom: 1X  
Hawxhurst 24-09 pad dump line leak

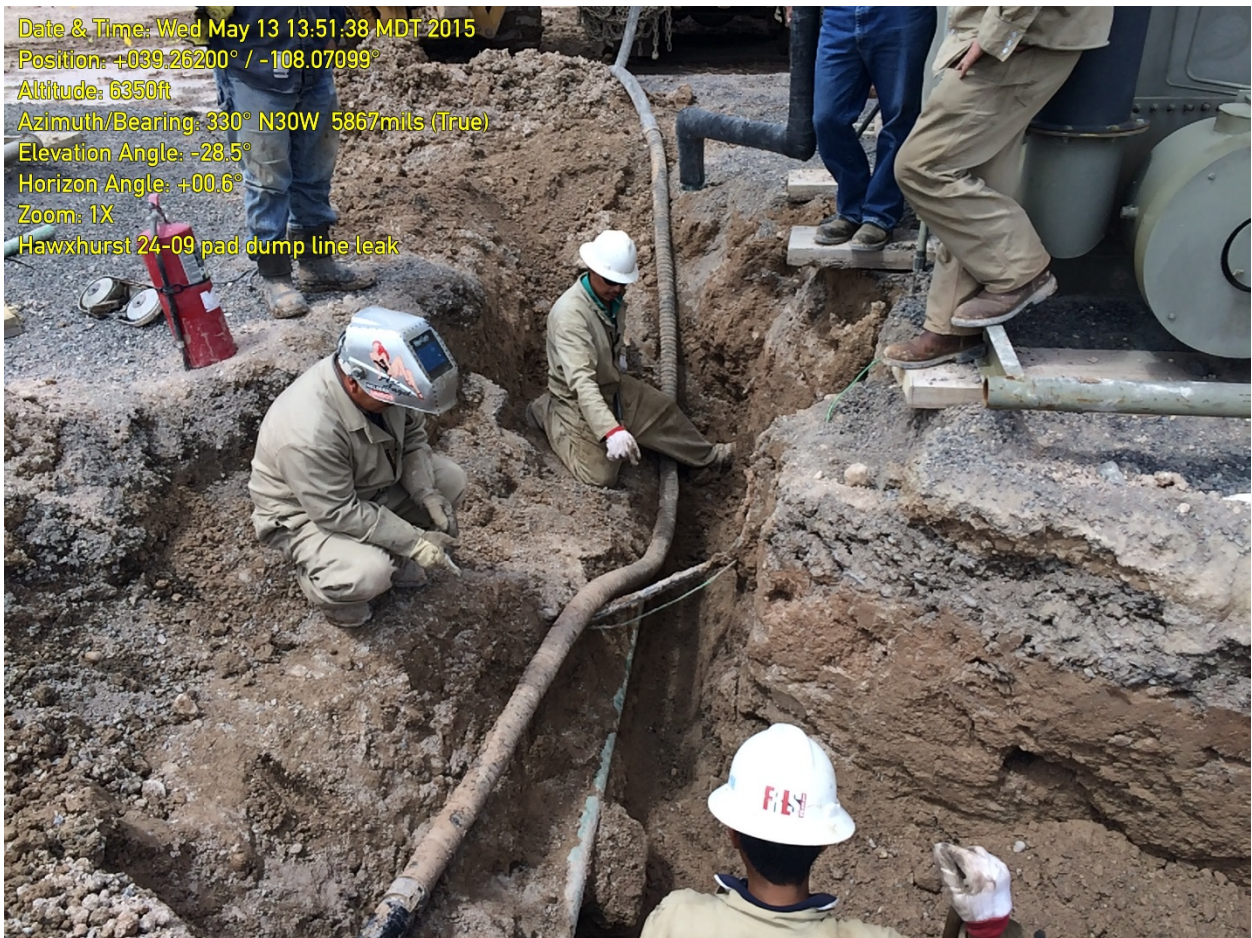
Date & Time: Wed May 13 13:51:38 MDT 2015  
Position: +039.26200° / -108.07099°  
Altitude: 6350ft  
Azimuth/Bearing: 330° N30W 5867mils (True)  
Elevation Angle: -28.5°  
Horizon Angle: +00.6°  
Zoom: 1X  
Hawxhurst 24-09 pad dump line leak

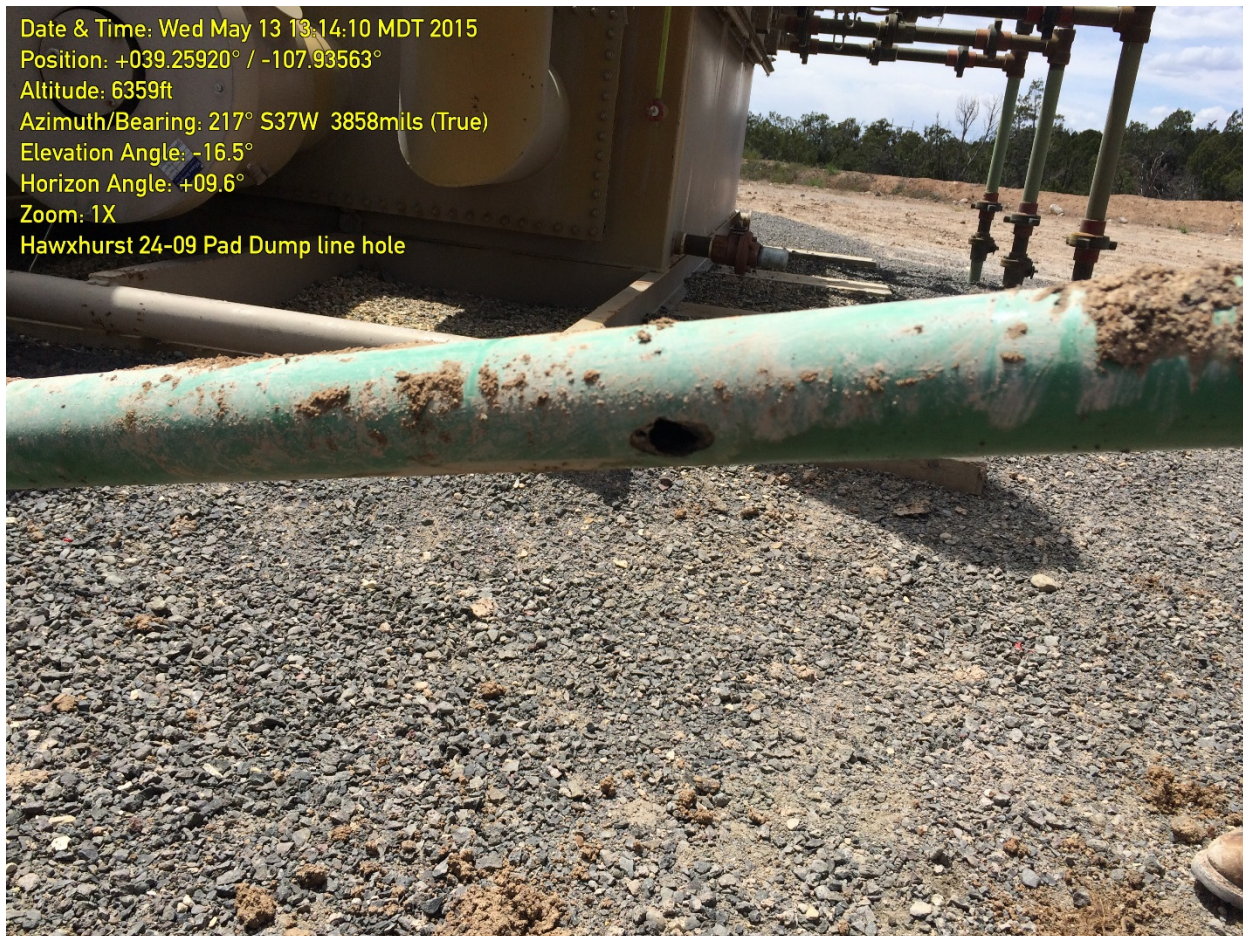
Date & Time: Wed May 13 13:14:10 MDT 2015  
Position: +039.25920° / -107.93563°  
Altitude: 6359ft  
Azimuth/Bearing: 217° S37W 3858mils (True)  
Elevation Angle: -16.5°  
Horizon Angle: +09.6°  
Zoom: 1X  
Hawxhurst 24-09 Pad Dump line hole

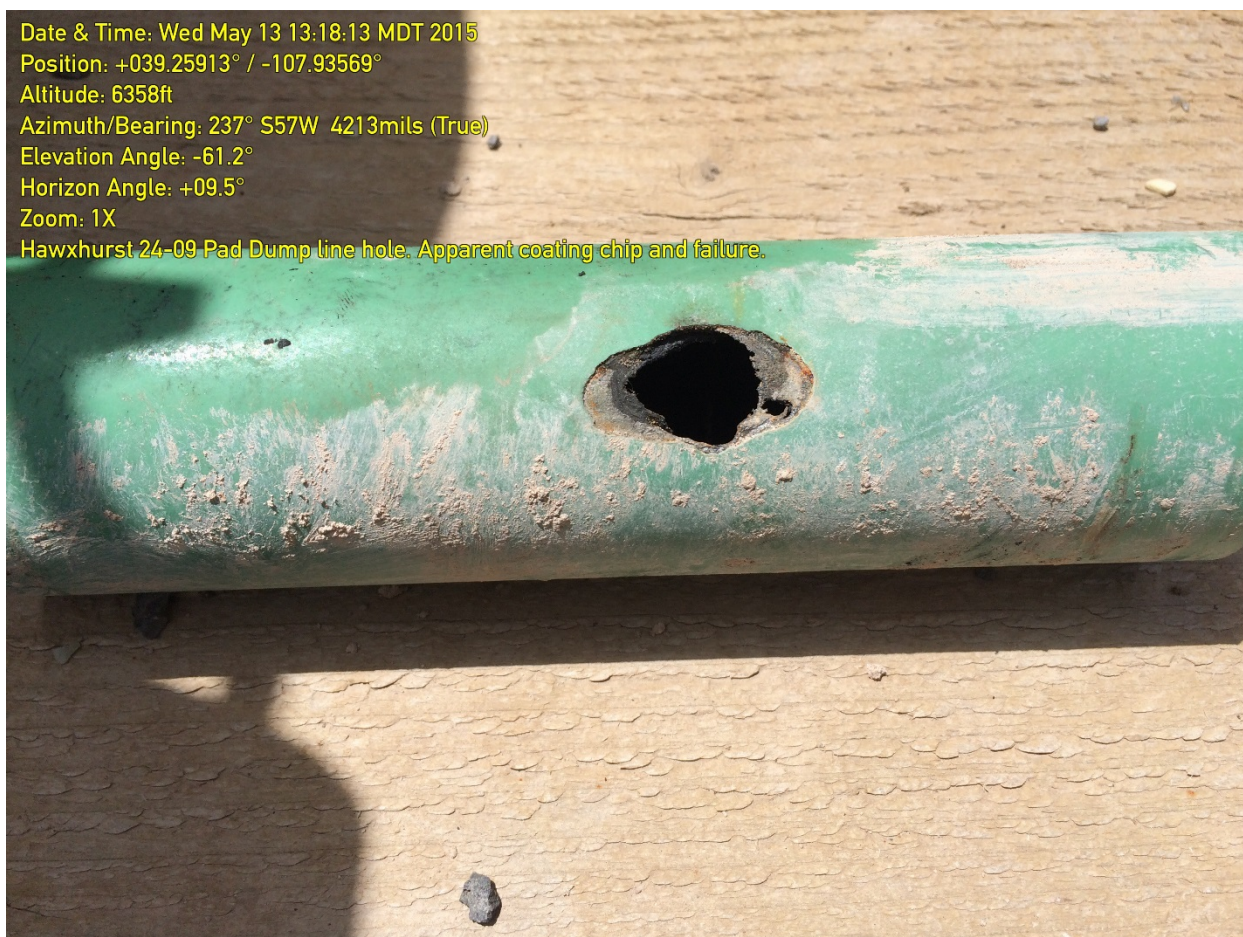
Date & Time: Wed May 13 13:18:13 MDT 2015  
Position: +039.25913° / -107.93569°  
Altitude: 6358ft  
Azimuth/Bearing: 237° S57W 4213mils (True)  
Elevation Angle: -61.2°  
Horizon Angle: +09.5°  
Zoom: 1X  
Hawxhurst 24-09 Pad Dump line hole. Apparent coating chip and failure.
