# Inspection Photos

3/6/2020

Operator: CHEVRON USA INC - 16700

Location ID: 414661

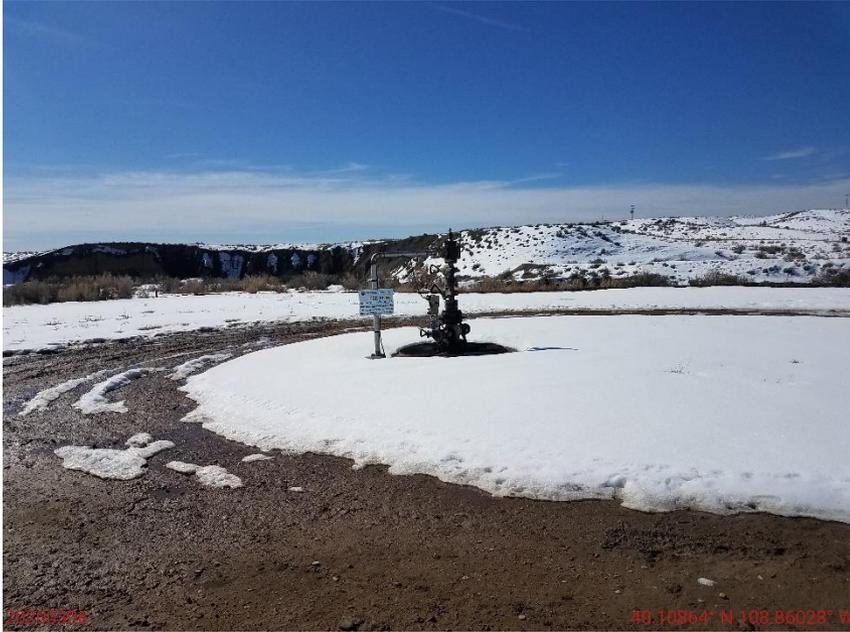
**Photo 1:** Photo of well

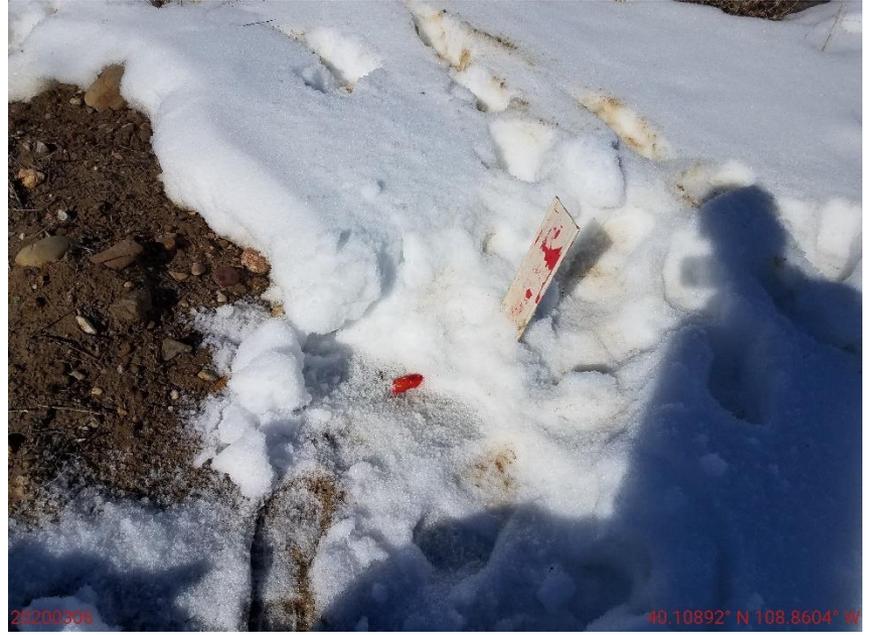
**Photo 2:** Photo taken from anchor on the northeast corner of the Location. Rule 1003.a requires anchors to be identified by a marker of bright color not less than 4 feet in height. Markers in disrepair.

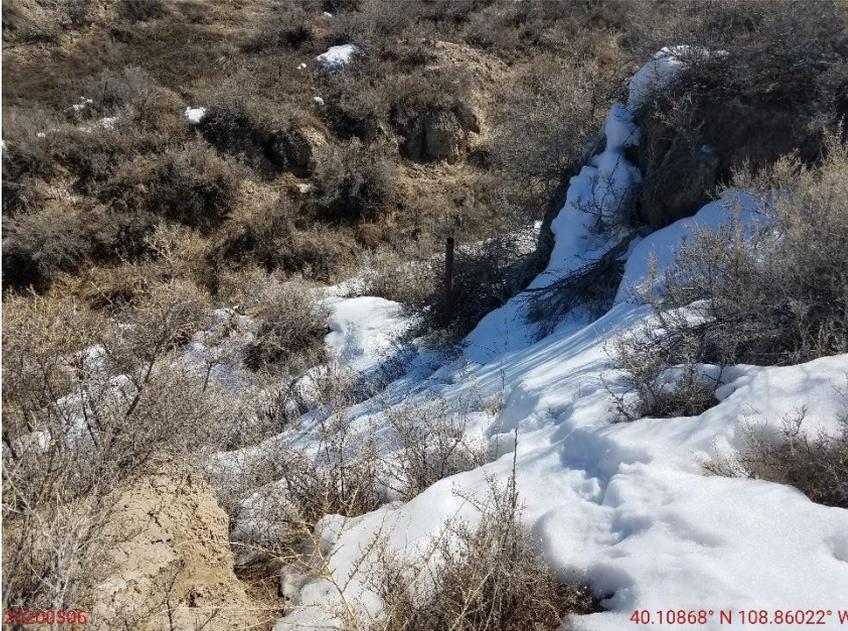
**Photo 3:** Photo taken from the east end of the Location. Photo shows trash debris within drainage.

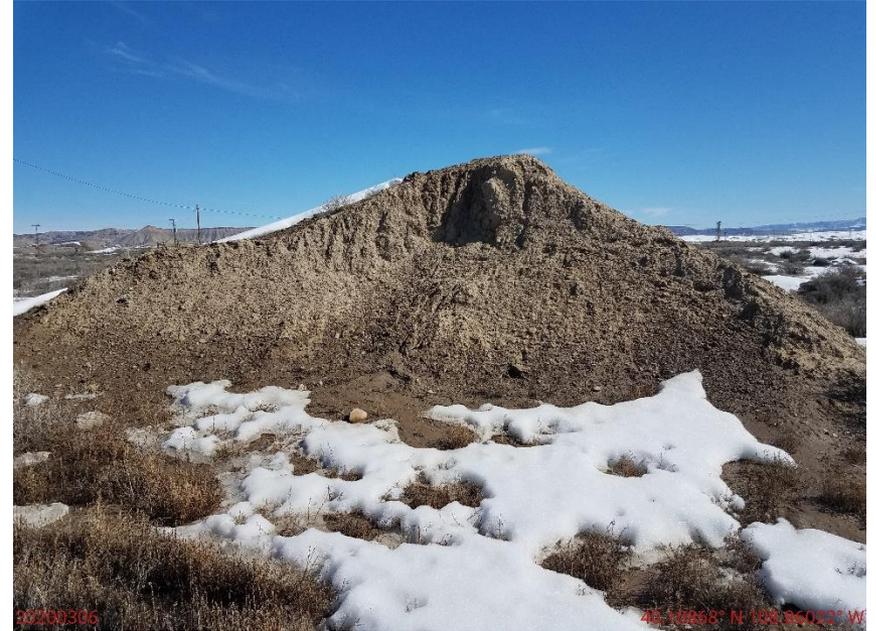
**Photo 4:** Photo taken from the south end of the Location, facing east. Photo shows soil stockpile is not protected in accordance with 1002.c; erosion degradation evident.

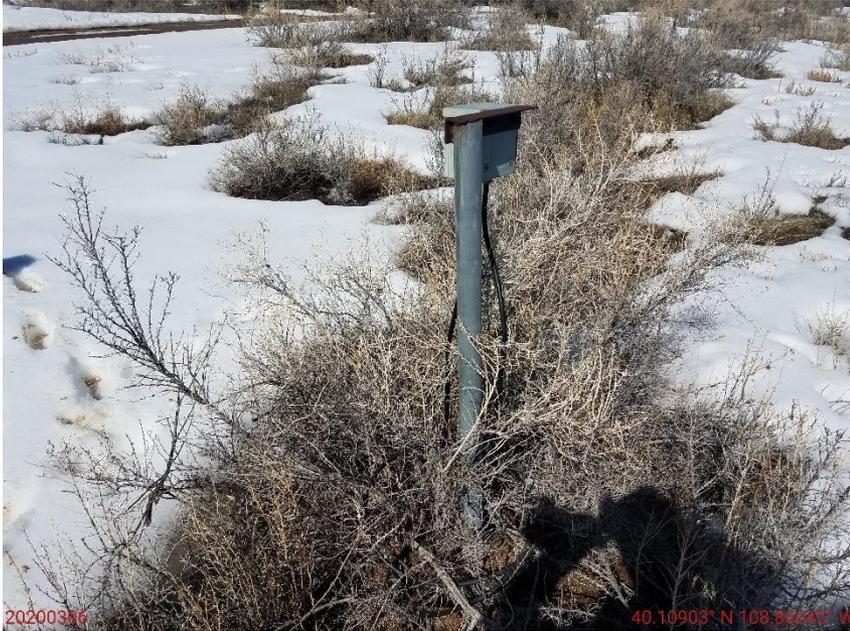
**Photo 5:** Photo taken from the north end of the Location. Photo shows what appears to be an electrical box; cables have been disconnected (see photo 6); Equipment is unused and needs to be removed in accordance with 603.f.

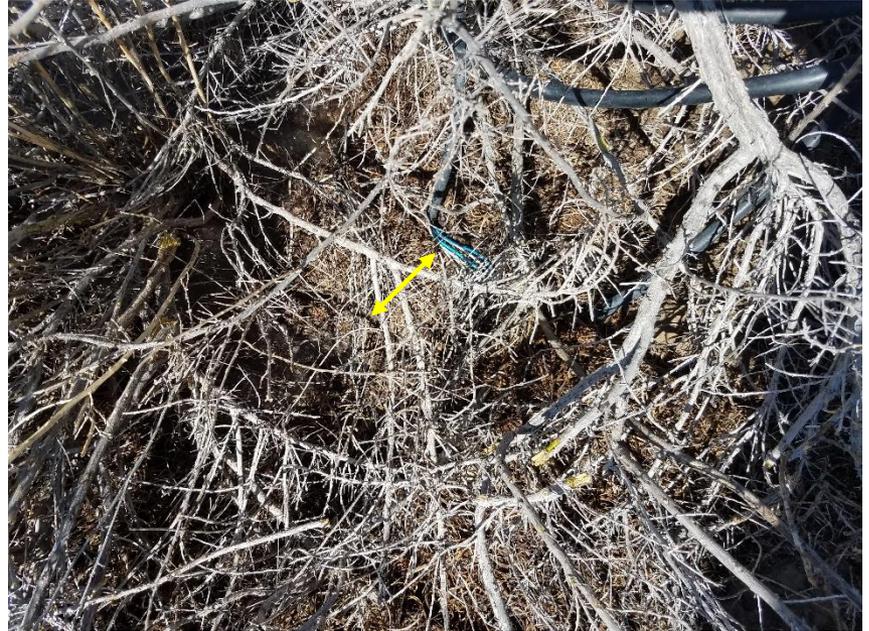
**Photo 6:** Continued from photo 5. Photo shows cables have been cut/disconnected.
