# Final Reclamation Inspection

March 3, 2020

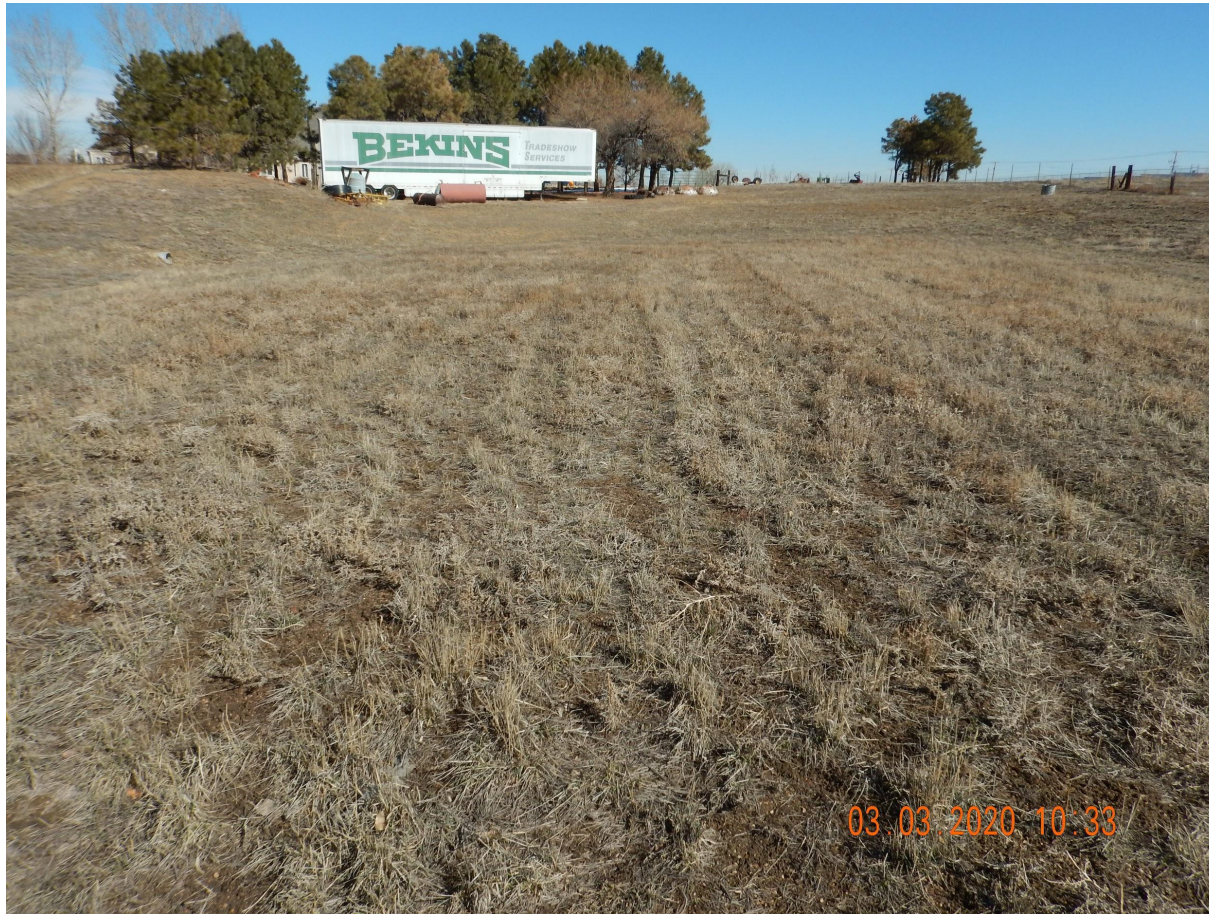
**Photo 1.** Photo taken from the well and tank battery location, facing North. All equipment has been removed. No noxious weeds or stormwater erosion issues observed.

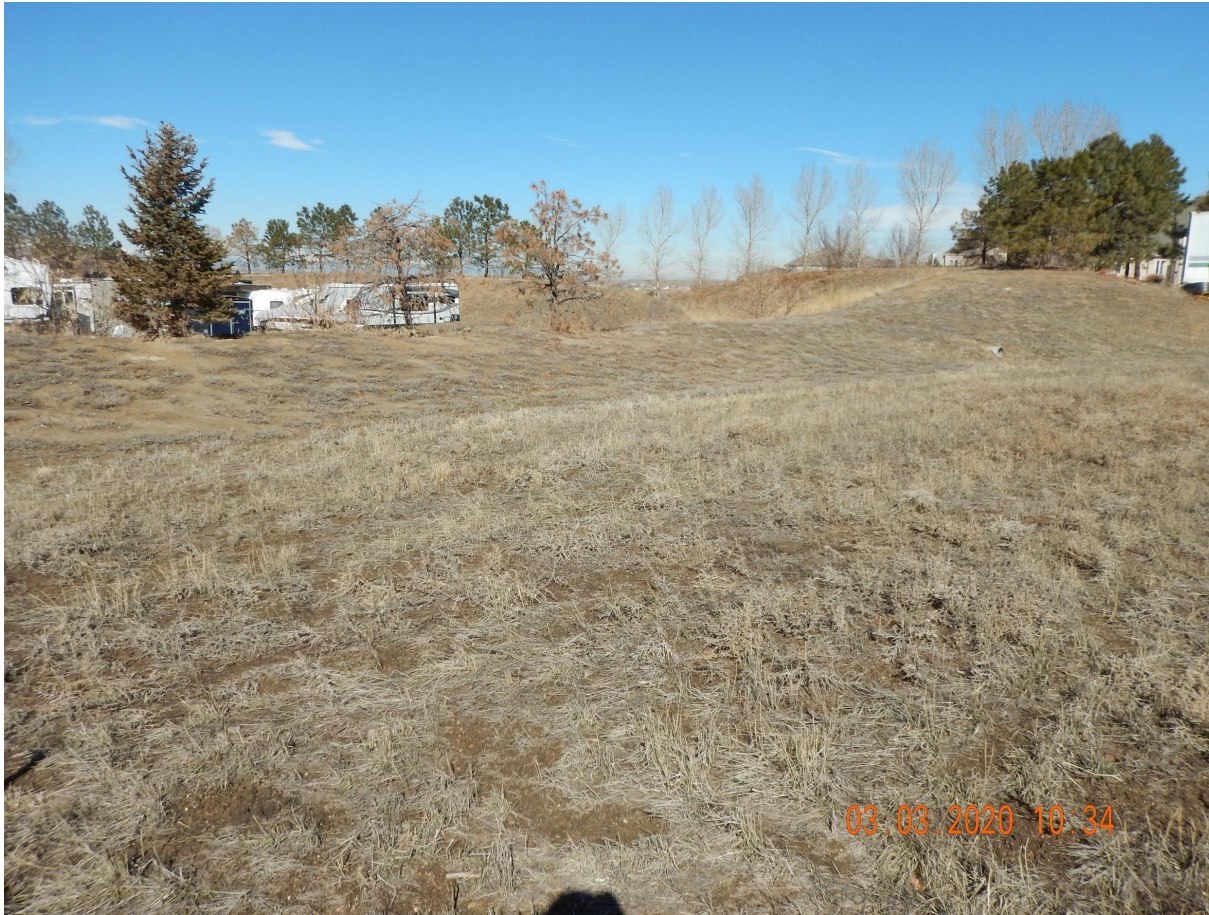
**Photo 2.** Photo taken from the offsite tank battery location, facing West. See comments under Photo 1.
