Inspection Photos

Location Name: VPR C NO. 35 CA 4-18-20

API#: 05-071-06957

INSP. #: 695102337

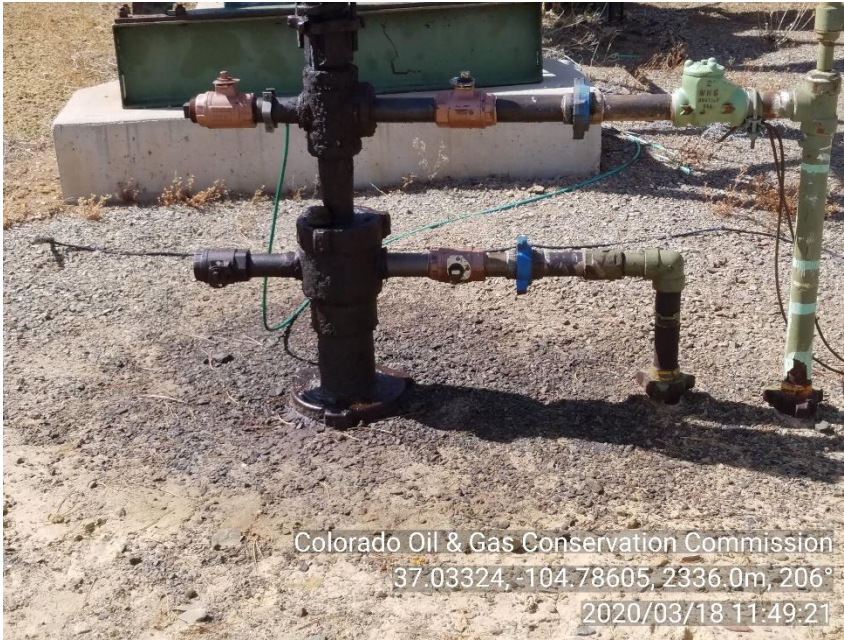
PHOTO 3: THERE IS AN AREA APP. 3' IN DIAMETER OF IMPACTED SOIL APPEARS TO BE COMING FROM POLISH ROD OILER. Conduct maintenance on equipment, cleanup stained material and review self inspection processes. CA DATE 4-18-20.
