Inspection Photos

Operator: Logos Operating
API#: 067-08097 Date:
3/16/2020

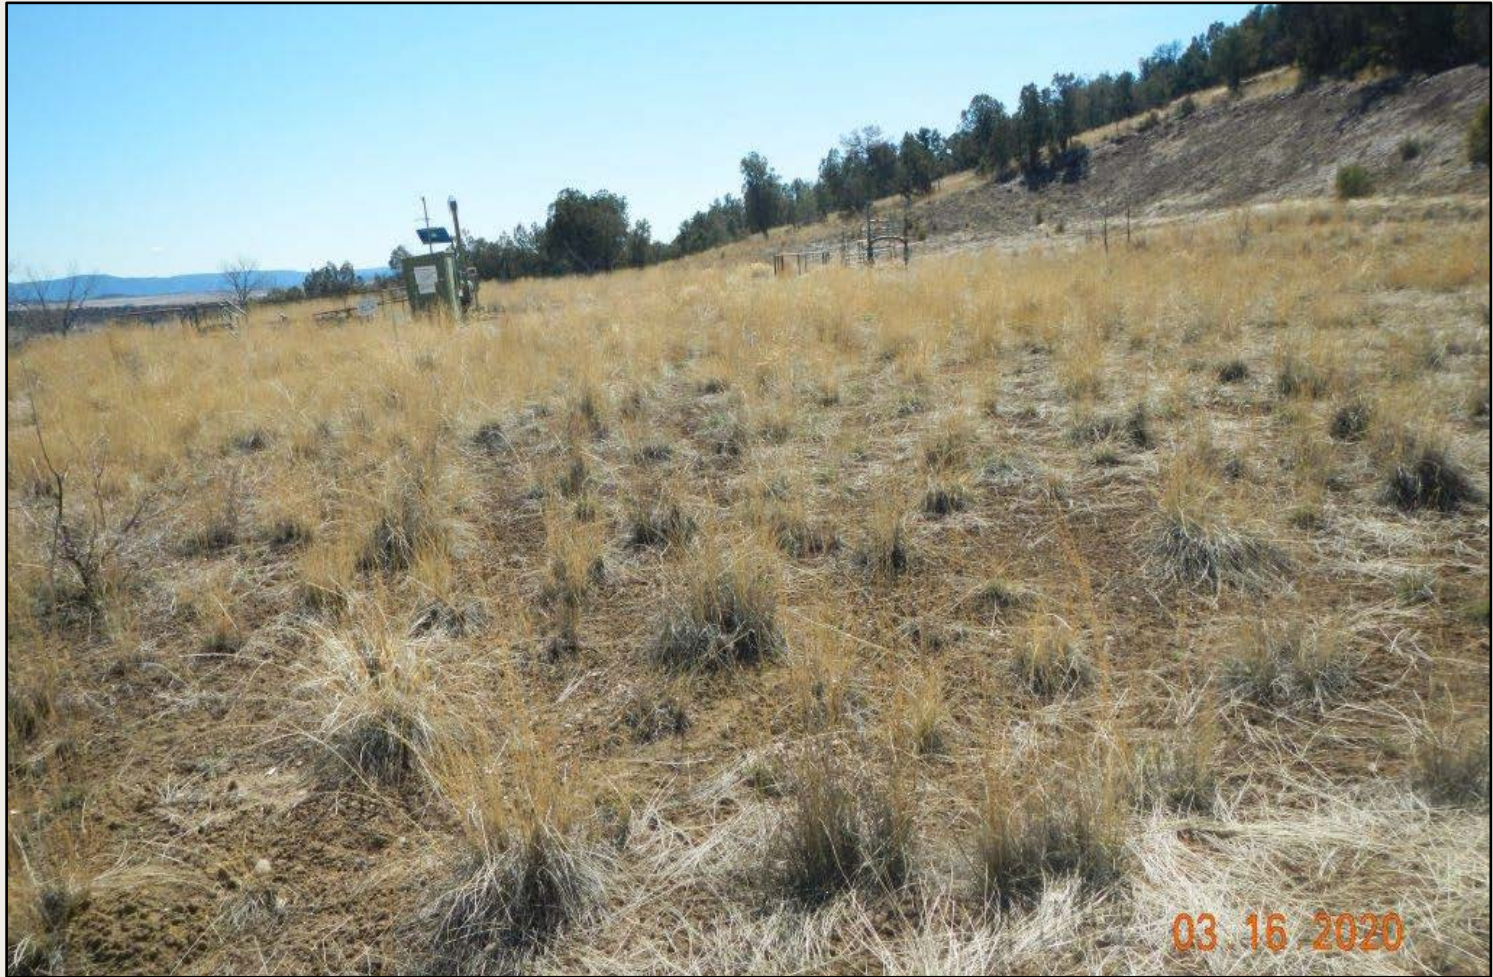
Photo 1. View of the project area from the northern edge facing center.

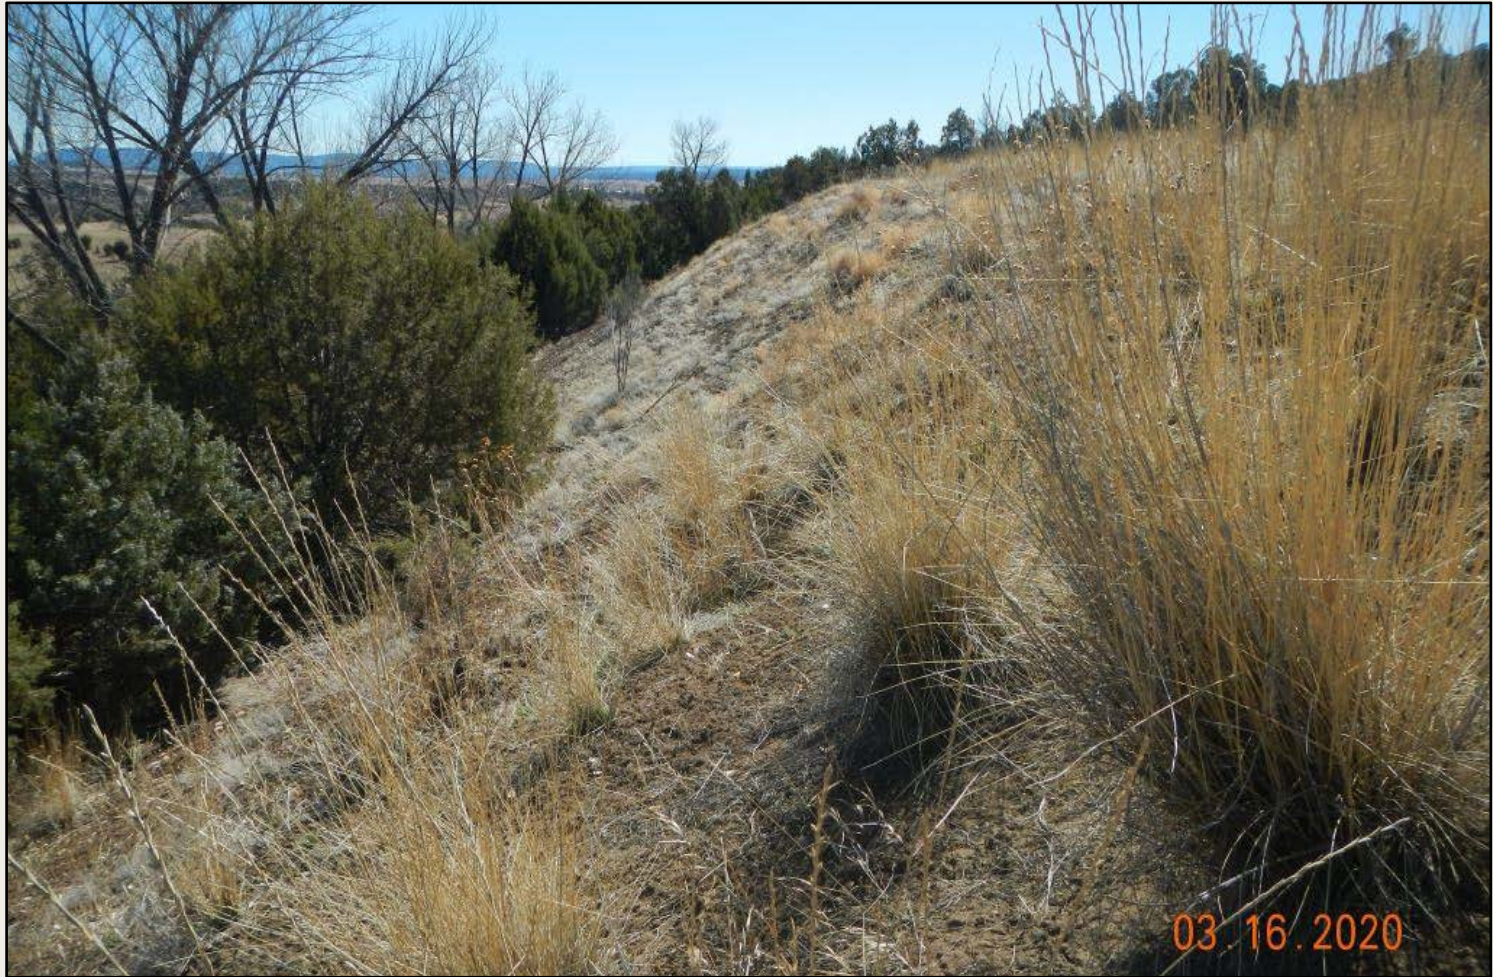
Photo 2. View of the eastern project area. Revegetation remains sparse in portions, progressing within grasses such as western wheatgrass, blue grama, and crested wheatgrass.

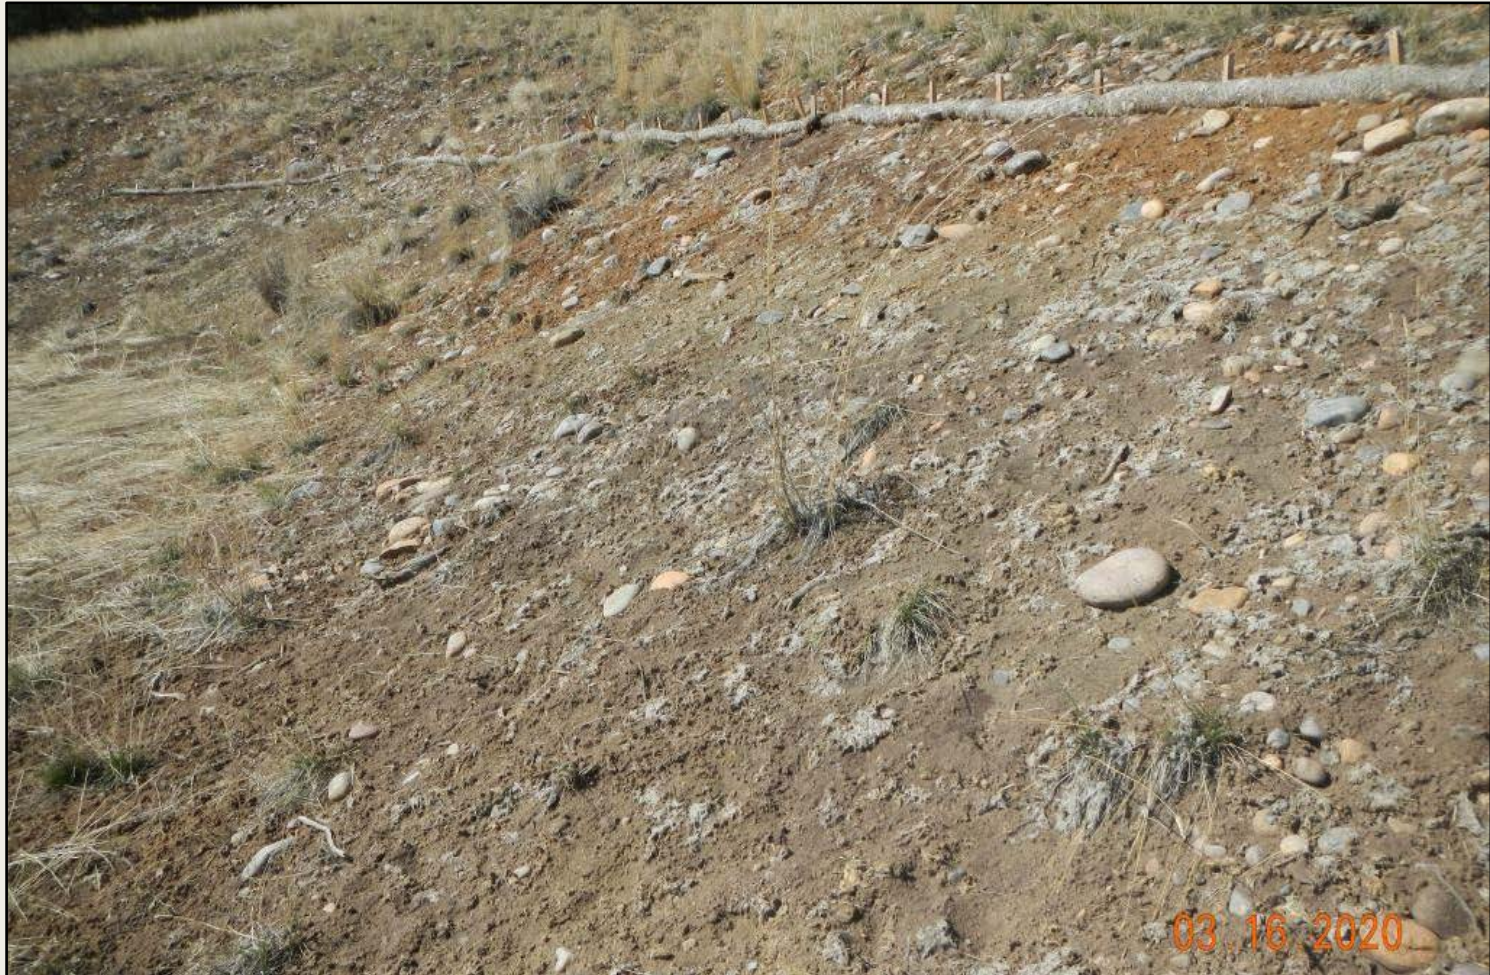
Photo 3. View of the northwestern cut-slope. Hydromulch and wattle on slope. Revegetation progressing in portions and remains sparse in other portions. Needs to be monitored during the 2020 growing season and if not progressing then additional measures will be needed.

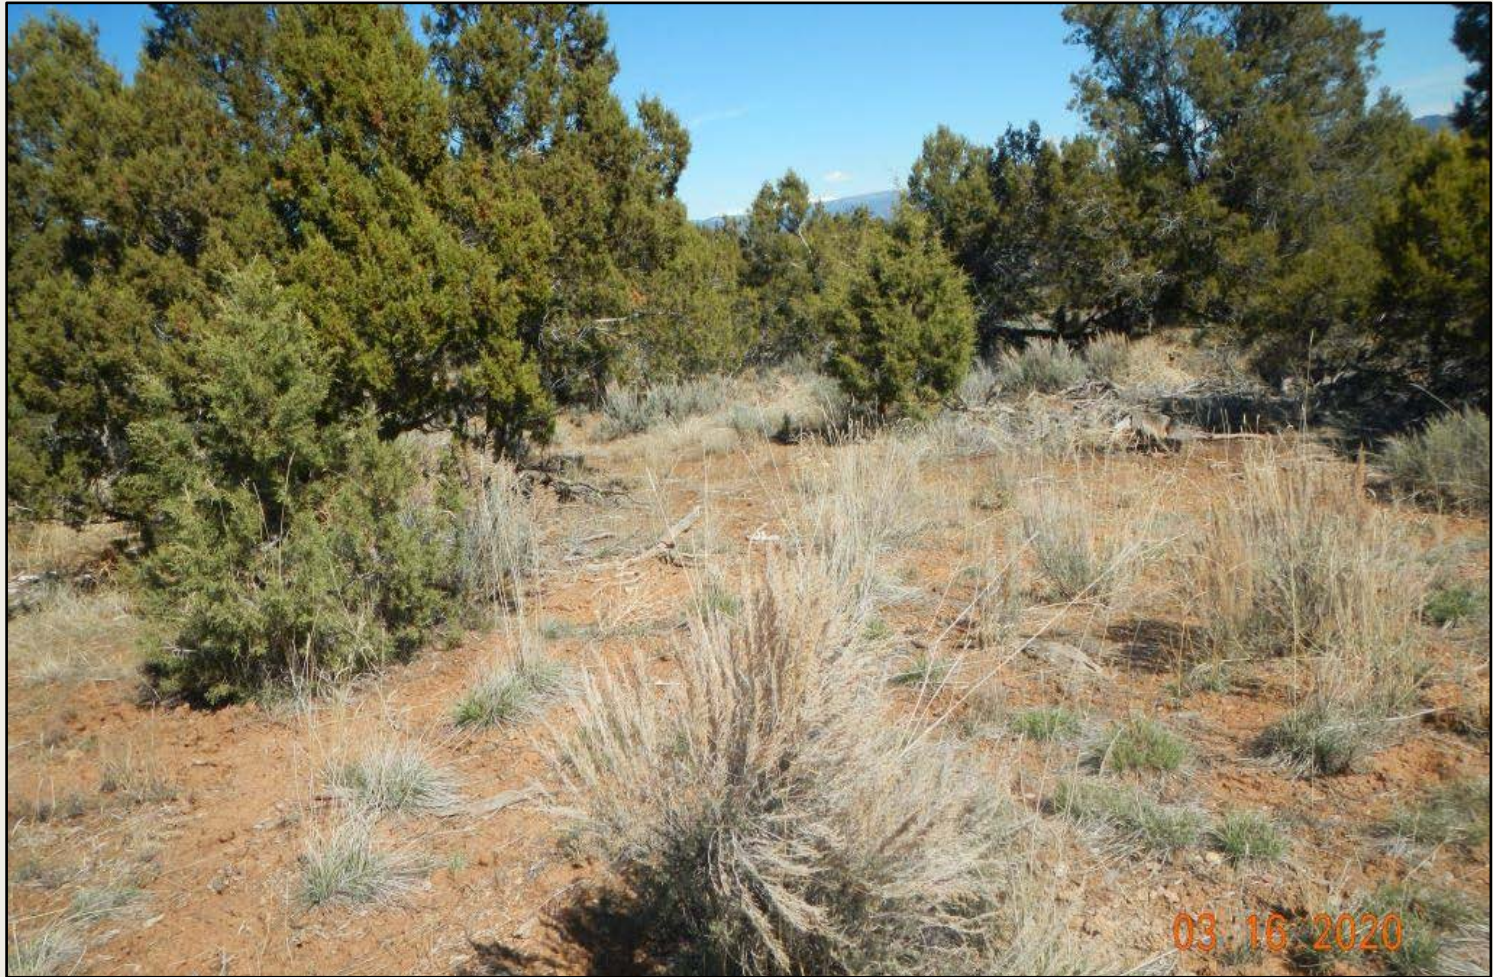
Photo 4. View of the reference area, comprised of open pinyon-juniper woodland with sagebrush and herbaceous understory.
