Inspection Photos

Location Name: VERN FEDERAL 33-8 FOLLOWUP

API#: 05-071-07493

INSP. #: 695102353

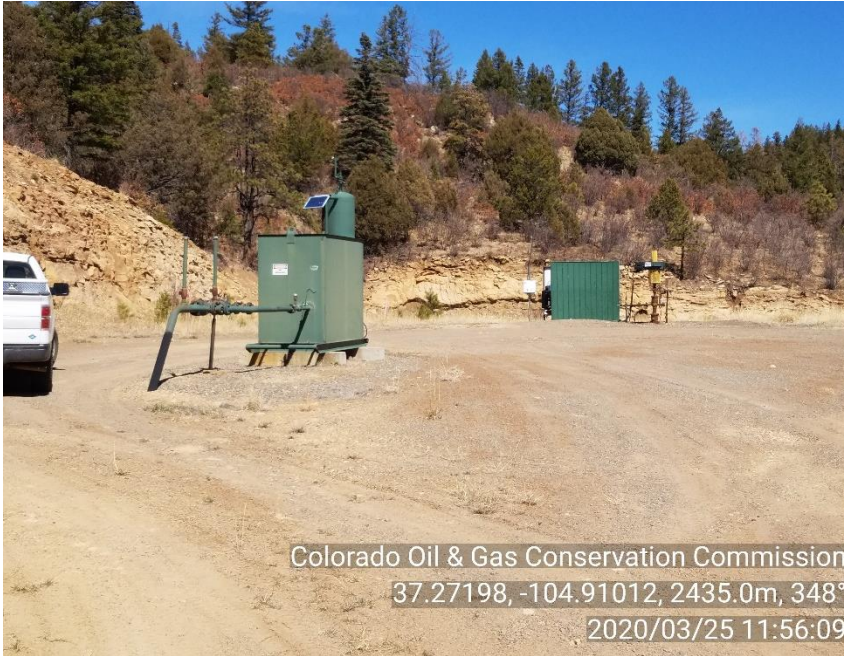
PHOTO 1: LOCATION

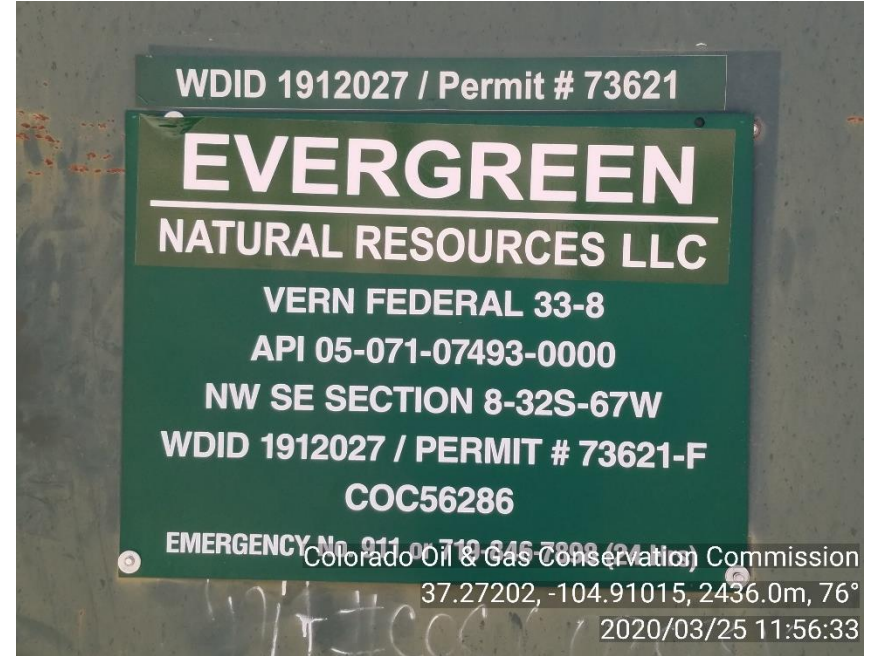
PHOTO 2: WELL SIGN/WELL NAME ON METER
HOUSE SIGN DOES NOT MATCH THE WELLNAME
REPORTED TO COGCC. **Install sign to comply with
Rule 210.b. CA DATE 4-25-19**

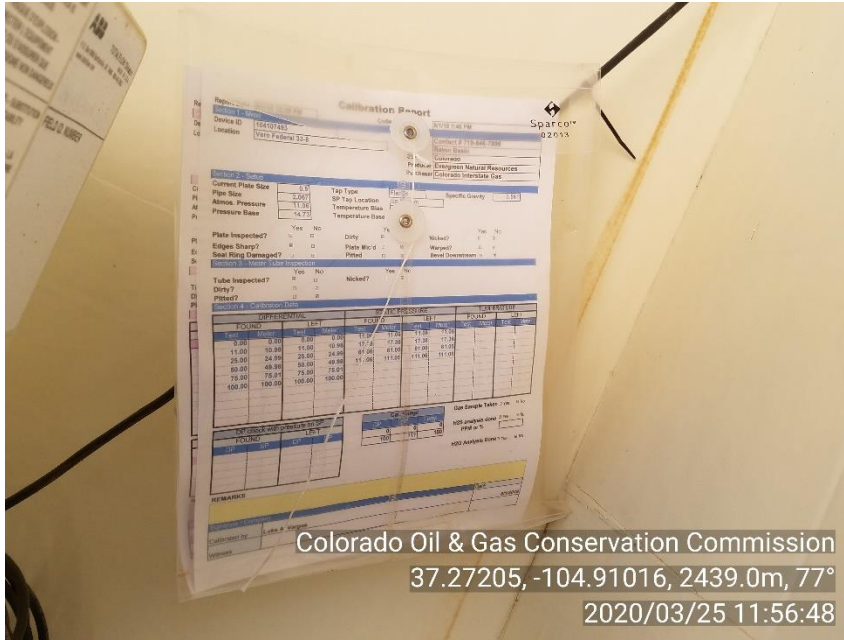
PHOTO 3: GAS METER CAL. REPORT

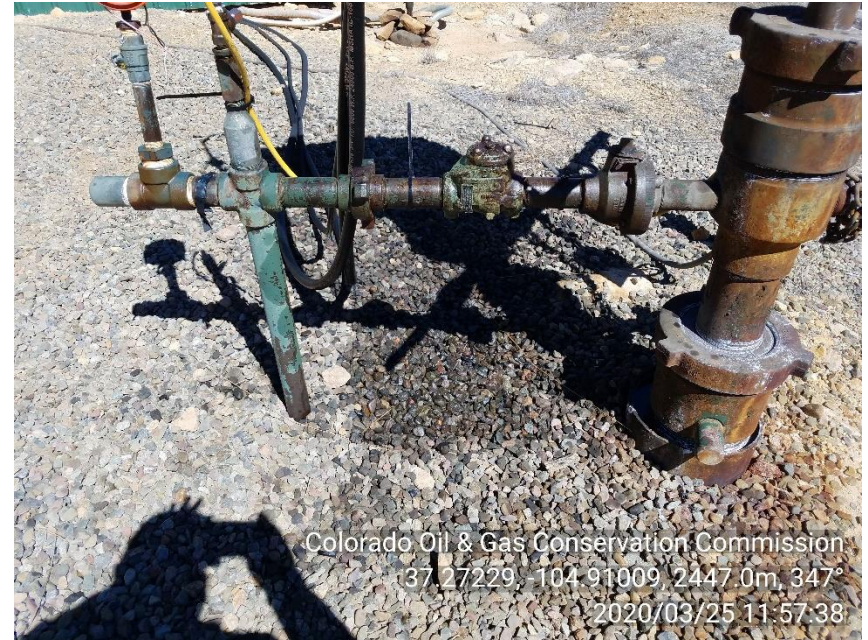
PHOTO 4: AREA OF IMPACTED SOIL NEAR WELLHEAD APPEARS TO BE COMING FROM HYDRAULIC HOSE. Non E&P Waste not properly stored, handled, transported, treated, or disposed per Rule 907A. CA DATE REMAINS THE SAME DATE ON THE ORIGINAL INSPECTION DOC#695102044.
