Inspection Photos

3/30/2020

Operator: RIO MESA RESOURCES INC - 74740

Location ID: 314813

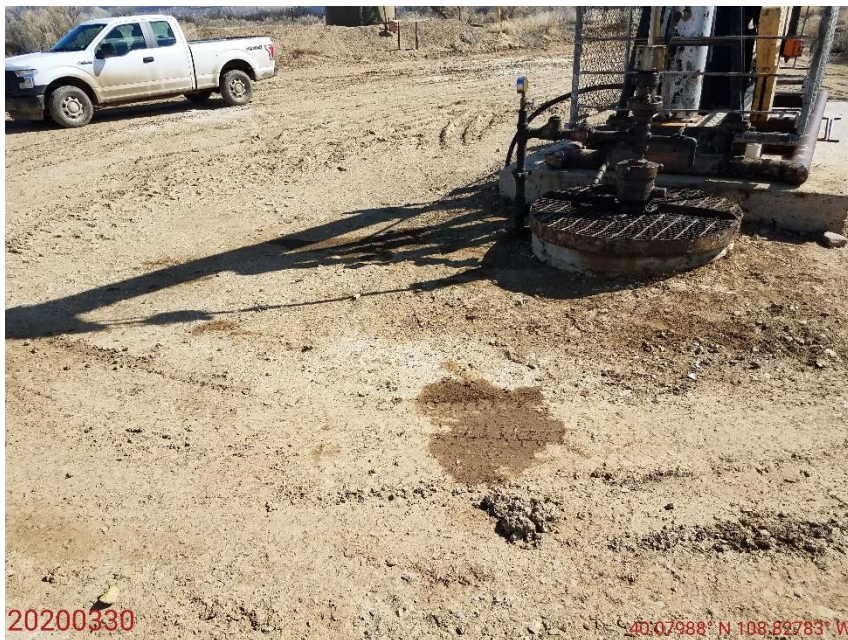
Photo 1: Photo taken from the wellhead, facing east. Inspection #696201101 required Operator to comply with Rule 907.e by 4/1/2020. Photo shows stained soils remain evident along areas adjacent to the wellhead.

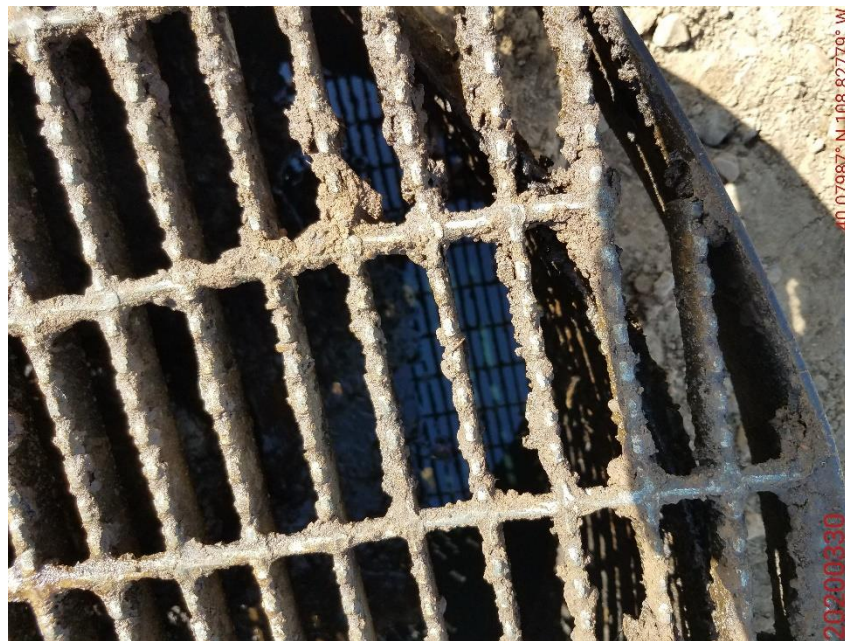
Photo 2: Photo of containment cellar at the wellhead. . Inspection #696201101 required Operator to remove fluids/chemicals within containment. Photo shows fluids/chemicals have not been removed per corrective actions.

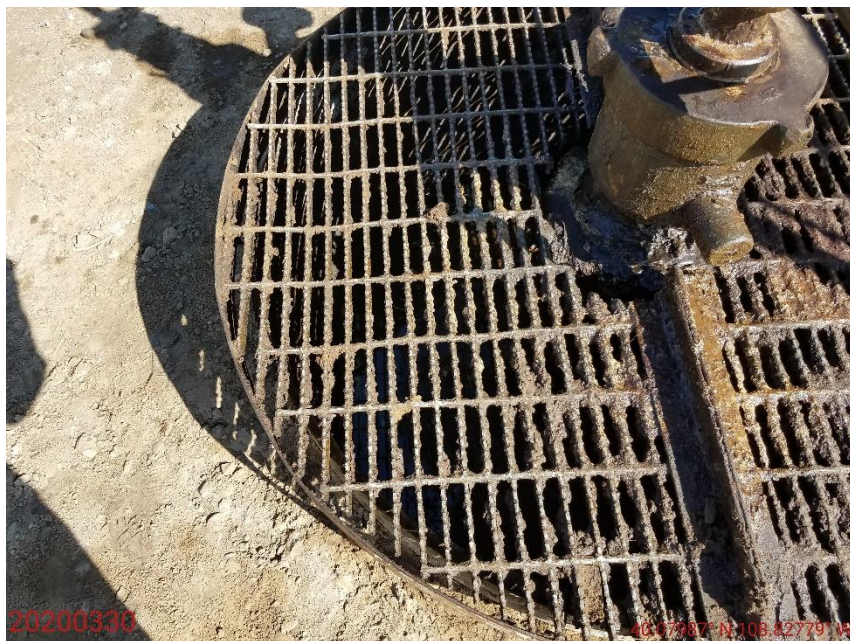
Photo 3: See comments under photo 2.

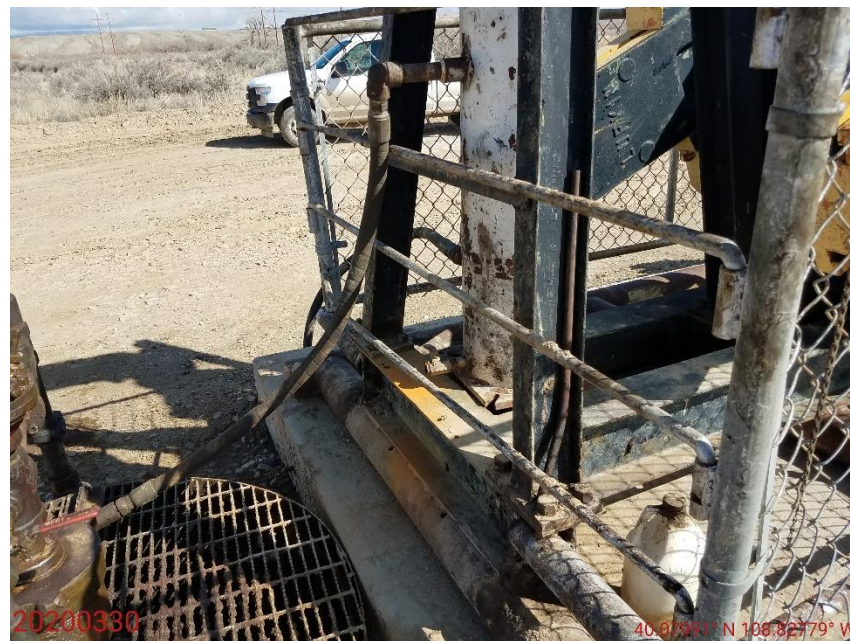
Photo 4: Photo taken from the wellhead. Inspection #696201101 documented venting from an open valve on equipment attached to the bradenhead. Valve appears to have been closed and well is no longer venting.

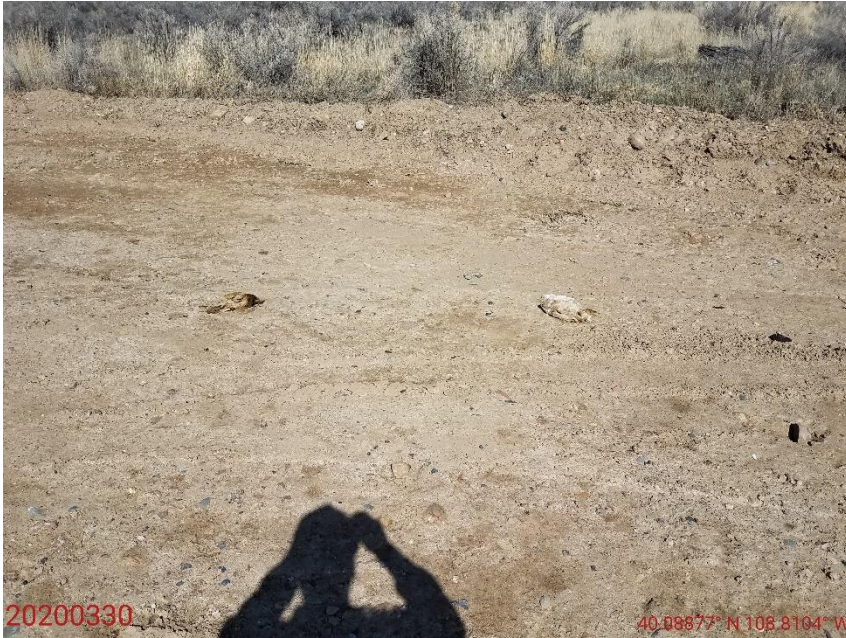
Photo 5: Photo taken from the northwest end of the Location, facing northwest. Photo shows oily rags on the Location. This is trash debris and requires removal.

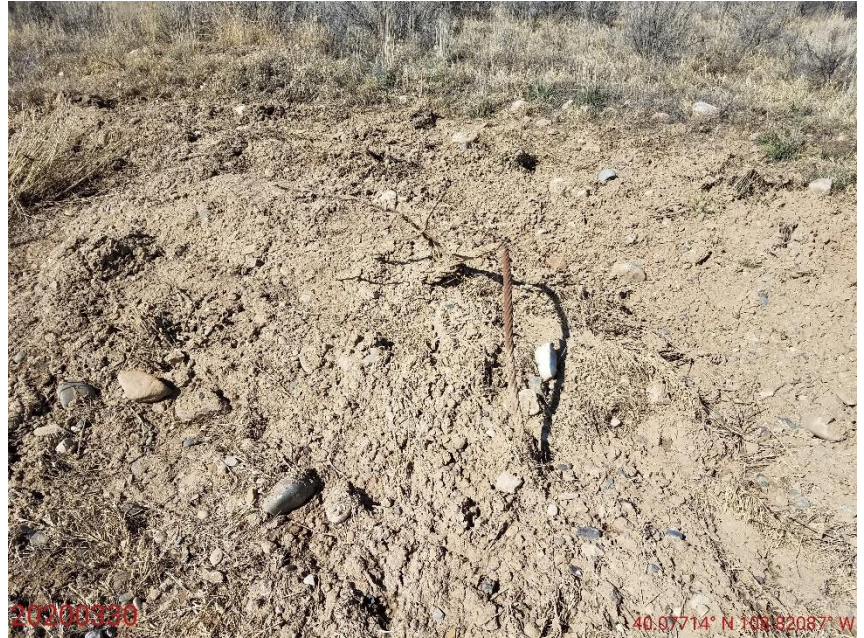
Photo 6: Photo taken from the west end of the Location, facing west. Photo shows cable on the Location. This is trash debris and requires removal.

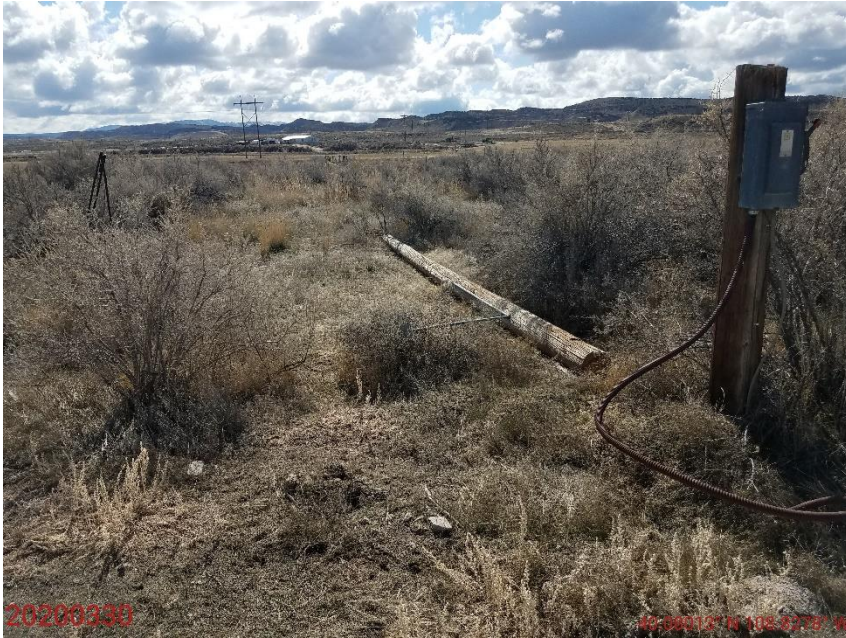
Photo 7: Photo taken from the southeast end of the Location, facing south. Photo shows the utility pole appears to have been cut above the electric box. Cut portion of the utility pole, as well as cable wires and the utility anchor was not removed, is considered unused equipment and trash debris, and requires removal.

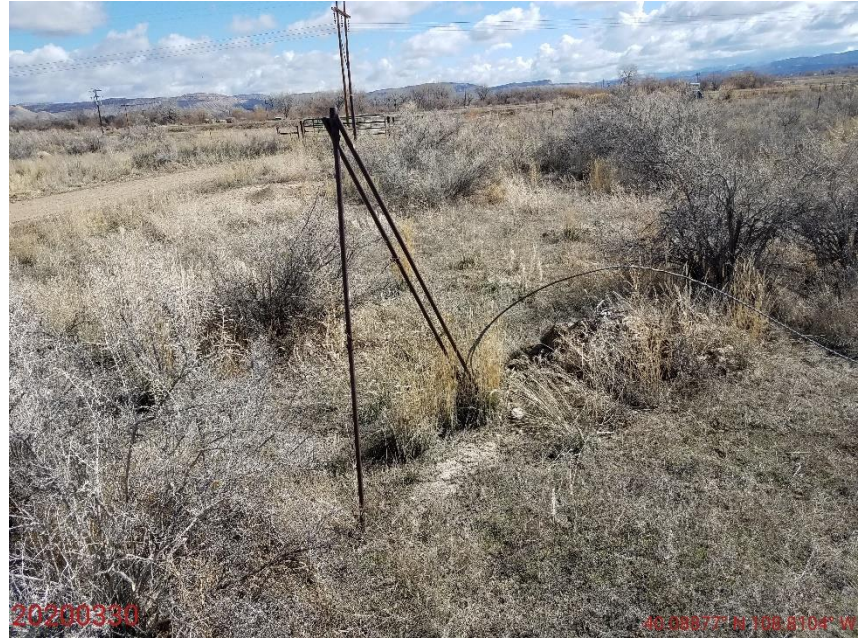
Photo 8: Continued from photo 7. Photo shows utility anchor and cable.

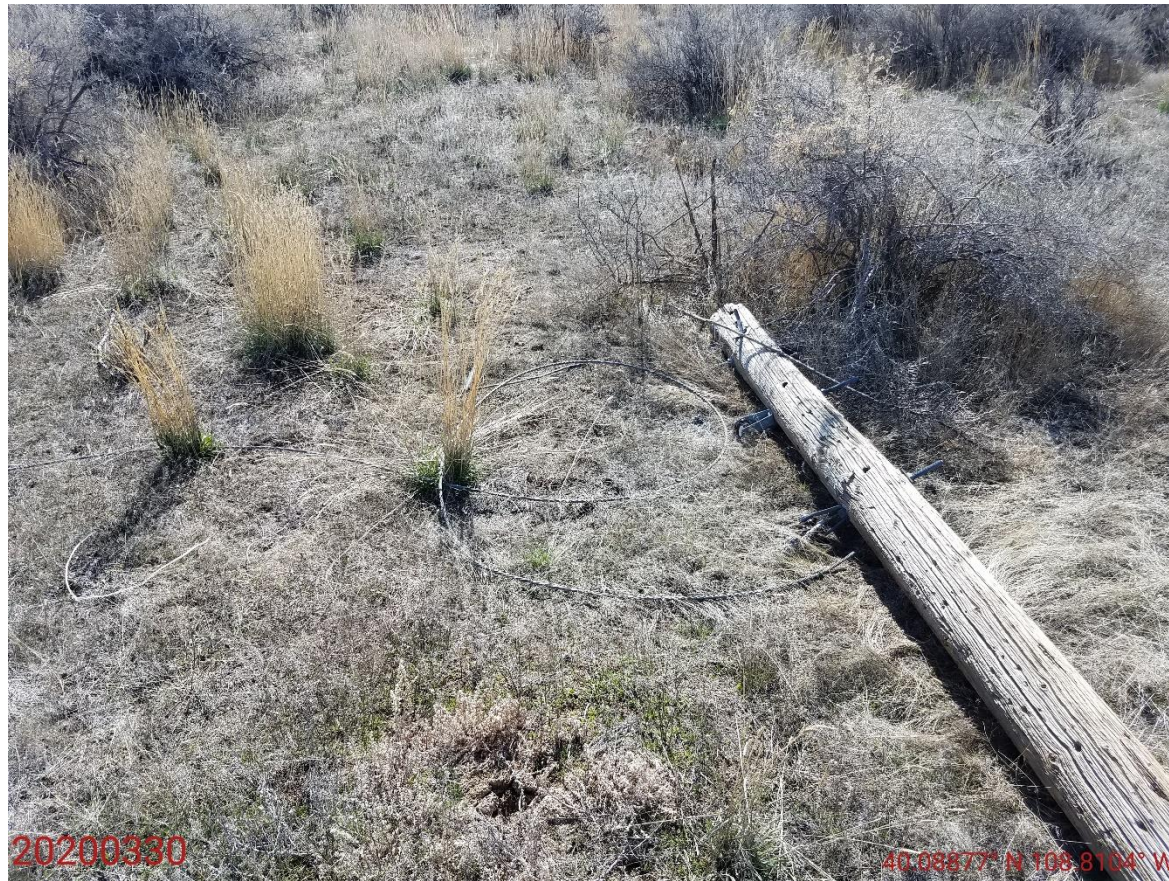
Photo 9: Continued from photo 7. Photo shows cut utility pole and cable wire.
