# Inspection Photos

Location Name: AP 12-02V CA DATE 4-30-20

API#: 05-071-07407

INSP. #: 695102485

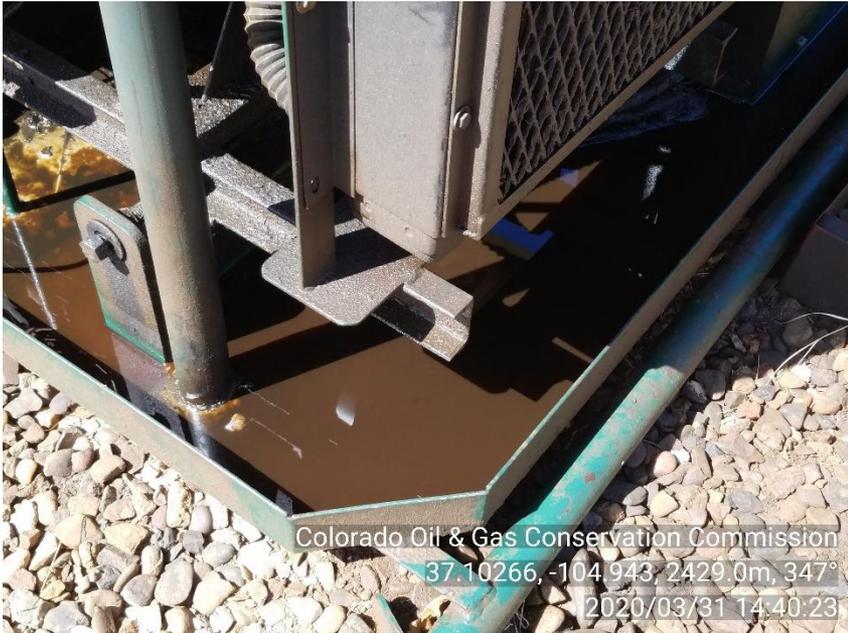
**PHOTO 3: STANDING OIL IN COMPRESSOR SKID. COMPLY WITH GENERAL PERSIVIONS OF OIL AND GAS ACT PERTAINING TO WILDLIFE PROTECTION. CA DATE 4-30-20**

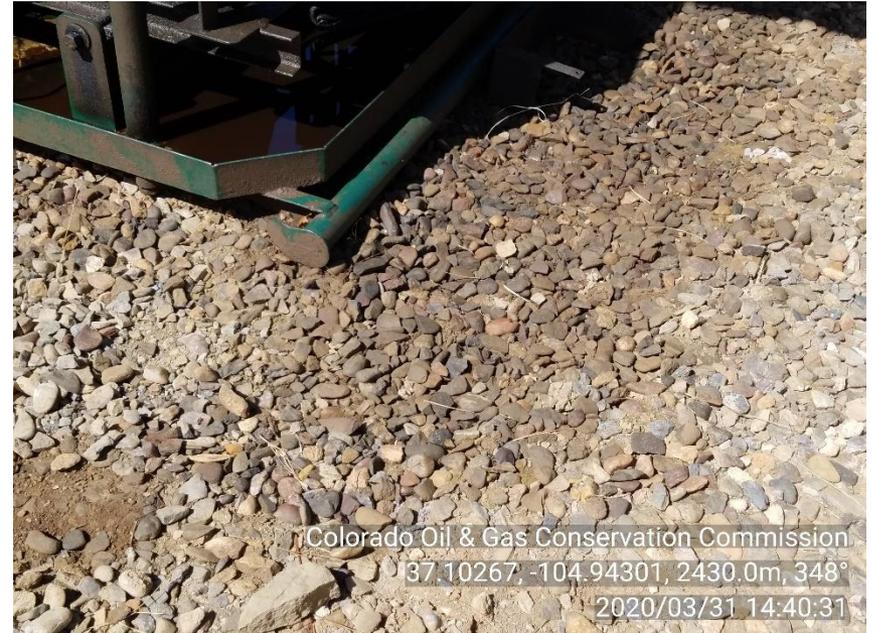
**PHOTO 4: AREA OF IMPACTED SOIL APPEARS TO BE OIL CONTAMINATION FROM COMPRESSOR. Conduct maintenance on equipment, cleanup stained material and review self inspection processes. CA DATE 4-30-20.**

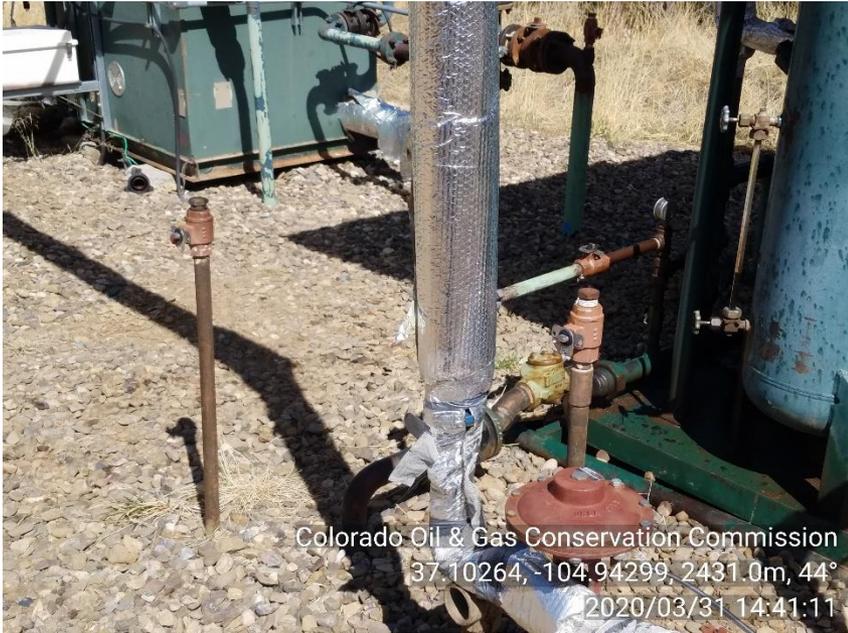
**PHOTO 5: TWO UNMARKED UNUSED RISERS. COMPLY WITH  
NTO AND RULE 603.f. CA DATE 4-30-20.**
