# Inspection Photos

Location Name: AP 07-08 CA DATE 4-30-20

API#: 05-071-08300

INSP. #: 695102491

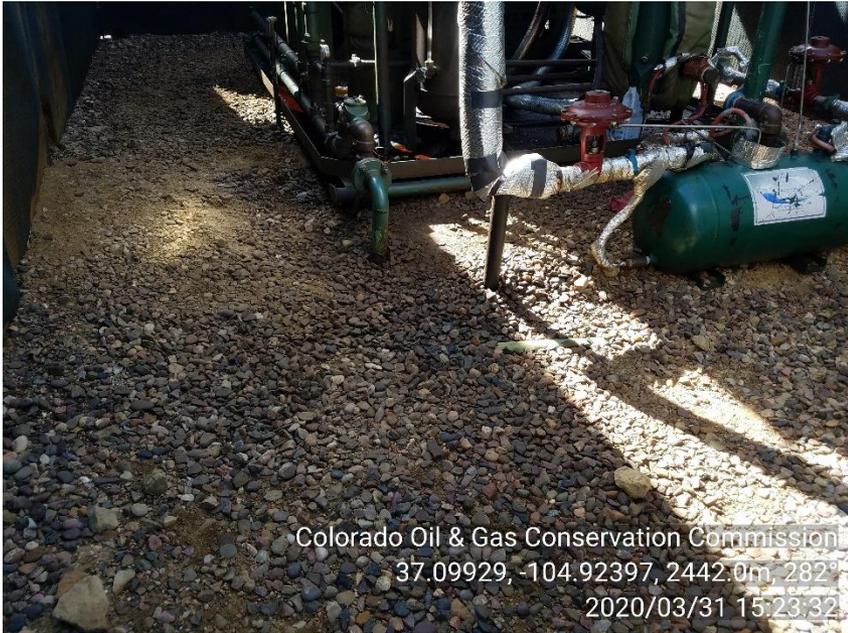
**PHOTO 3: AREA OF IMPACTED SOIL ALL AROUND COMPRESSOR INSIDE SOUND WALLS. Conduct maintenance on equipment, cleanup stained material and review self inspection processes. CA DATE 4-30-20.**

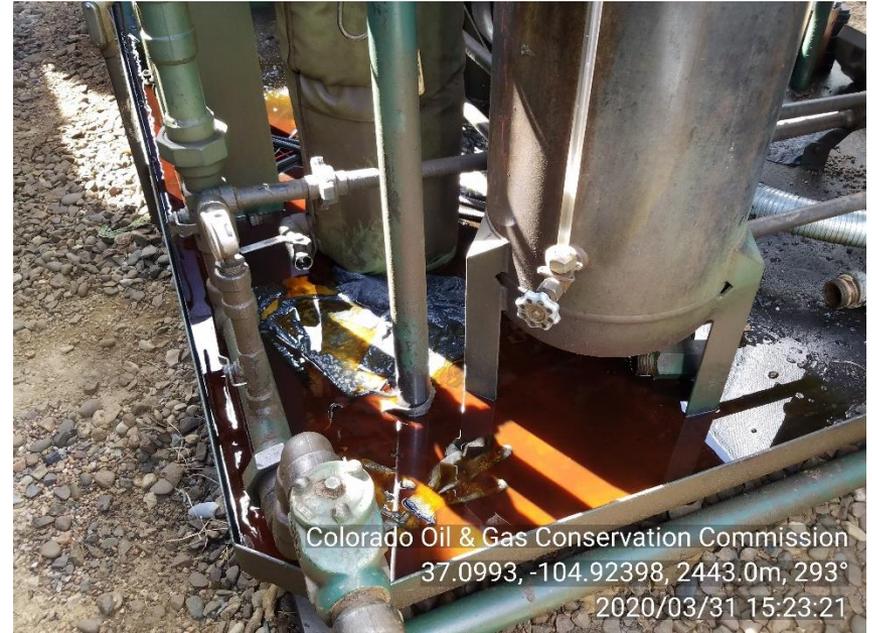
**PHOTO 4: STANDING OIL INSIDE OF COMPRESSOR SKID. COMPLY WITH GENERAL PERVERSIONS OF OIL AND GAS ACT & SB-181 PERTAINING TO WILDLIFE PROTECTION. CA DATE 4-30-20**
