Well Name : Mount Hope Unit W 36

API # : 075-06281

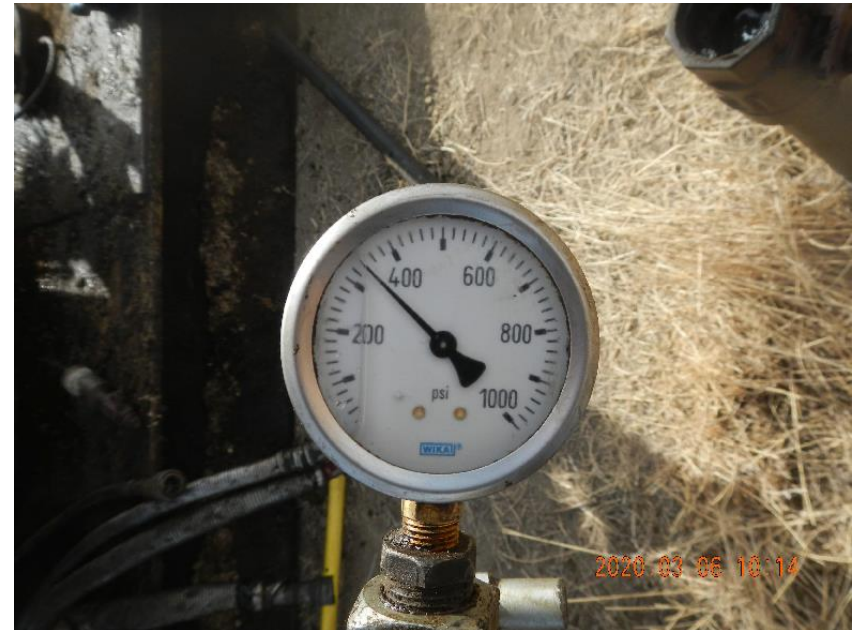
Photo 2: Passed pressure test reading.

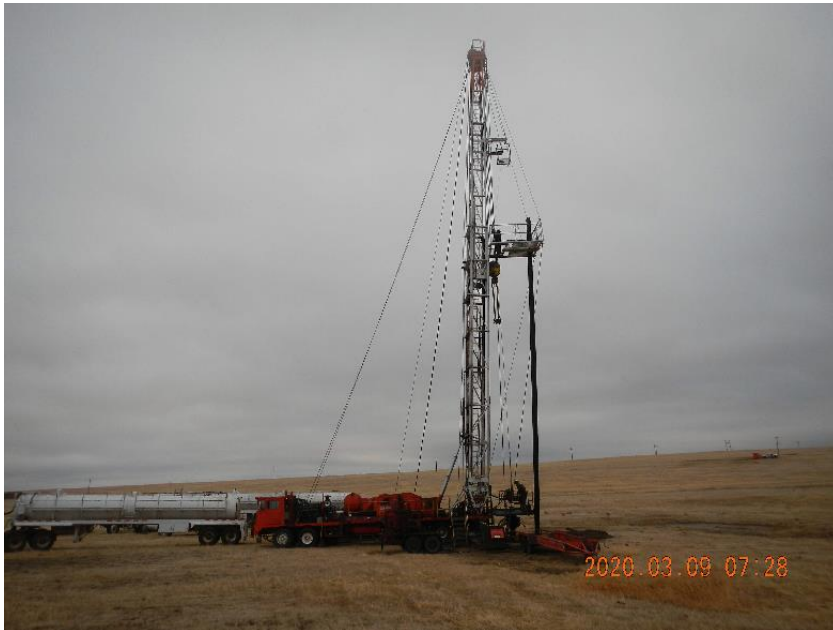
Photo 3: Tubing tripped out of well and standing in the derrick.

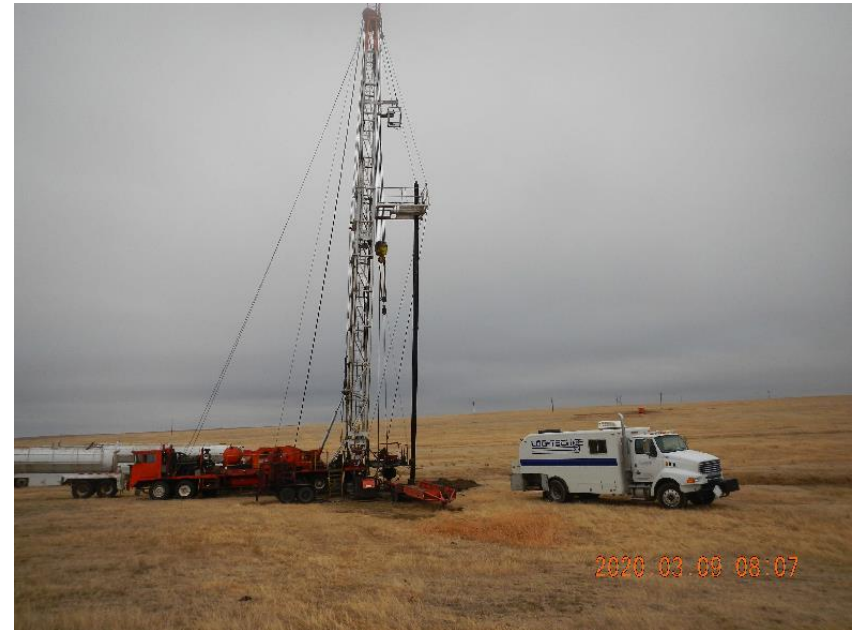
Photo 4: Wireline on location to run CBL, Perforate casing for cement plugs, and set CICR.

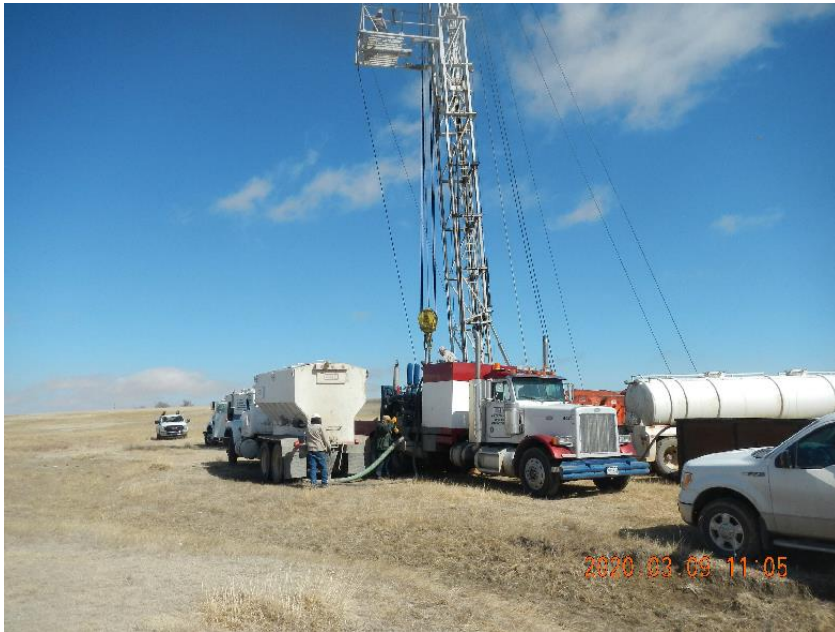
Photo 5: Cement pump truck rigged into well to pump cement plug.

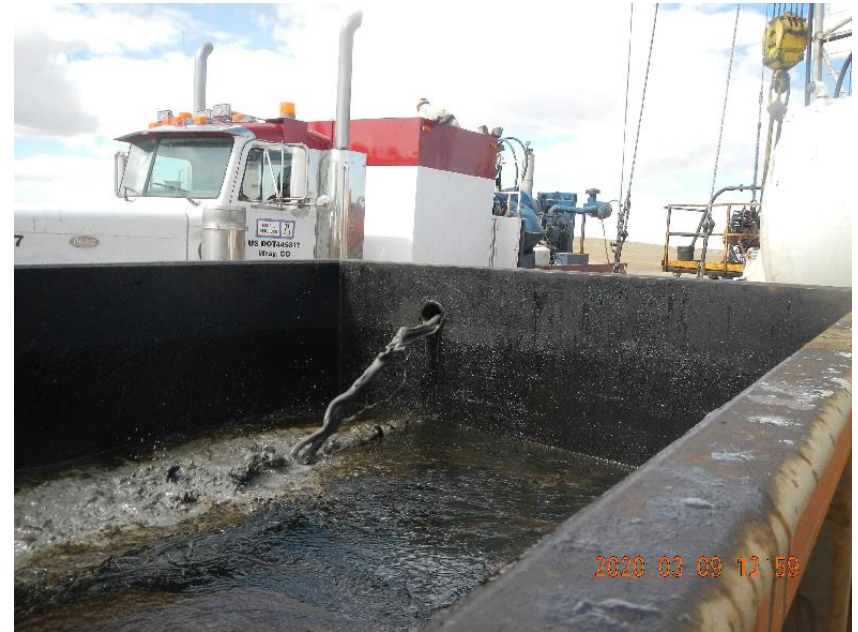
Photo 6: Returns from well to tank.

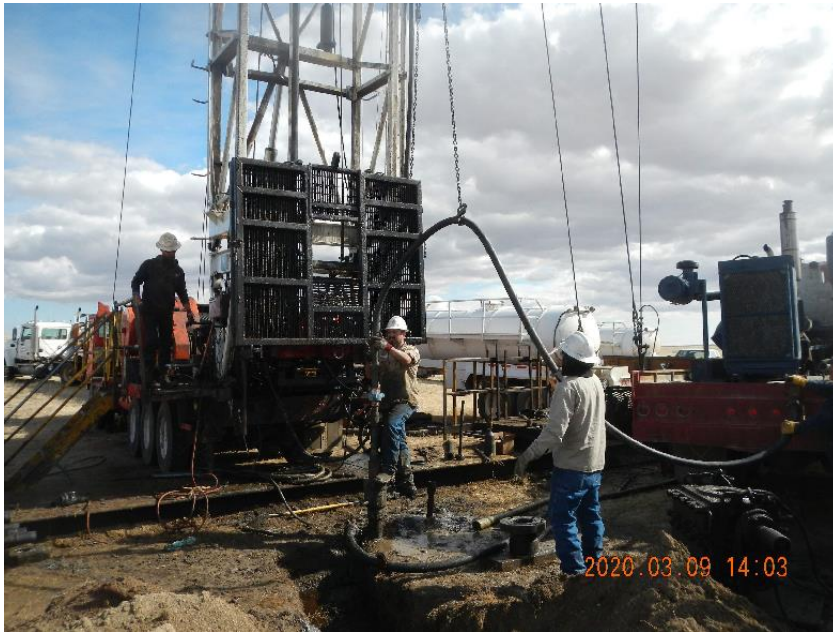
Photo 7: Rigging up to pump surface plug.

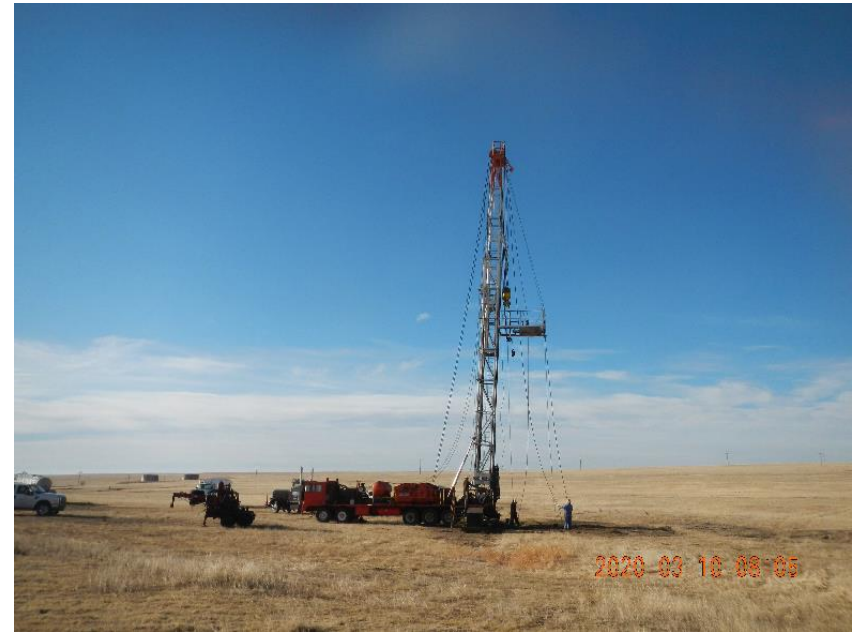
Photo 8: Rigging down to move.

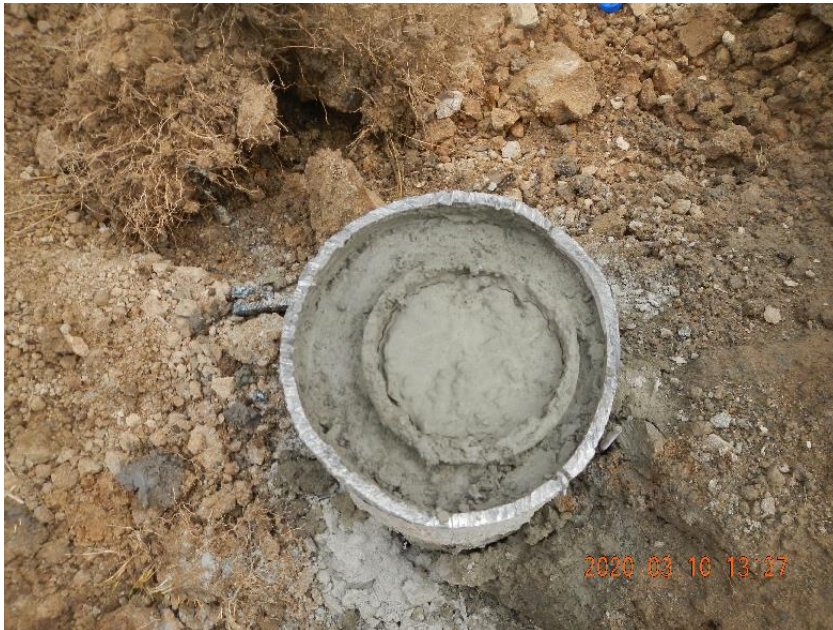
Photo 9: Surface casing topped off with cement.

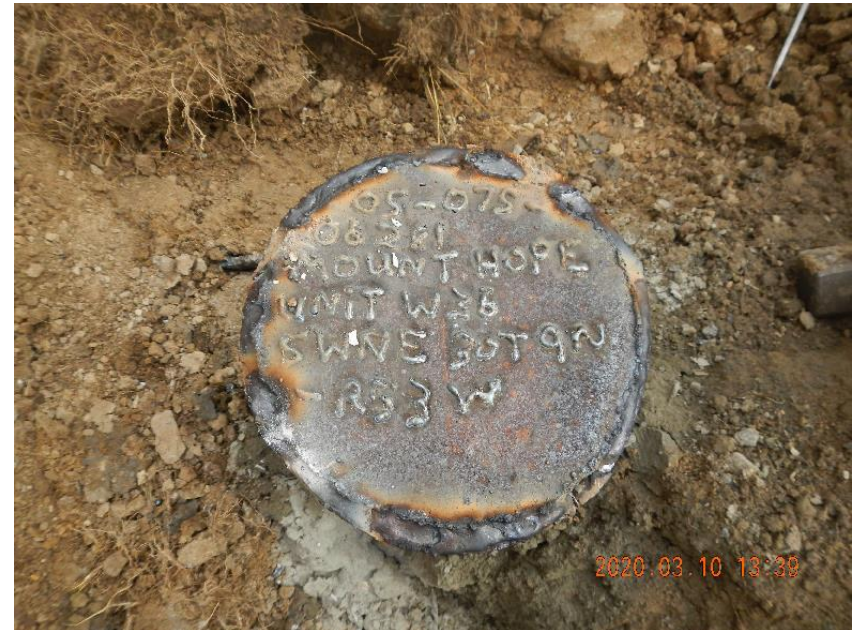
Photo 10: Marker plate welded onto surface casing.

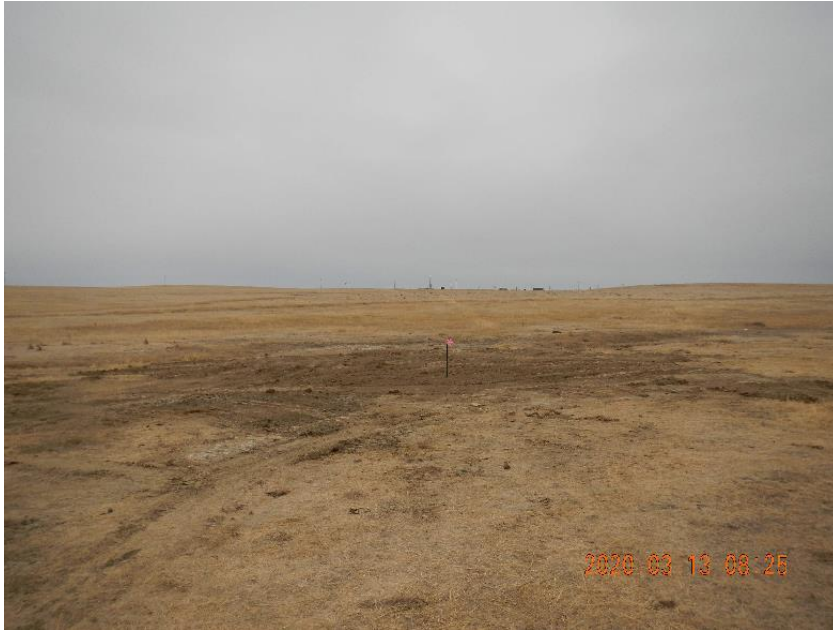
Photo 11: View of location and marker post.

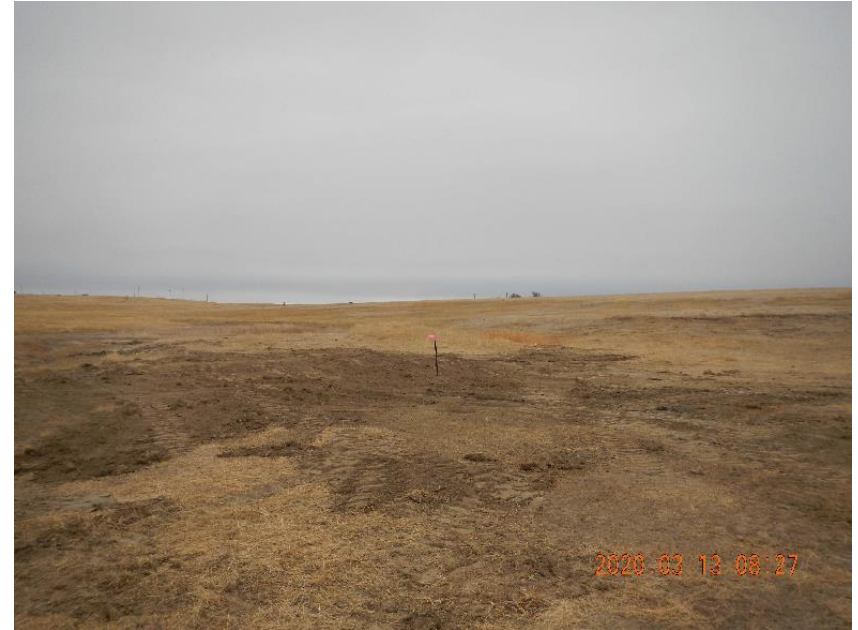
Photo 12: View of location and marker post.

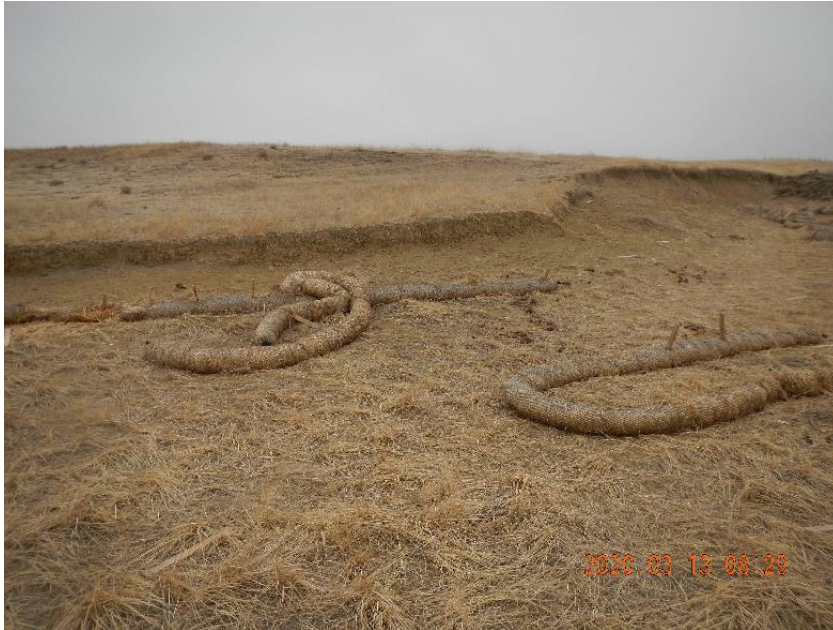
Photo 13: Erosion at entrance area to location Waddles pulled up by livestock.

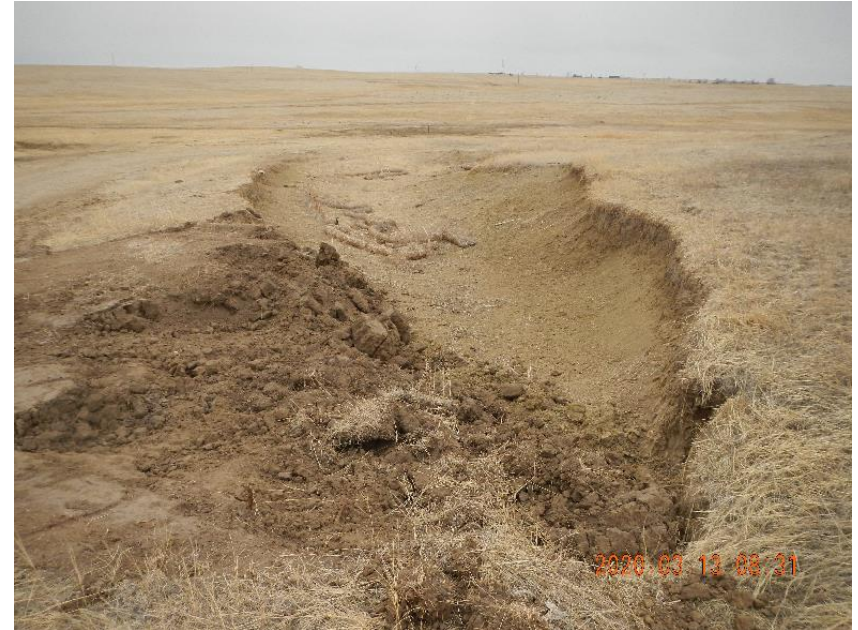
Photo 14: Washed out area at top of channel erosion. Placed additional fill as temp repair.

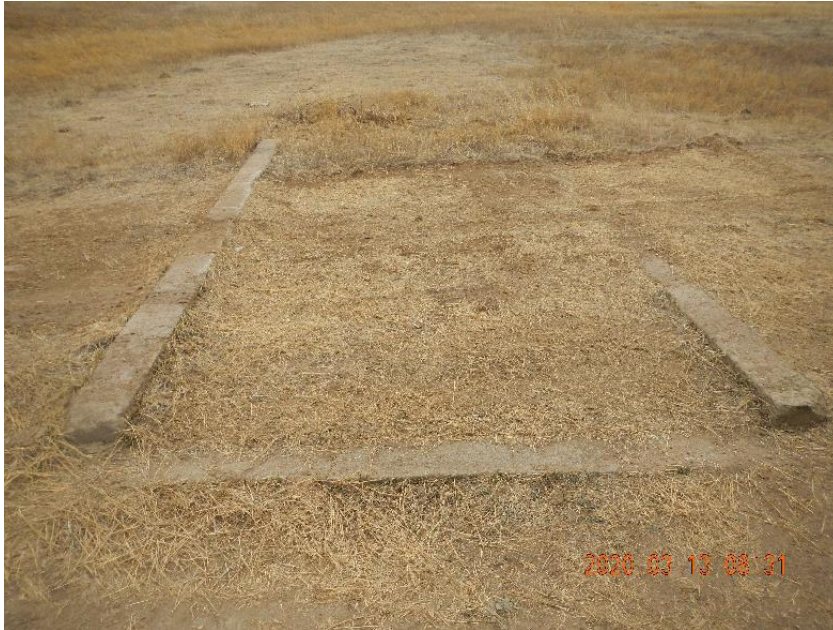
Photo 15: Possible cattle guard along access road.

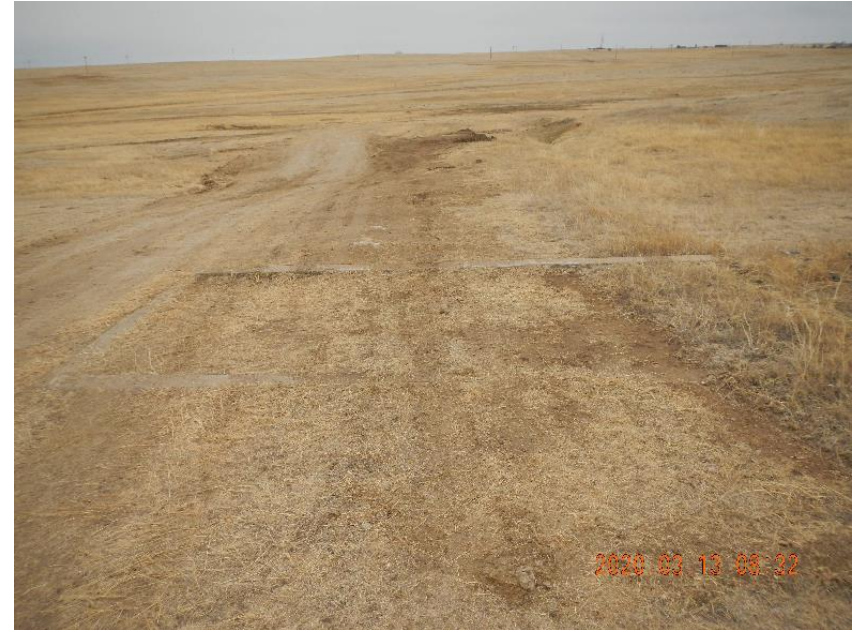
Photo 16: Access road with cement base along right side of road.
