# Inspection Photos

4/09/2020

Operator: LARAMIE ENERGY LLC - 10433

Location ID: 335091

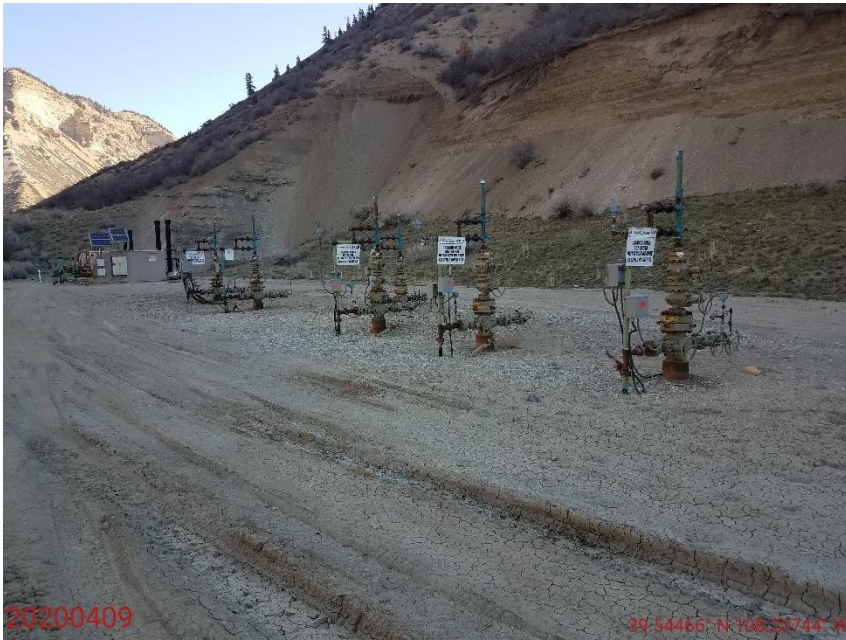
**Photo 1:** Photo taken from the active wells on the Location, facing north.

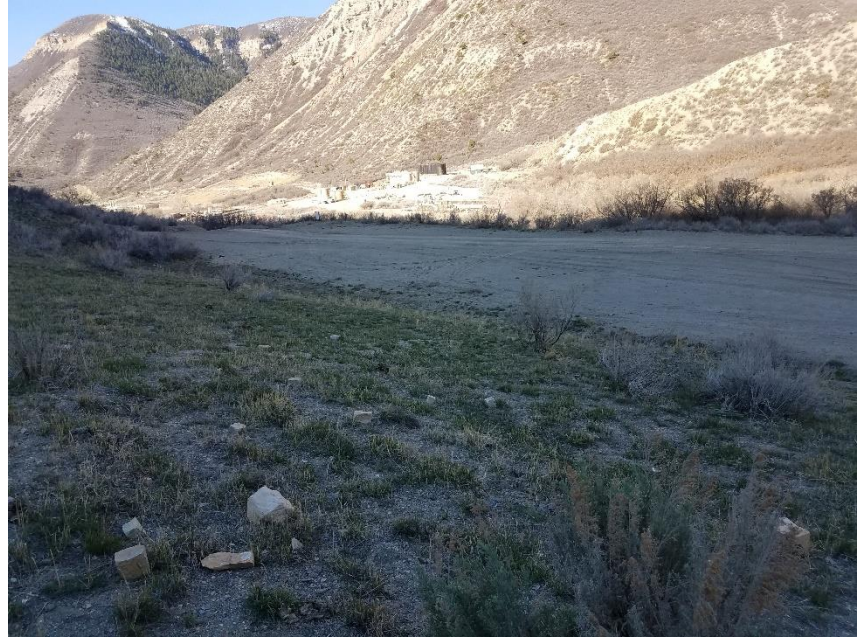
**Photo 2:** Photo taken from the interim areas on the east end of the Location, facing southwest. Photos 2-5 provide an overview of the Location from southwest, west, northwest to north.

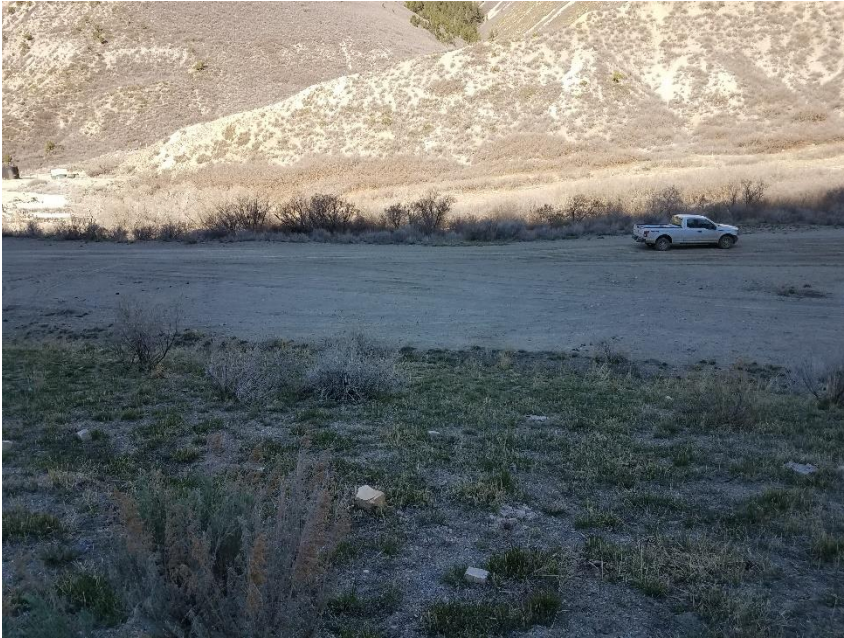
**Photo 3:** See comments under photo 2.

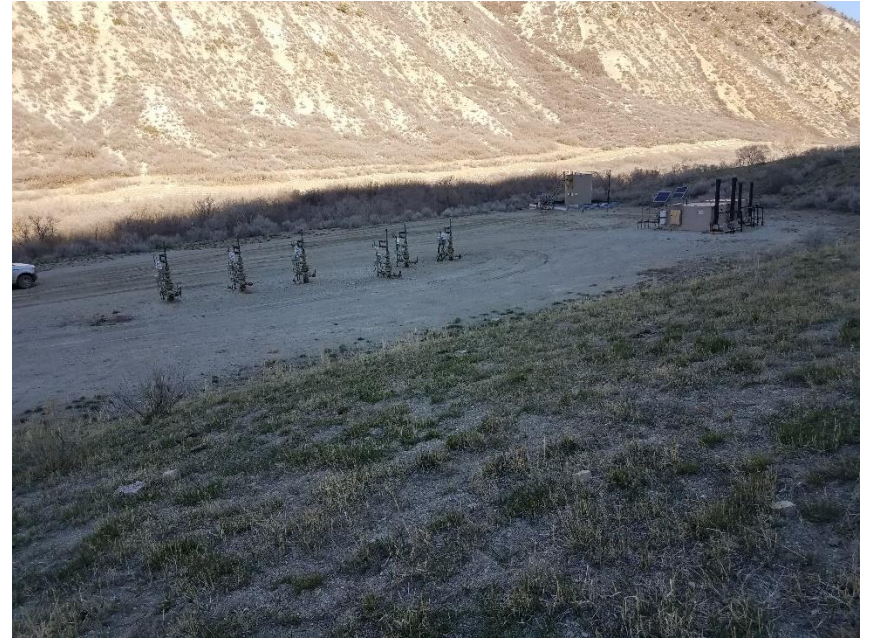
**Photo 4:** See comments under photo 2.

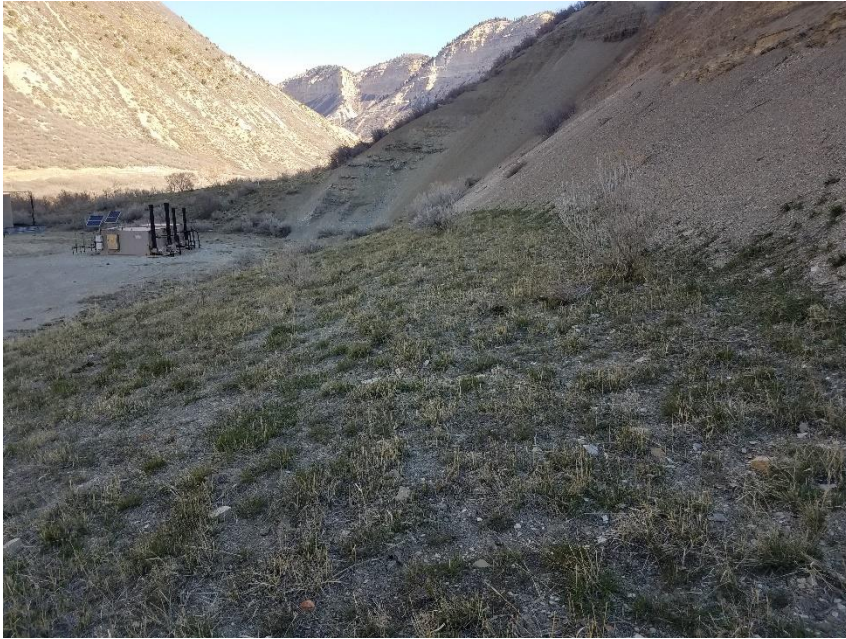
**Photo 5:** See comments under photo 2.

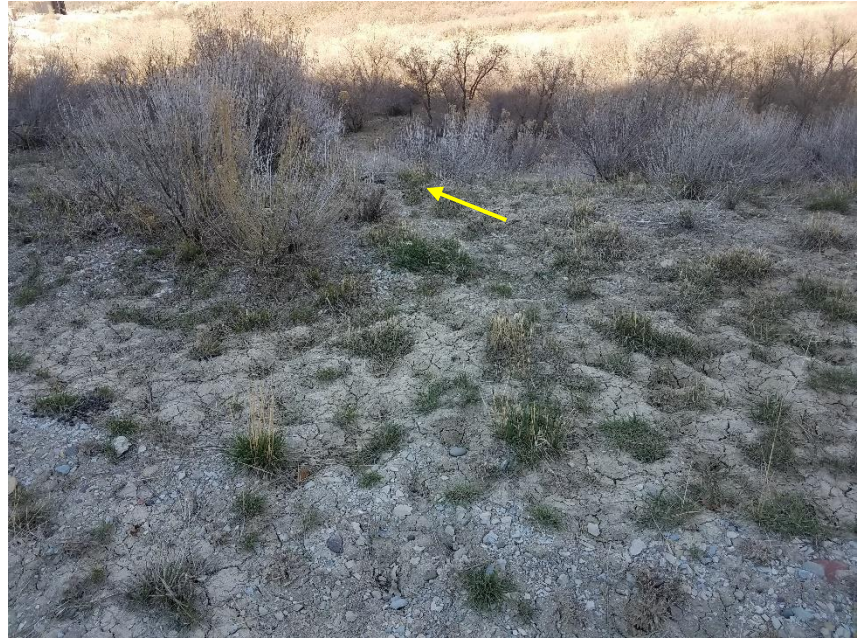
**Photo 6:** Photo taken from the west end of the Location. Photo shows area where stormwater ponding is evident, and where stormwater runoff from the Location is beginning to form a gully (arrow).

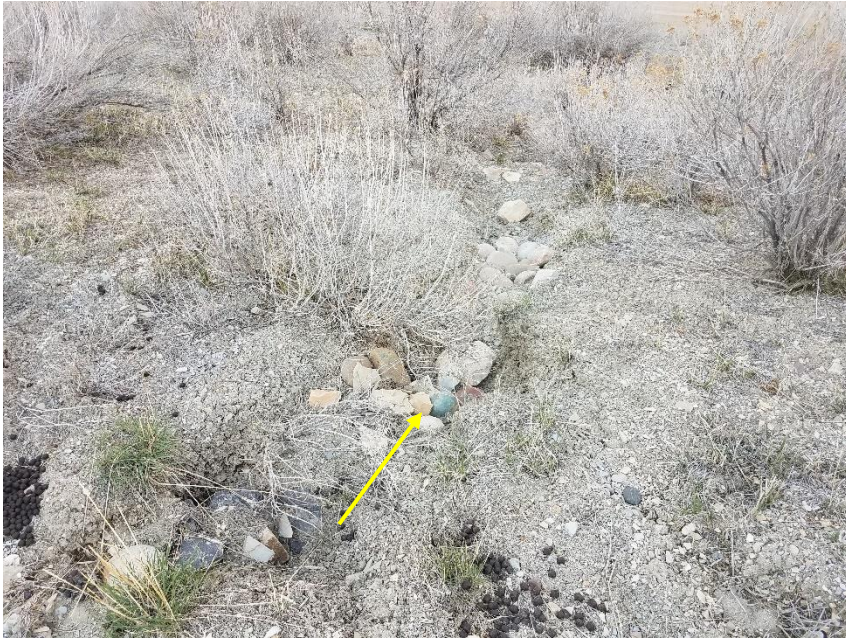
**Photo 7:** Photo taken from the west end of the location, facing west. Photo shows erosion degradation due to stormwater runoff from the Location.

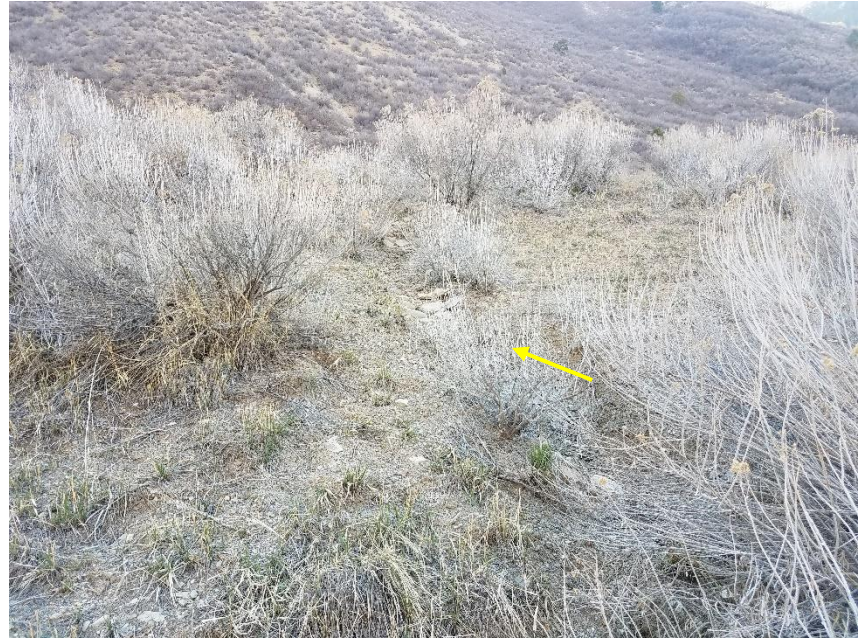
**Photo 8:** Photo taken from the west end of the location, facing east. Photo shows erosion degradation due to stormwater runoff from the Location.
