Final Reclamation and Stormwater Inspection

Operator: GREAT WESTERN OPERATING COMPANY LLC- #10110

Location ID: 320281

Inspection Photos
Location Name: SELTZER #1-4
Location ID: 320281

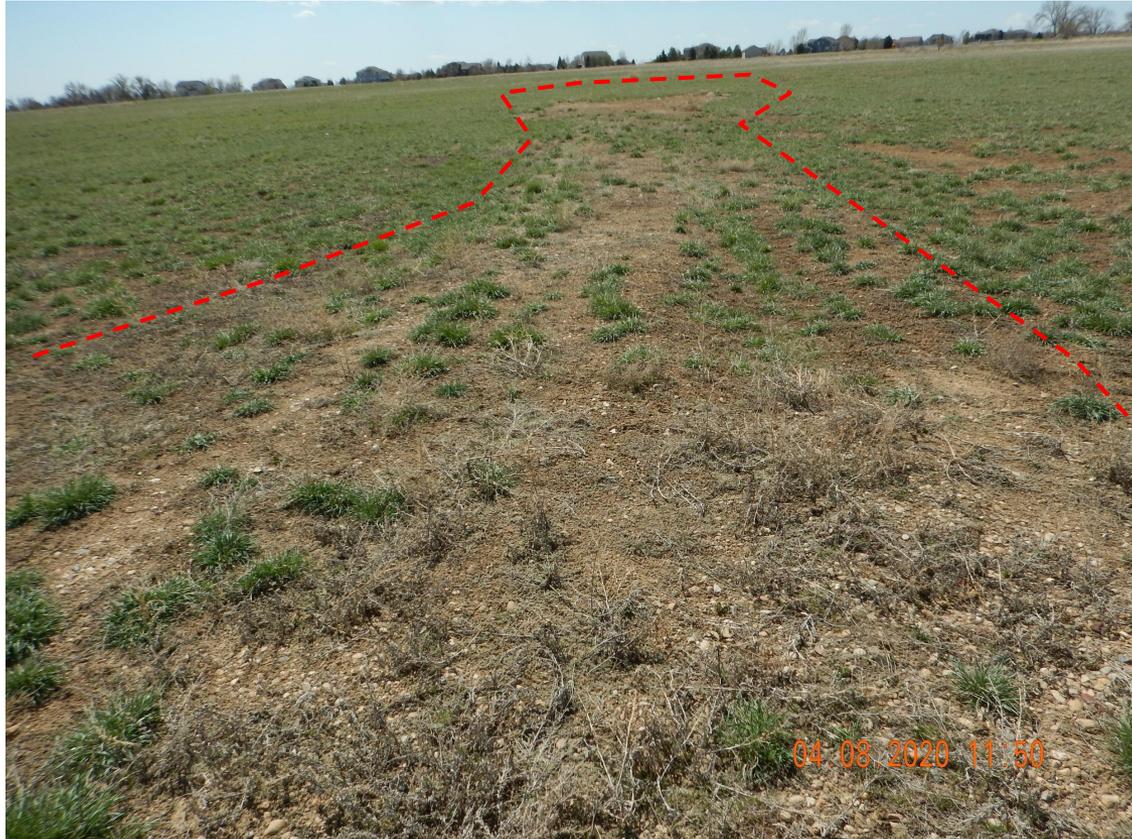
Photo 1. Photo taken from the well location entrance, facing South. Photo illustrates Operator has failed to remove all gravel and perform reclamation per Rule 1004 standards.

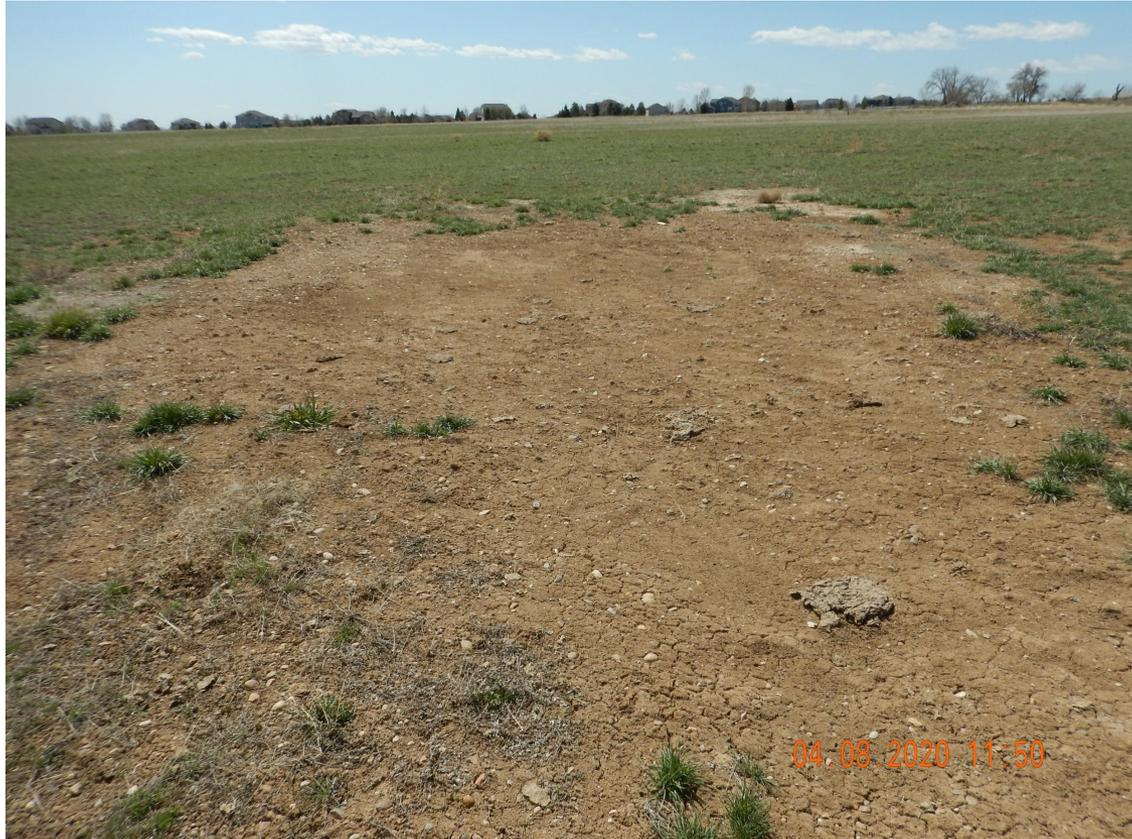
Photo 2. Photo taken from the well location, facing South. Photo illustrates the well location is not reflective of reference area vegetation.
