# Final Reclamation and Stormwater Inspection

Operator: GREAT WESTERN OPERATING COMPANY LLC- #10110

Location ID: 320412

Inspection Photos  
Location Name: SELTZER PP #4-7  
Location ID: 320412

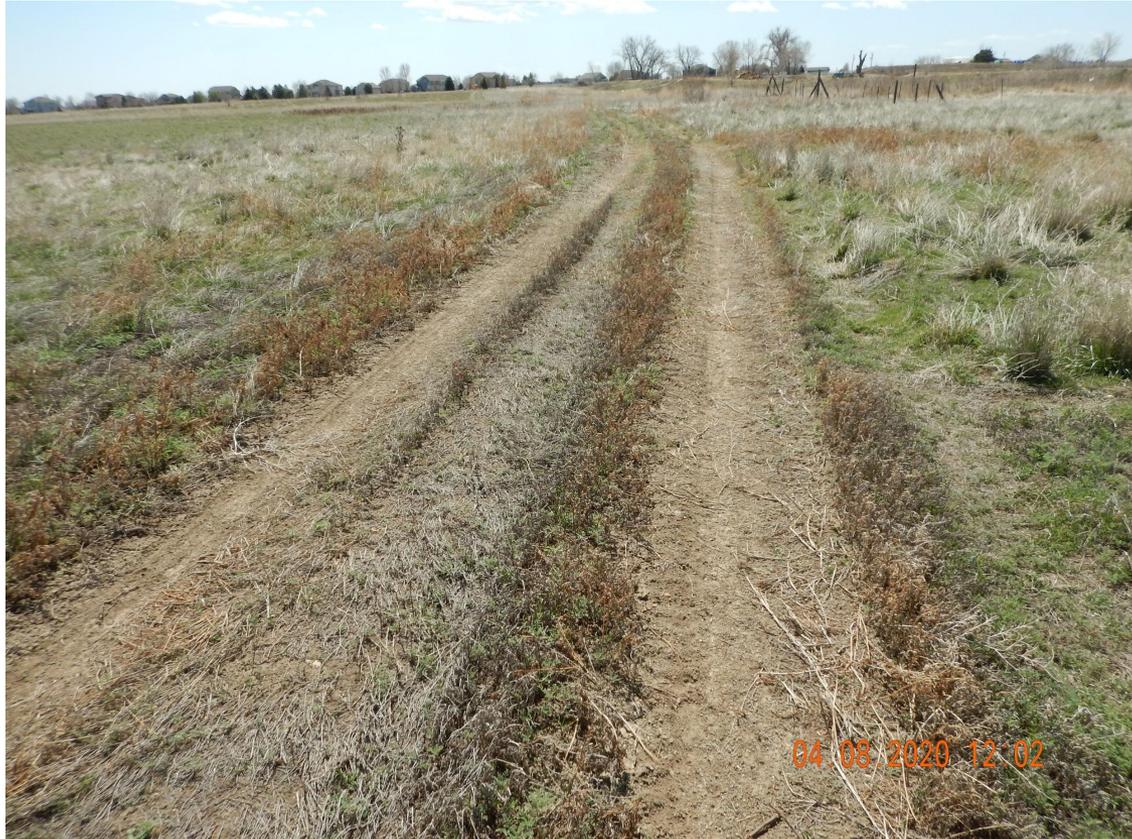
**Photo 1.** Photo taken from the well location access road, facing South. Photo illustrates Operator has failed to properly perform reclamation per Rule 1004 standards.

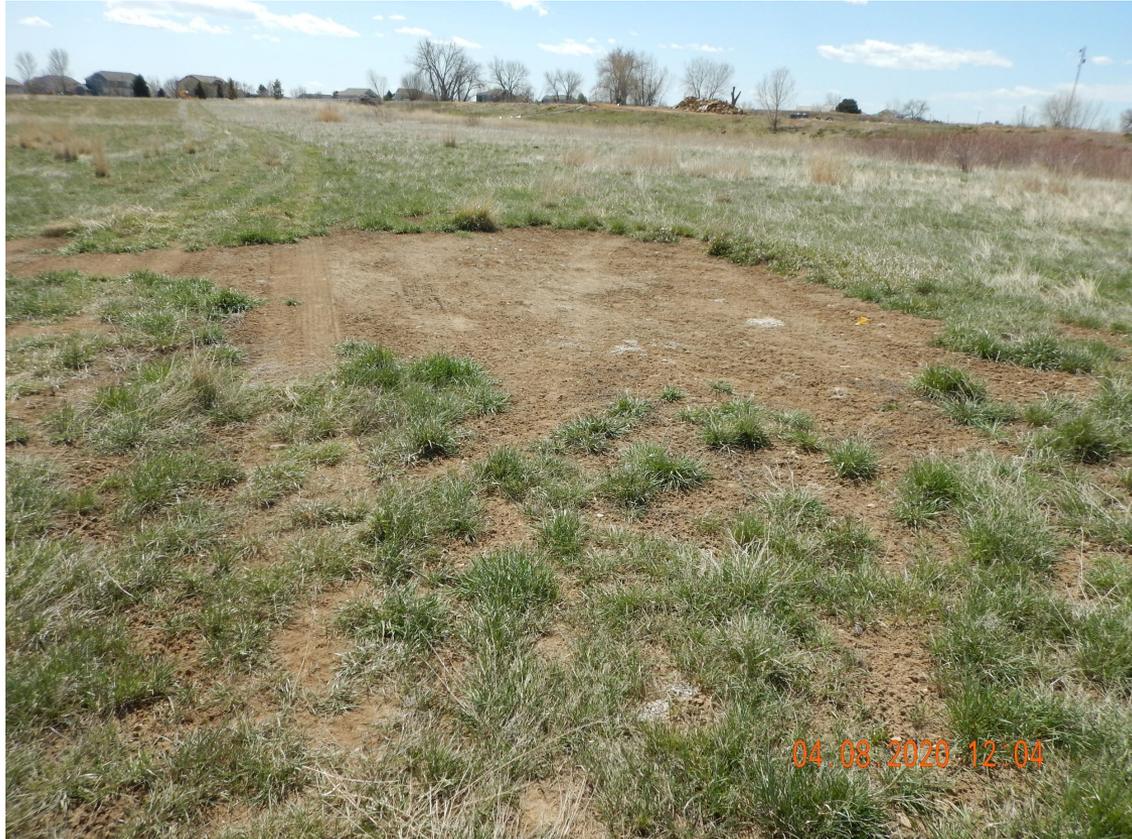
**Photo 2.** Photo taken from the well location, facing South. See comments under Photo 1.

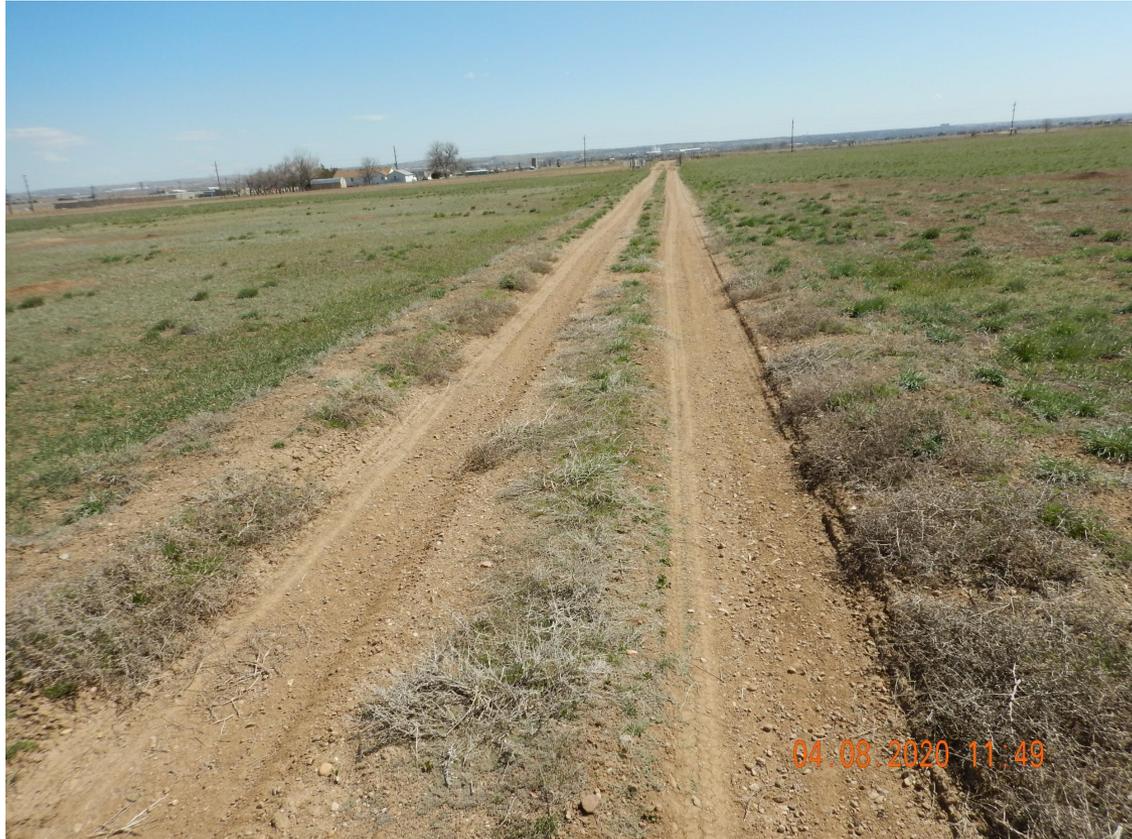
**Photo 3.** Photo taken from a portion of the main access road, facing East. Photo illustrates Operator has failed to reclaim the main access road.

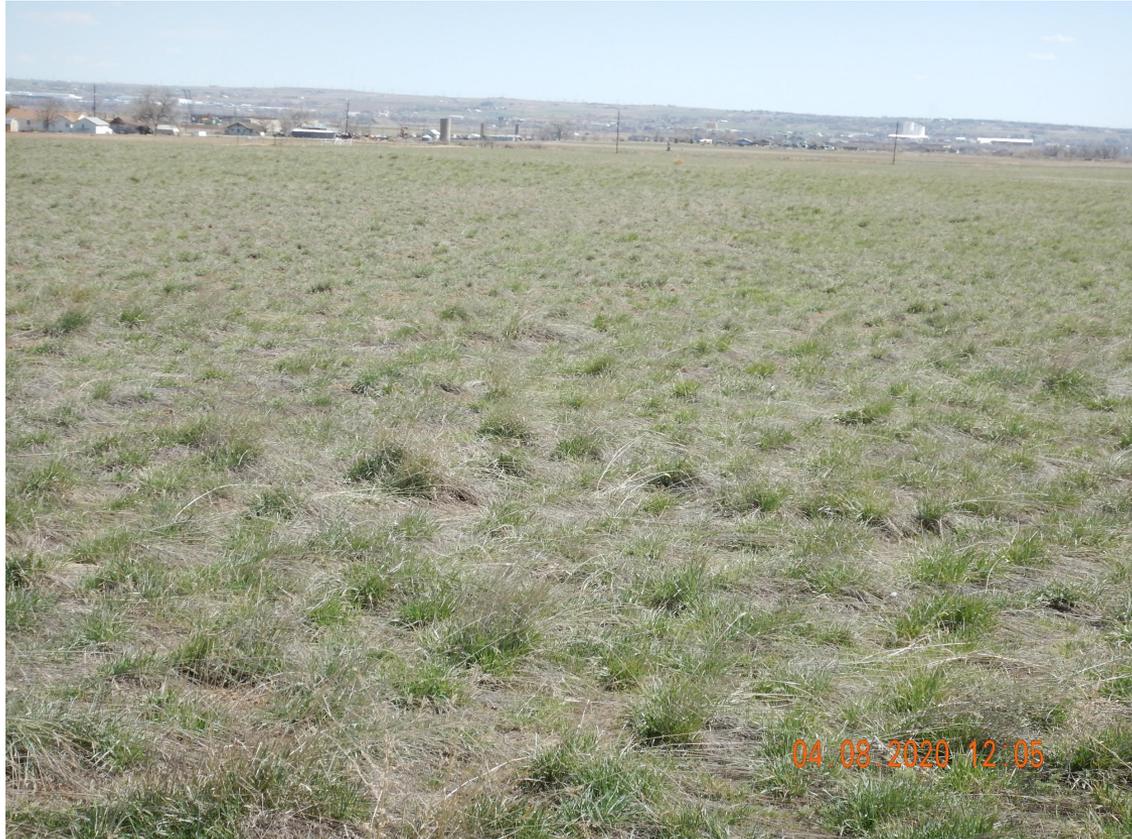
**Photo 4.** Reference photo taken western of the well location, facing East. Photo illustrates vegetation consisting mostly of Crested wheatgrass with some smooth brome.

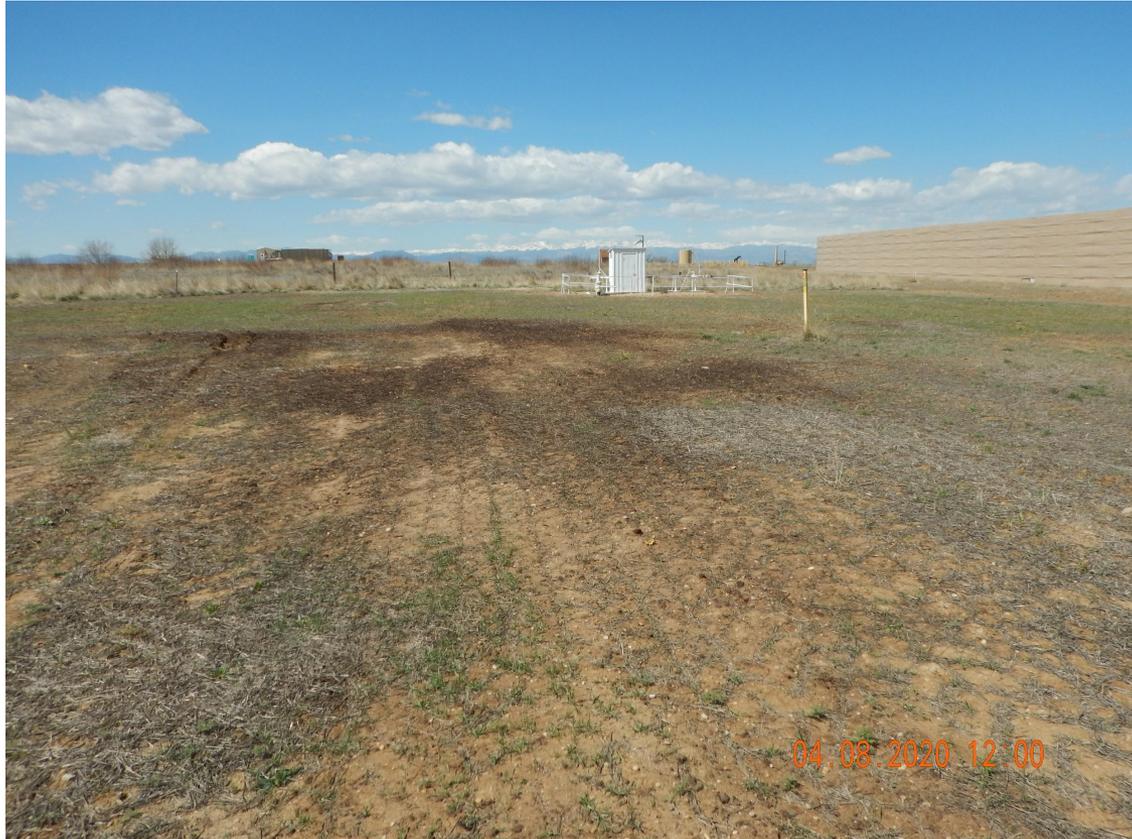
**Photo 5.** Photo taken from the associated offsite tank battery location, facing West. Photo illustrates Operator has performed final reclamation activities with the evidence of drill rows and germination. However, not all equipment has been removed.

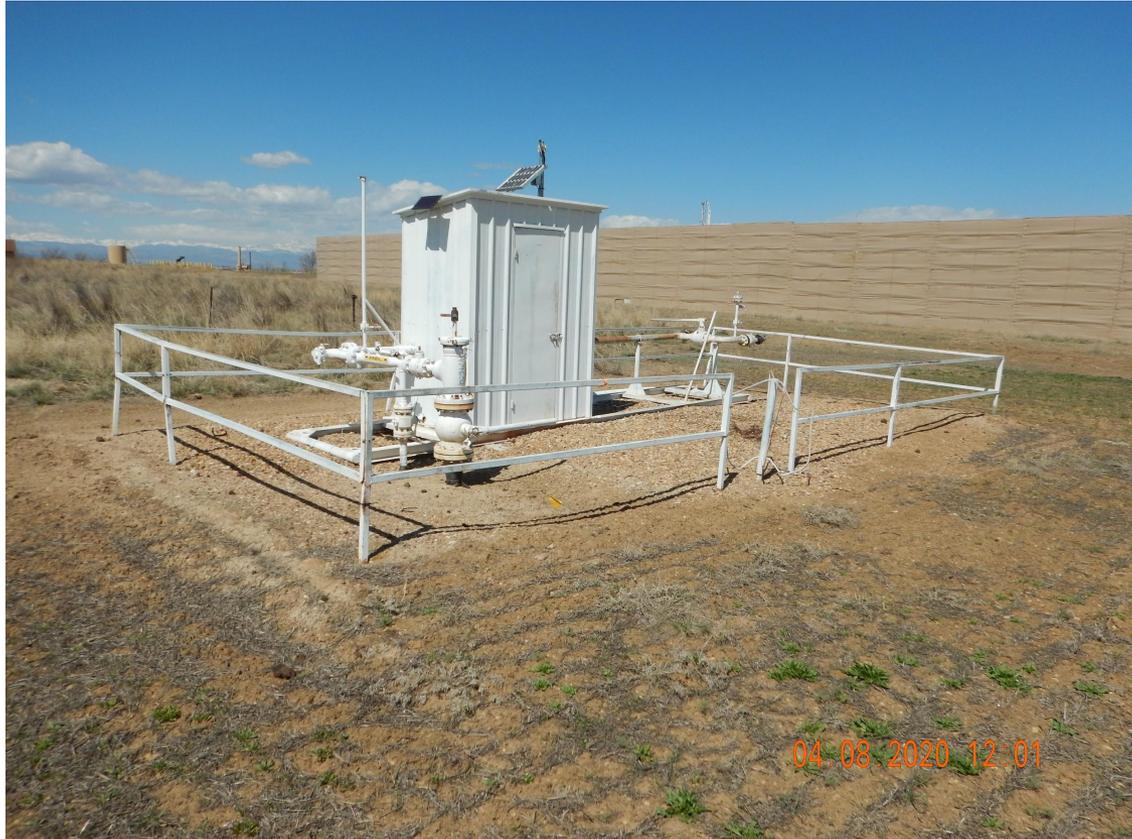
**Photo 6.** Photo taken from the western associated offsite tank battery location, facing Northwest. See comments under Photo 5.
