Inspection Photos

API: 071-09237

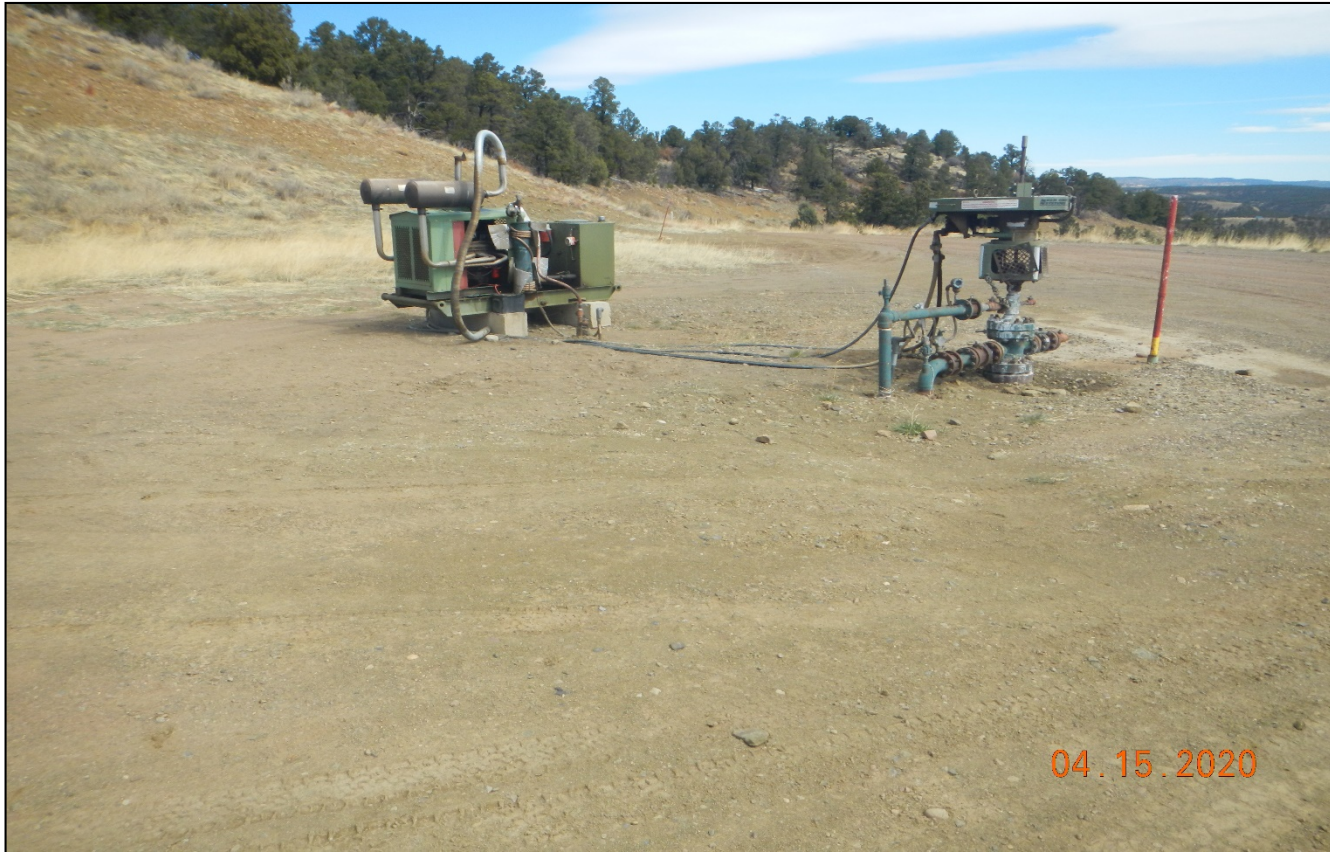
Photo 2. The dripping water leak at the wellhead has been stopped.

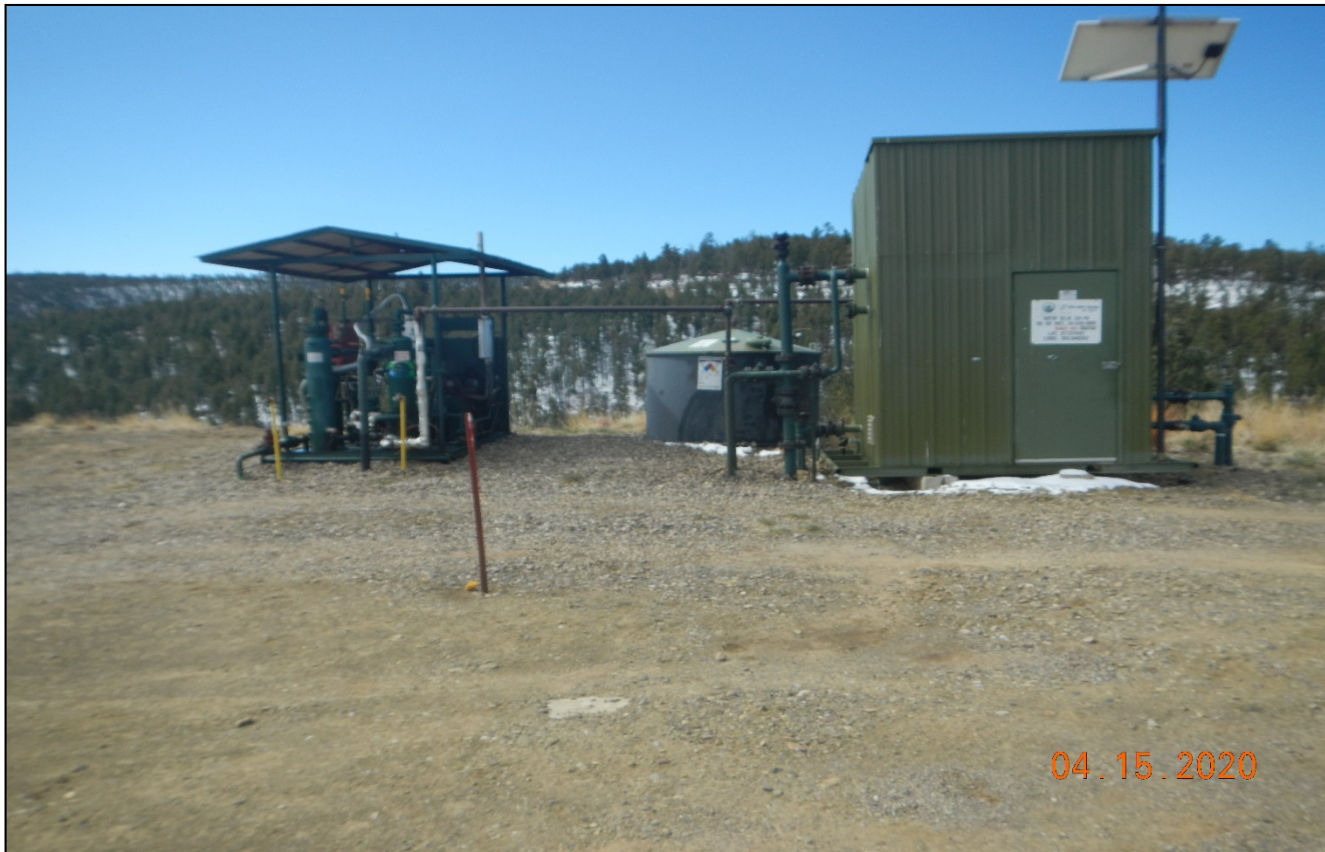
Photo 4. The lid on tank has been closed and stained soils cleaned up. Well sign is posted at the meter shed.
