# Final Reclamation and Stormwater Inspection

Operator: RED HAWK PETROLEUM LLC - #10503

Location ID: 426701

Inspection Photos  
Location: Bridgman #1-1H  
Location ID: 426701

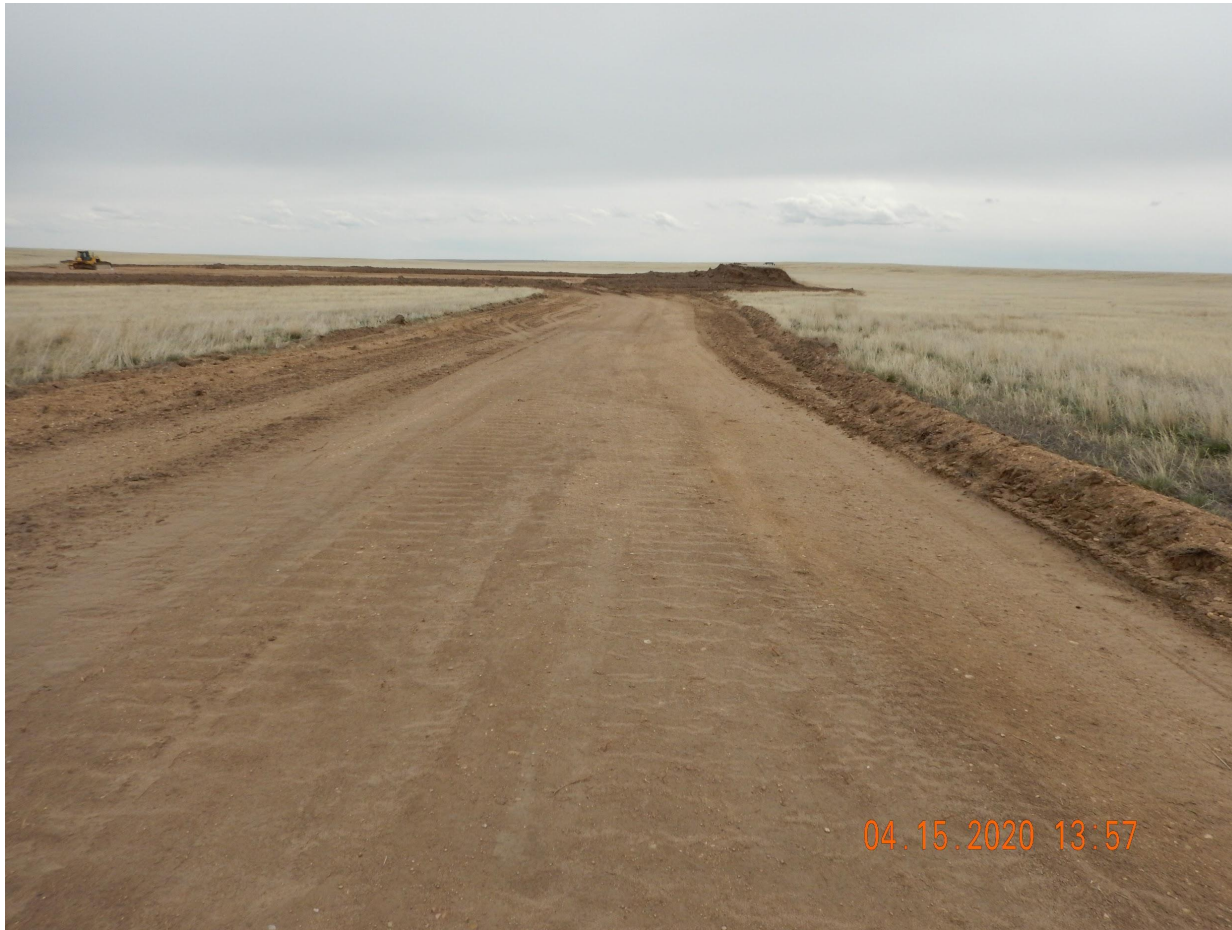
**Photo 1.** Photo taken from the entrance of location, facing South. Photo illustrates Operator is in-process of performing final reclamation.

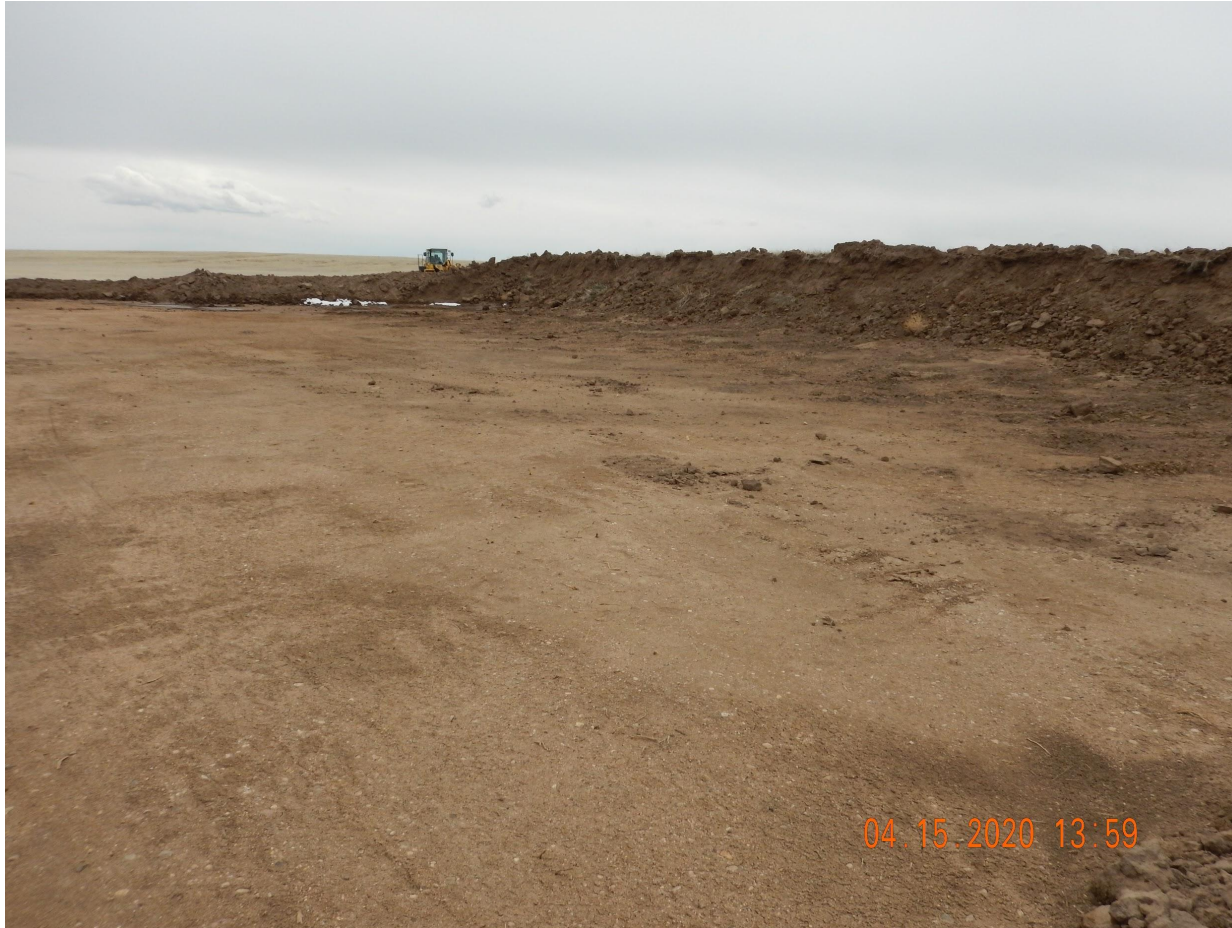
**Photo 2.** Photo taken from the northern location, facing South. See comments under Photo 1. Appears the Operator is starting to spread topsoil. Operator shall cross-rip disturbance areas to a depth of 18" prior to spreading topsoil.  
Note: There is a ditch and berm around the downgradient perimeter of location.

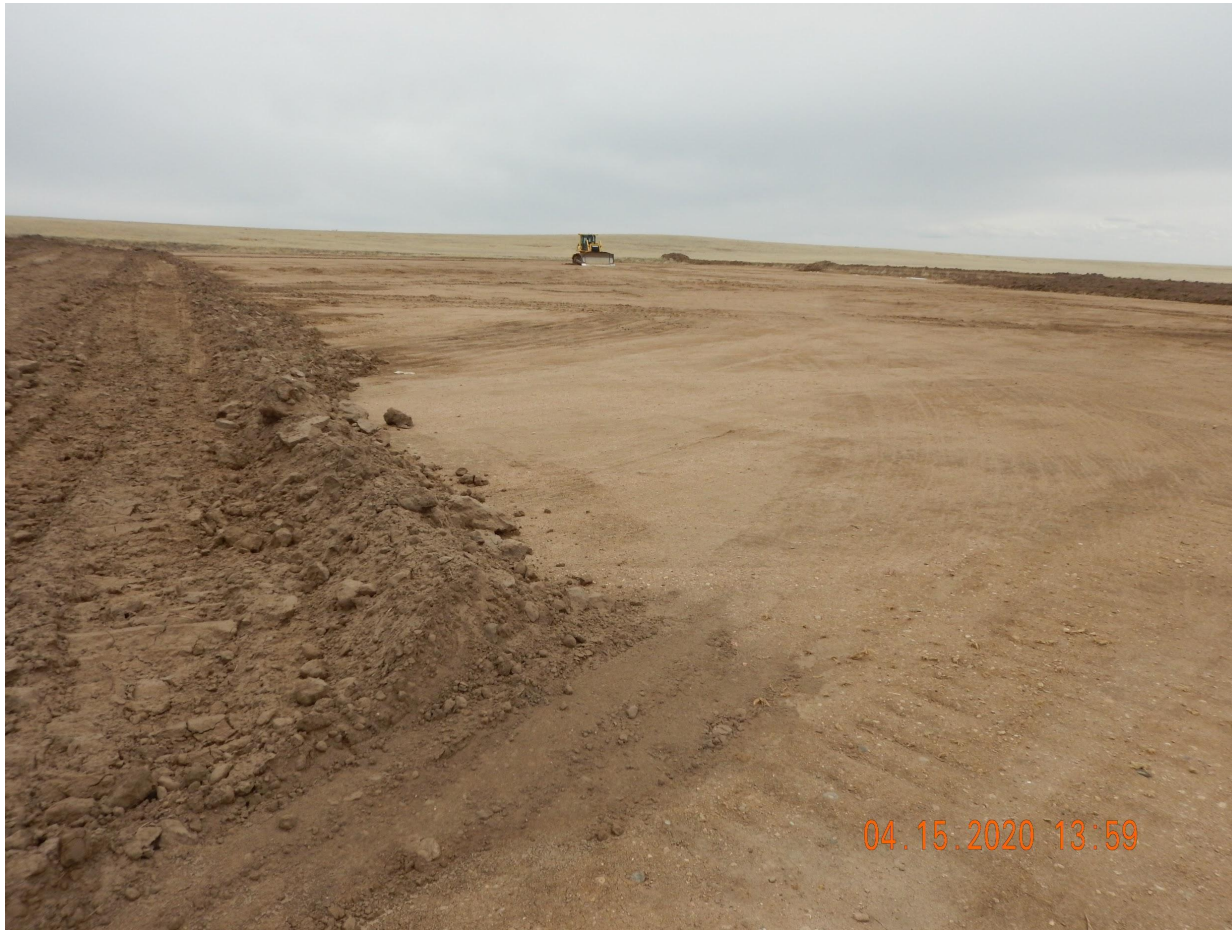
**Photo 3.** Photo taken from the northern location, facing East. See comments under Photo 1 and 2.

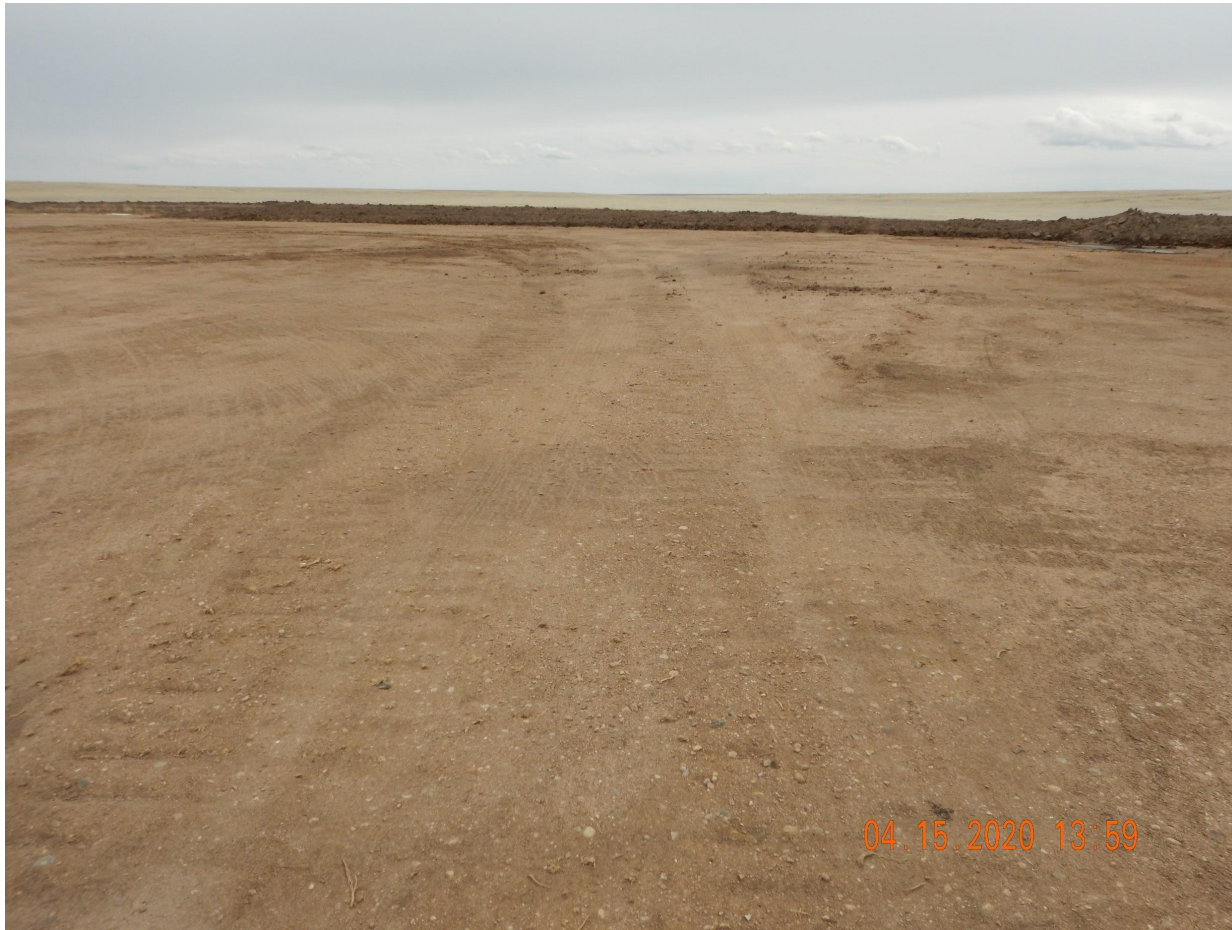
**Photo 4.** Photo taken from the northern location, facing South. See comments under Photo 1 and 2.
