## Inspection Photos

Location Name: GOLDEN EAGLE 17-15

API#: 05-071-07775

INSP. #: 695102716

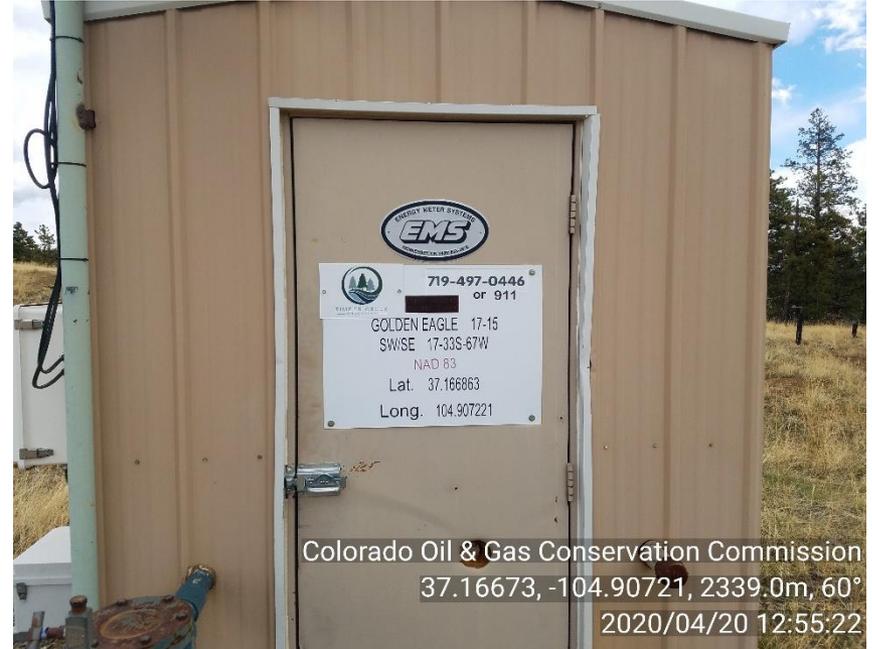
PHOTO 2: WELL SIGN

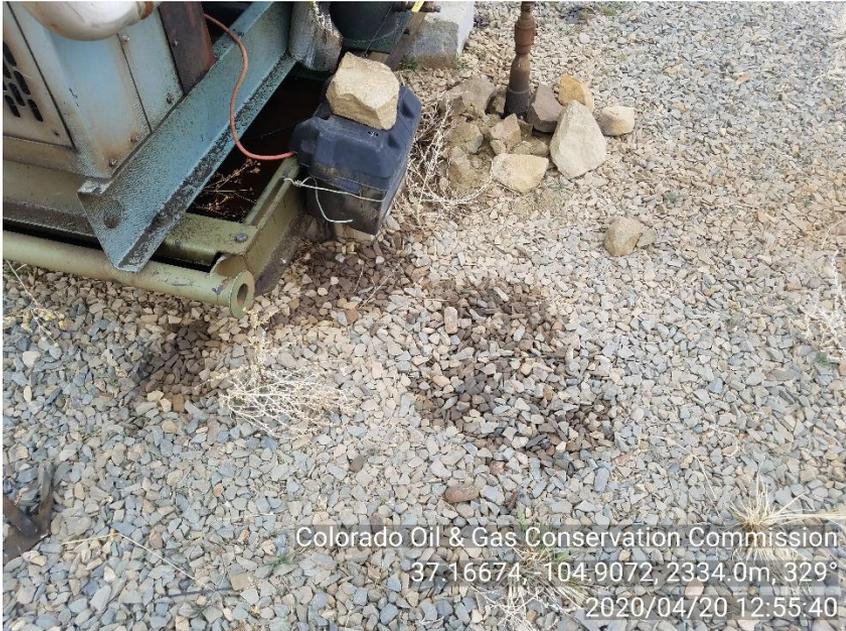
**PHOTO 3: AREA OF IMPACTED SOIL NEAR ENGINE SKID. Conduct maintenance on equipment, cleanup stained material and review self inspection processes. CA DATE 4-25-20.**

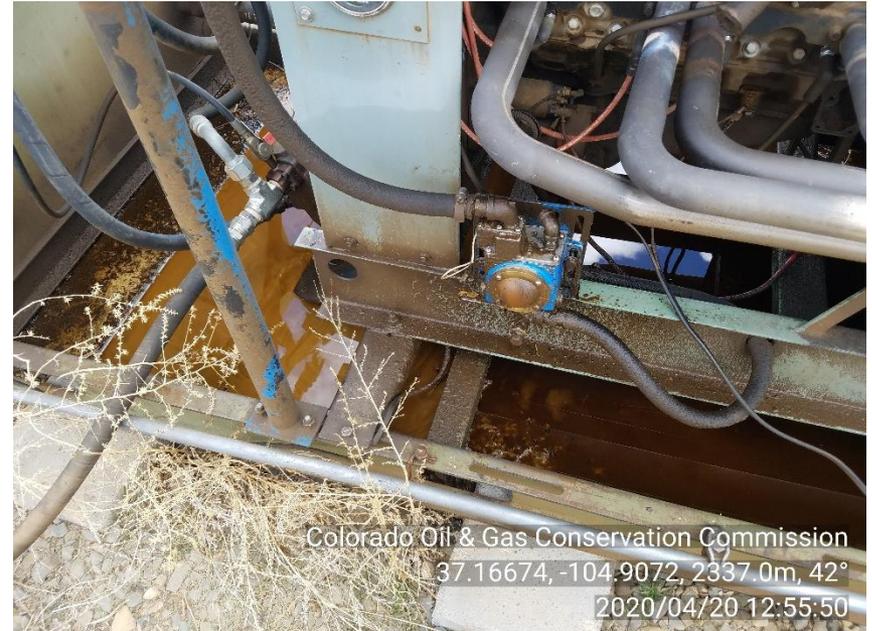
**PHOTO 4: THERE IS STANDING OIL IN ENGINE SKID. Comply with general provisions of the oil and gas act for wildlife protection. CA DATE 5-20-20**
