Final Reclamation Inspection

Operator: PDC ENERGY INC - 69175

Location ID: 328083

Inspection Photos
Location Name: WEIDERSPON ST #J16-12
Location ID: 328083

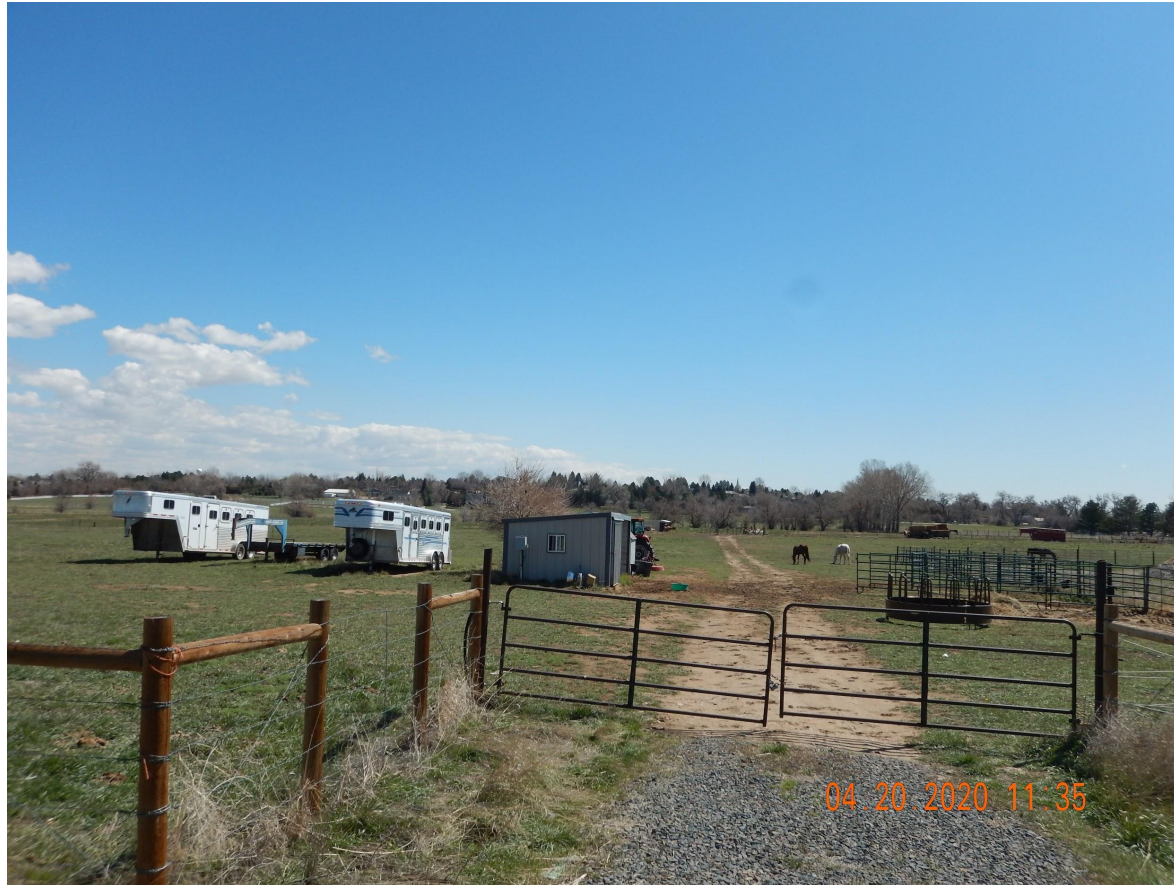
Photo 1. Photo taken from the well location entrance, facing East. Photo illustrates the gate was locked with livestock. COGCC staff will have to perform a future inspection to ensure all equipment was removed and that the well location meets vegetative standards.

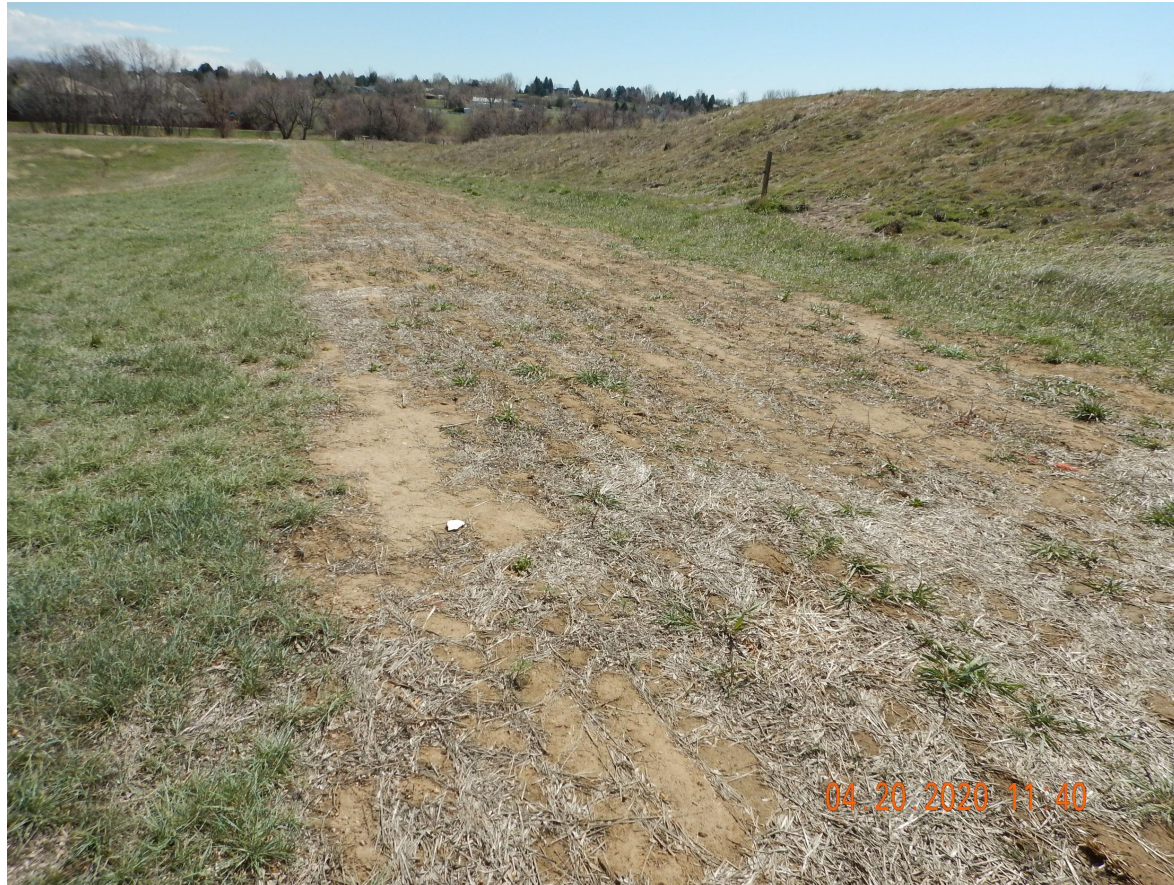
Photo 2. Photo taken from the western access road for the associated offsite tank battery, facing East. See comments under Photo 1. Operator did perform final reclamation activities with the evidence of drill rows and straw crimped mulch. Germination of desirable species was sparse throughout the access road compared to the tank battery..

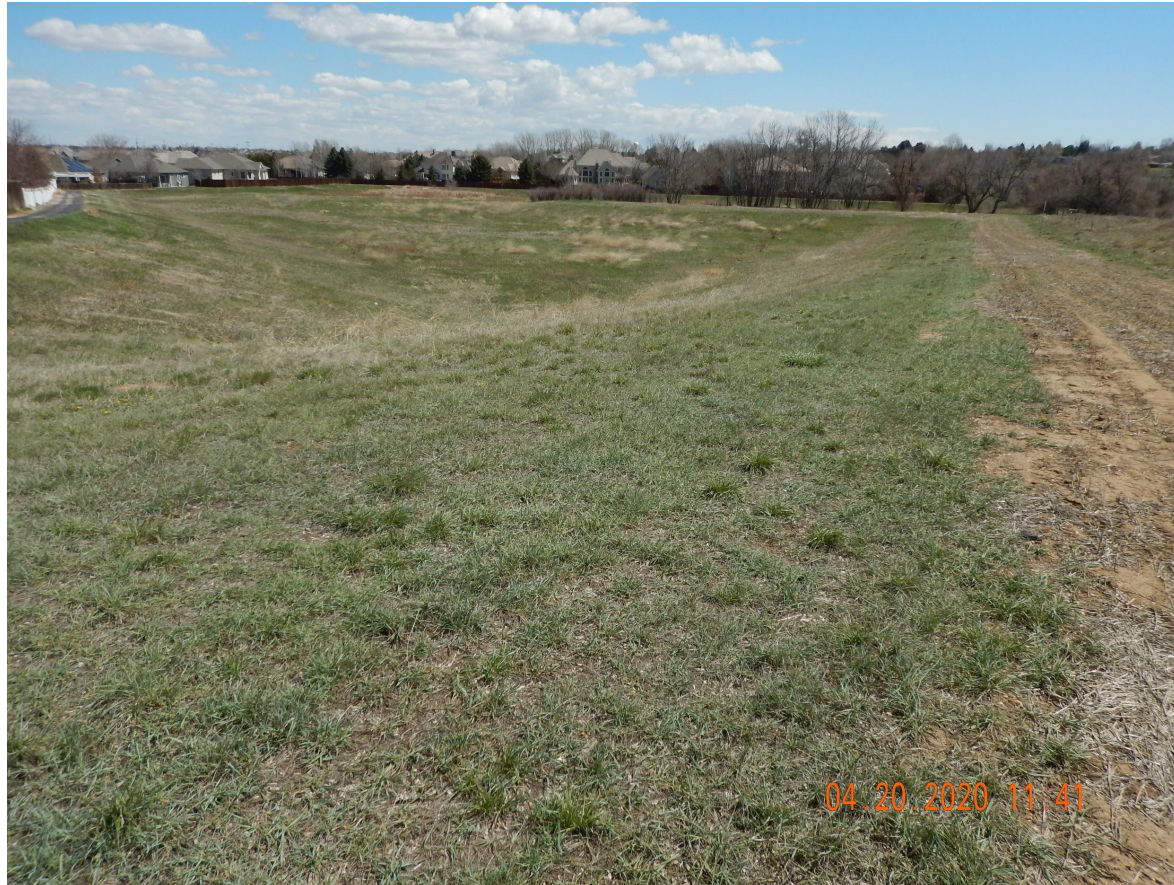
Photo 3. Photo taken from the western access road for the associated offsite tank battery, facing East. Photo illustrates what appears to be a stabilized retention area for stormwater related to the housing development.

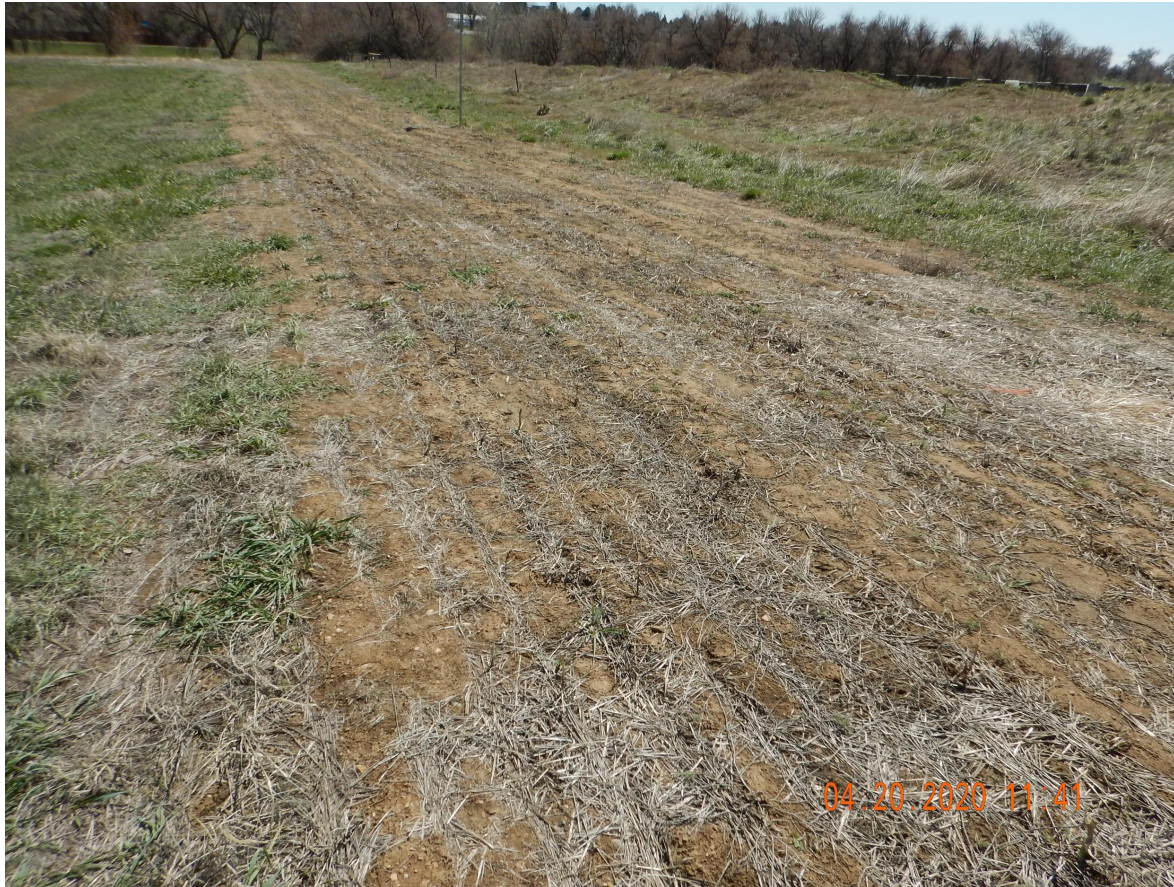
Photo 4. Photo taken from a portion of the access road for the associated offsite tank battery, facing East. See comments under Photo 2.

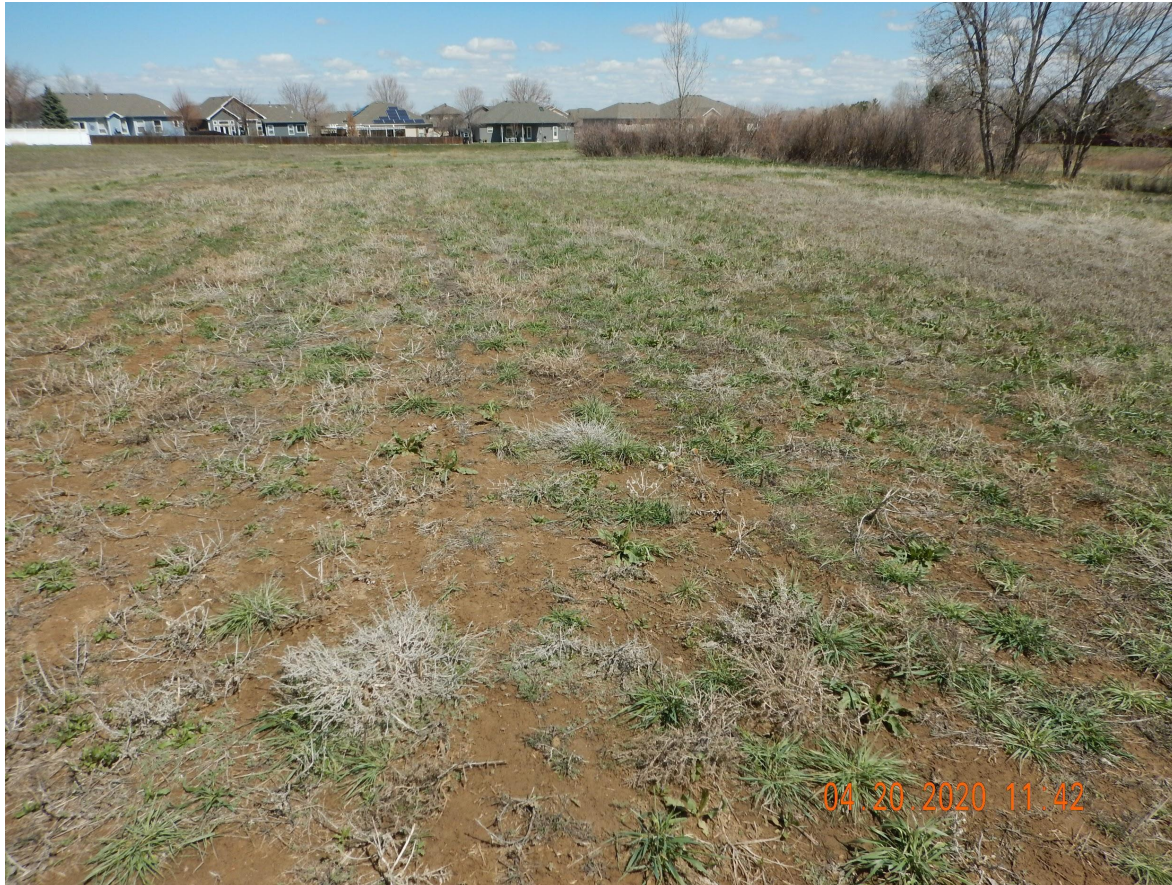
Photo 5. Photo taken from the associated offsite tank battery, facing North. Photo illustrates Operator performed final reclamation activities with the evidence of drill rows, straw crimped mulch, and germination of desirable species.
