Final Reclamation Inspection

Operator: CRESTONE PEAK RESOURCES OPERATING LLC - 10633

Location ID: 333142

Inspection Photos
Location Name: SELTZER #14-34
Location ID: 333142

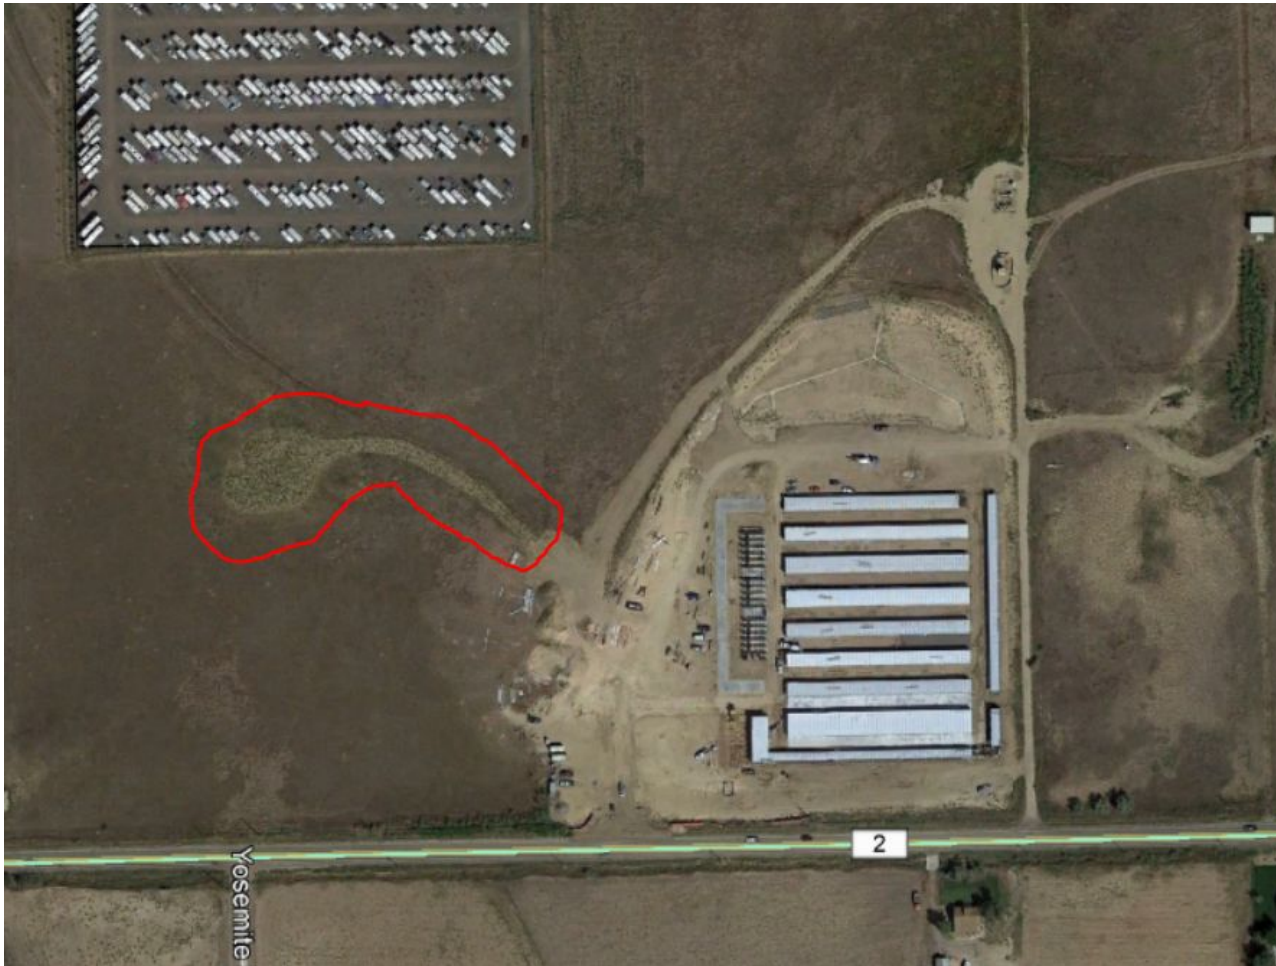
Photo 1. Google Earth aerial imagery from 9/12/2019 illustrates an area circled in red that is subject to comply with COGCC rules and regulation. Other portions of the eastern access road are within a final land use change (i.e., storage facility).

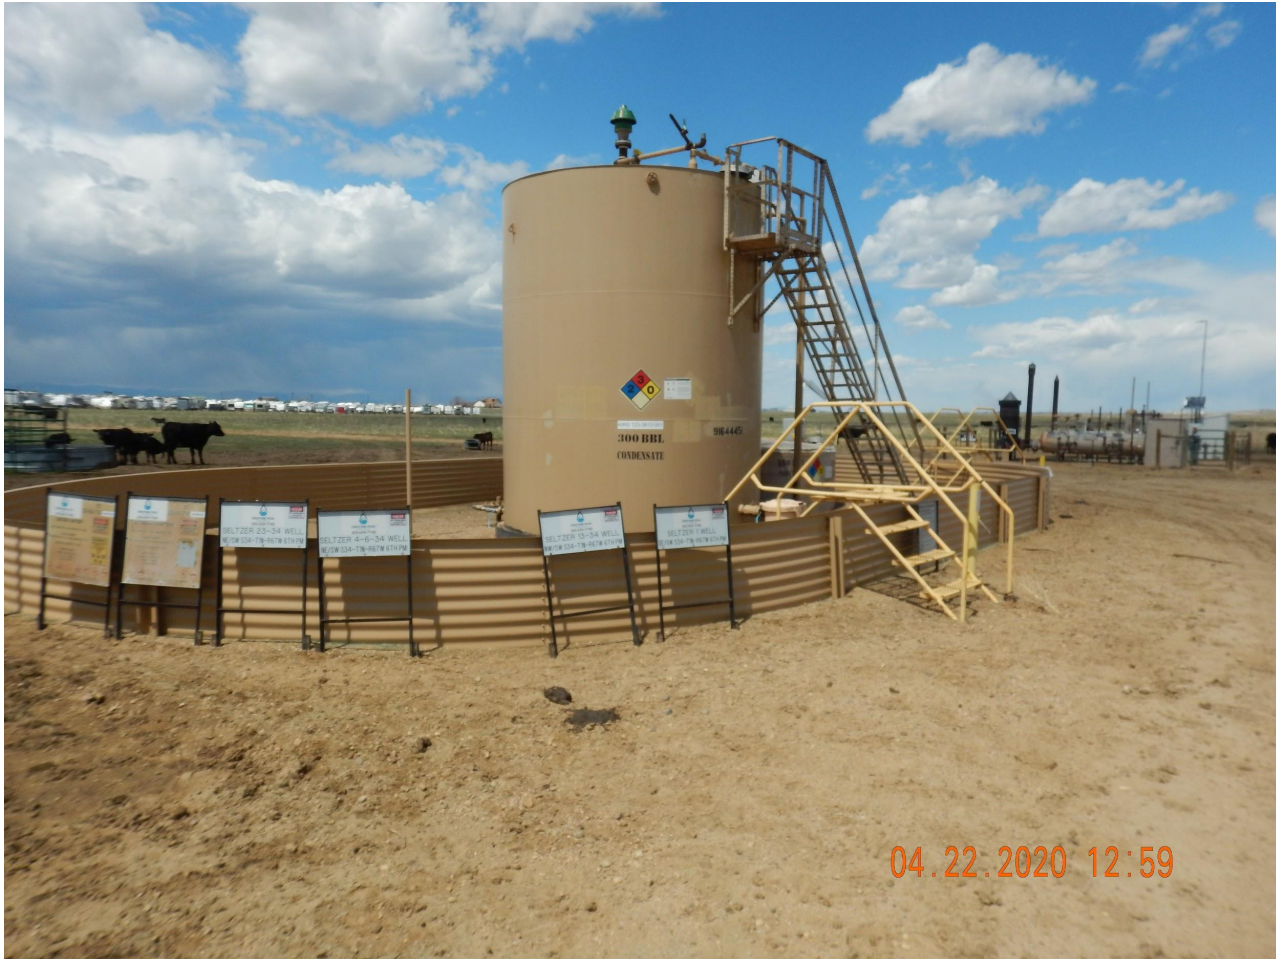
Photo 2. Photo taken from the associated offsite tank battery, facing Northwest. Photo illustrates tank battery is in use for other nearby wells.

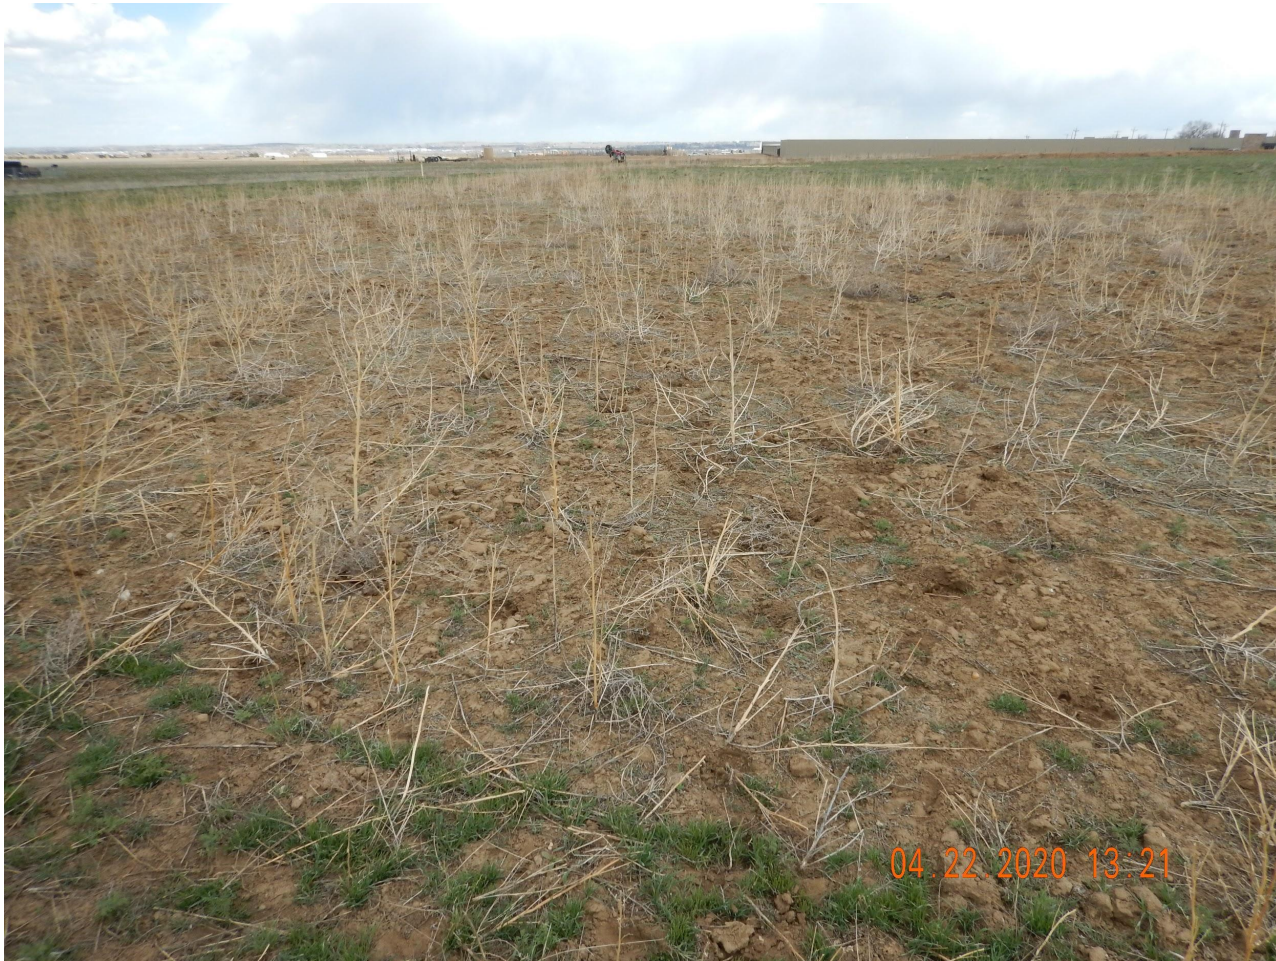
Photo 3. Photo taken from the well location, facing East. Photo illustrates there is no evidence to suggest final reclamation activities were completed. Annual, weedy vegetation with bare ground was observed.

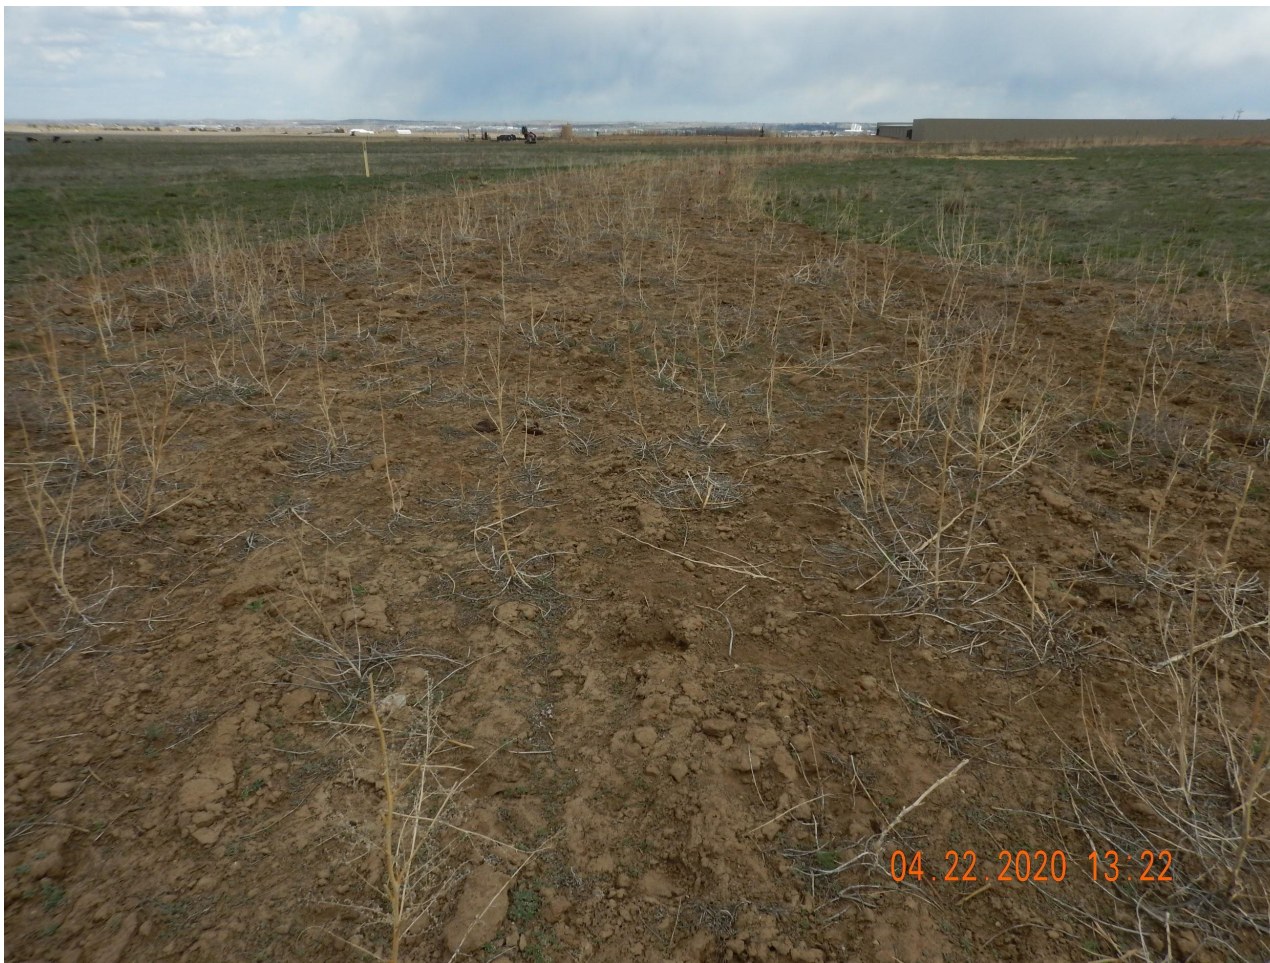
Photo 4. Photo taken from a portion of the well location access road, facing East. See comments under Photo 3.

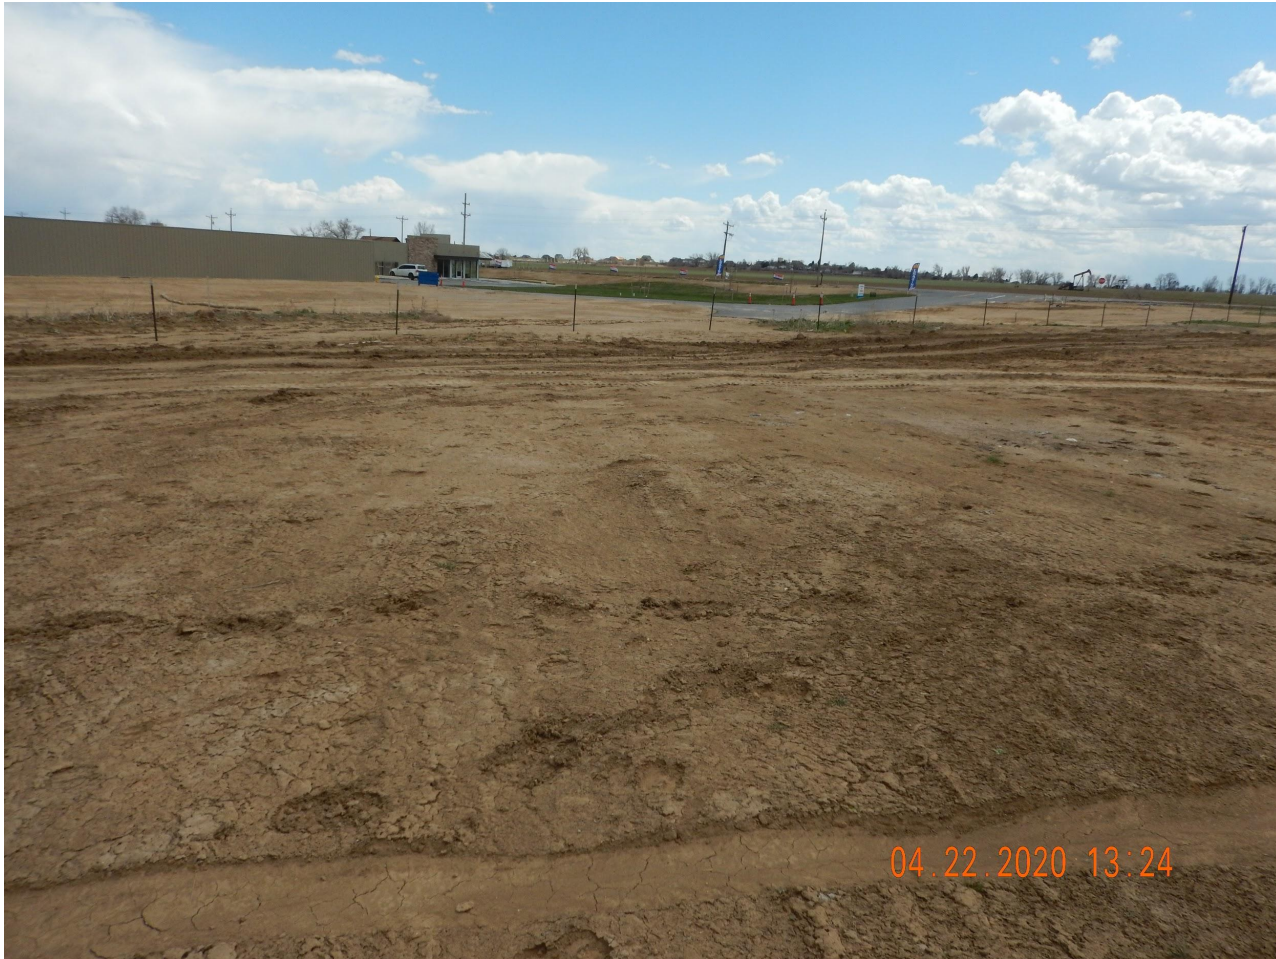
Photo 5. Photo taken from a portion of the well location access road, facing East. Photo illustrates a portion of the well location access road has been disturbed by the construction of a storage facility (final land use change).

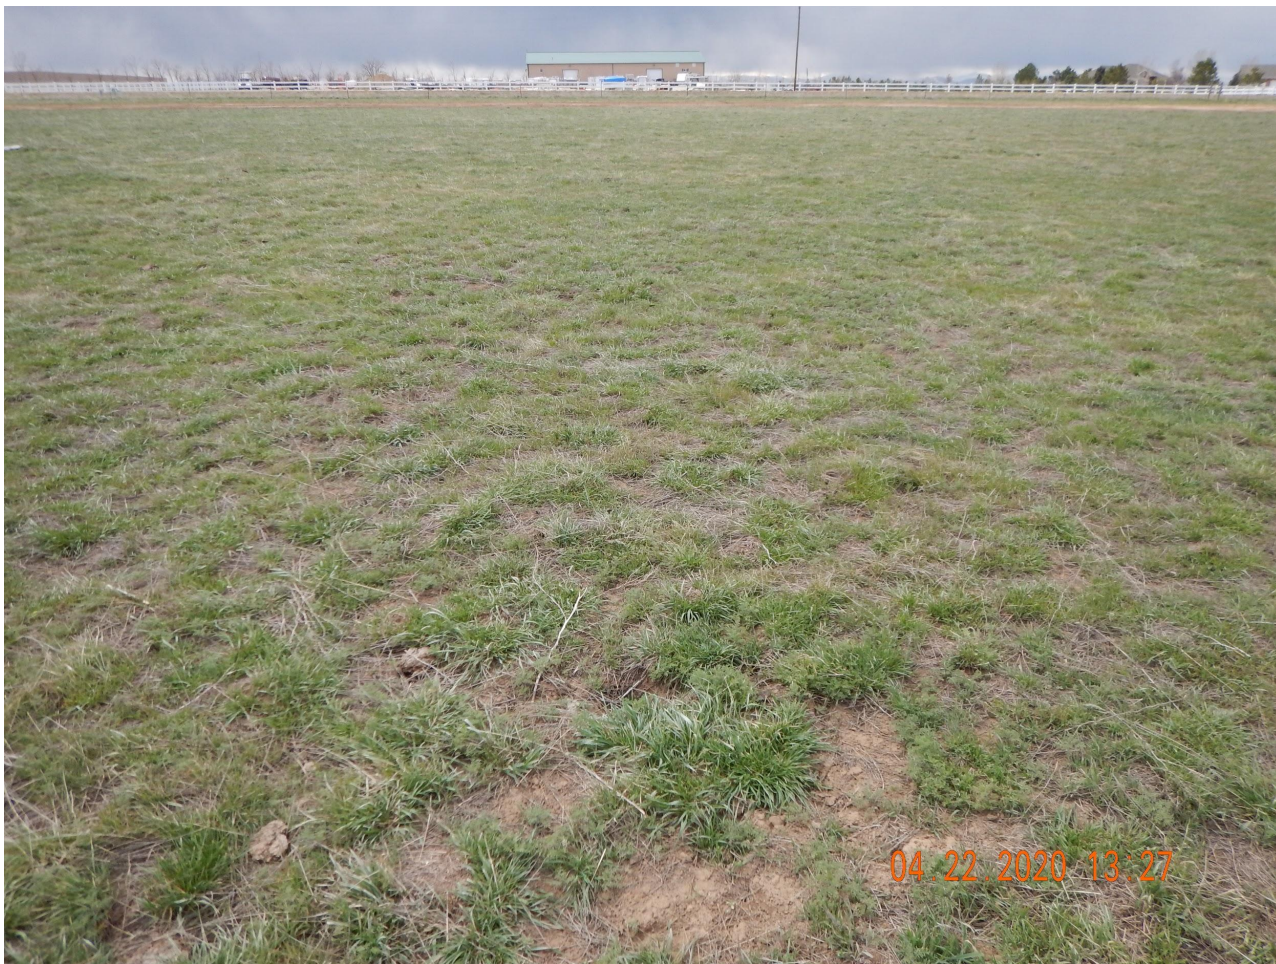
Photo 6. Reference photo taken west of the well location, facing West. Photo illustrates vegetation mostly consists of crested wheatgrass.
