# Final Reclamation Inspection

Operator: K P KAUFFMAN COMPANY INC- #46290

Location ID: 405998

Inspection Photos  
Location Name:  
AMOCO-CHARTER-SCHNEIDER #1  
Location ID: 405998

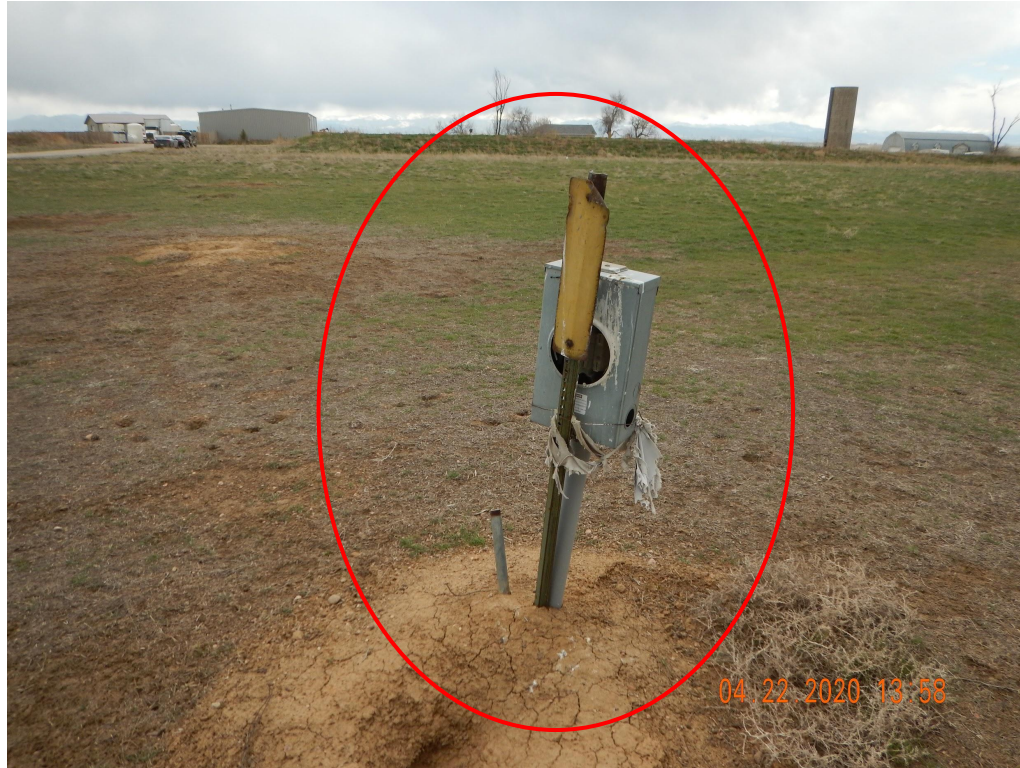
**Photo 1.** Photo taken from the location of the former AMOCO-CHARTER-SCHNEIDER #1 well, facing West. Operator shall remove all remaining equipment per Rule 1004.a.

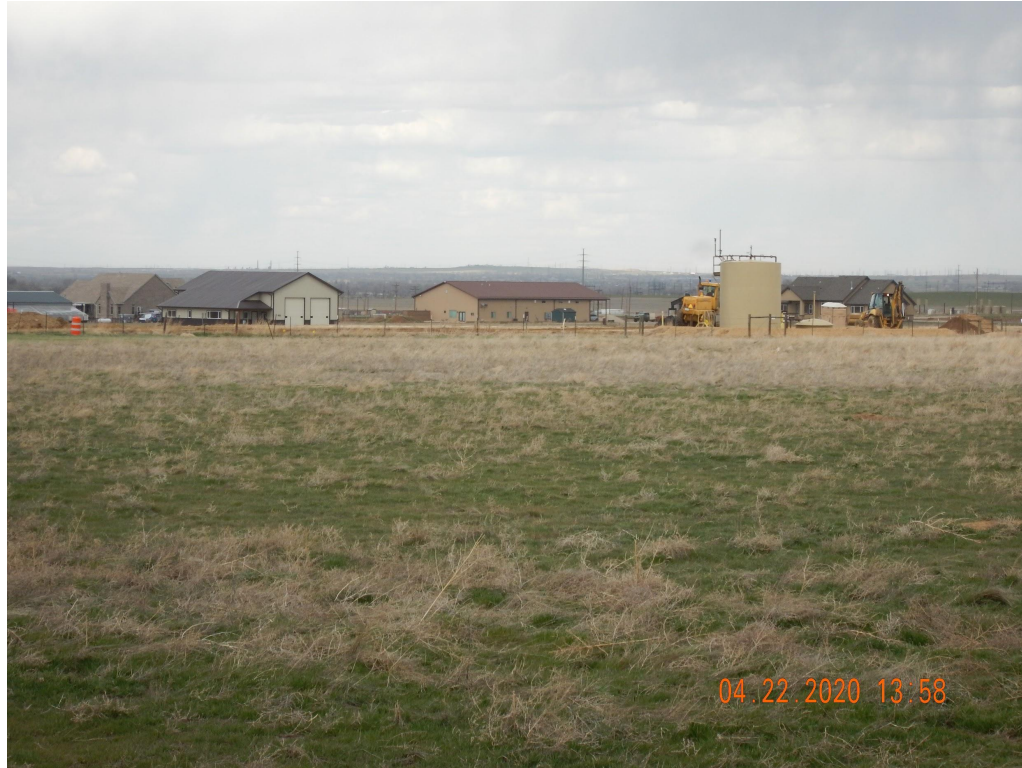
**Photo 2.** Photo taken of the associated offsite tank battery, facing North. Photo illustrates tank battery is still in use by other nearby wells. Appears dirt work was being performed at the time of this inspection.
