Inspection Photos

Location Name: Puckett 697-26A Pad

Location ID: #416157

Inspection Date: April 24, 2020

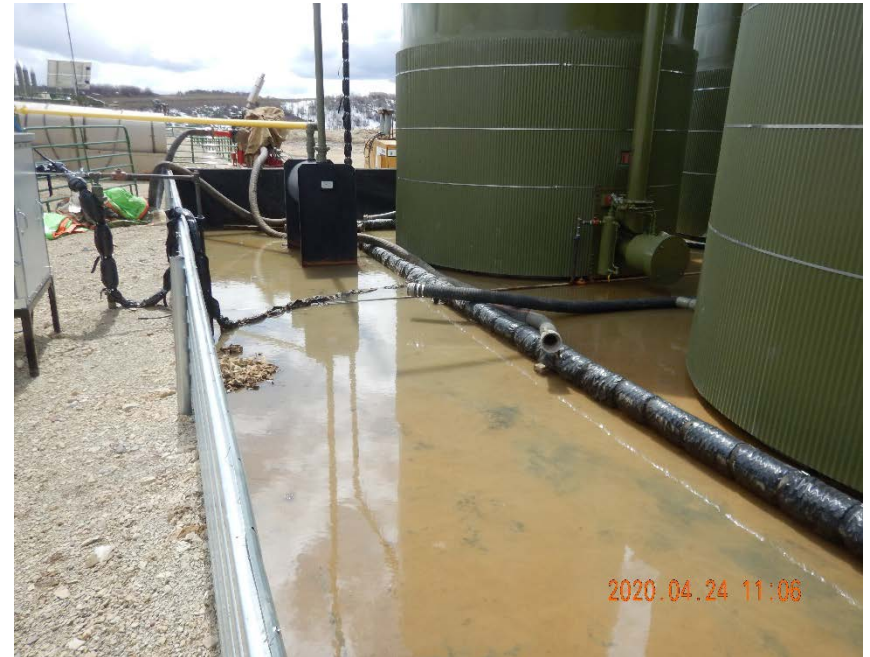
Photo #2 – View of fluids inside of tank battery secondary containment area (east side). Note hoses stored inside of secondary containment area.

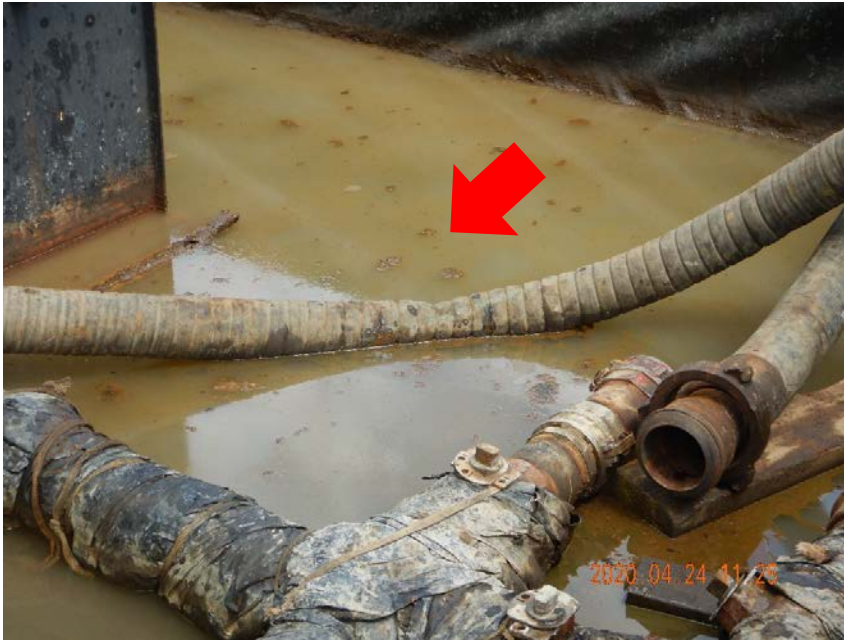
Photo #3 – Mixed fluids, hoses with metal fittings, and wood debris inside of tank battery secondary containment area (SE corner). Note presence of condensate floating on fluids (red arrow). Hydrocarbon odors were observed in this area.

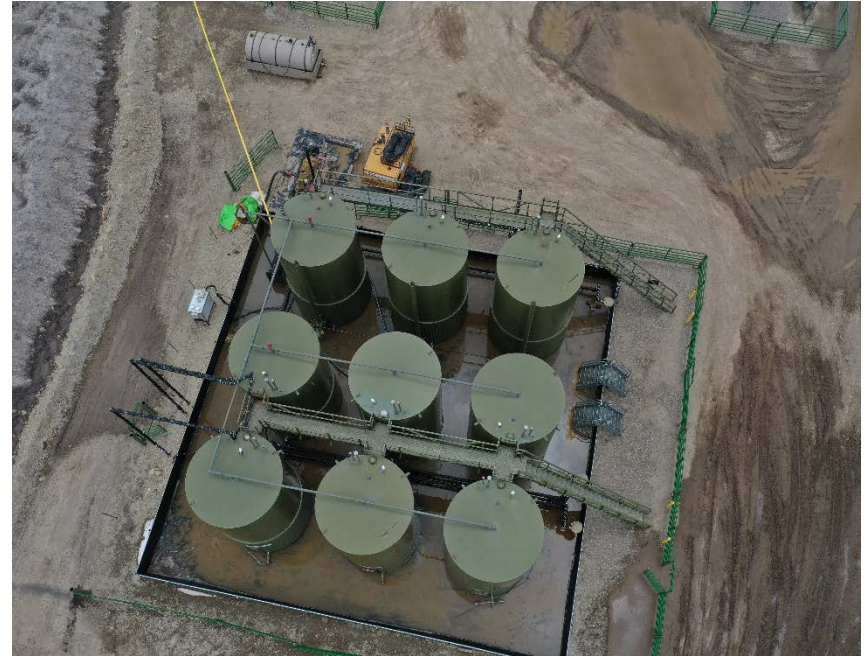
Photo #4 – Aerial photograph of tank battery documents the amount of fluids present in secondary containment area during inspection.

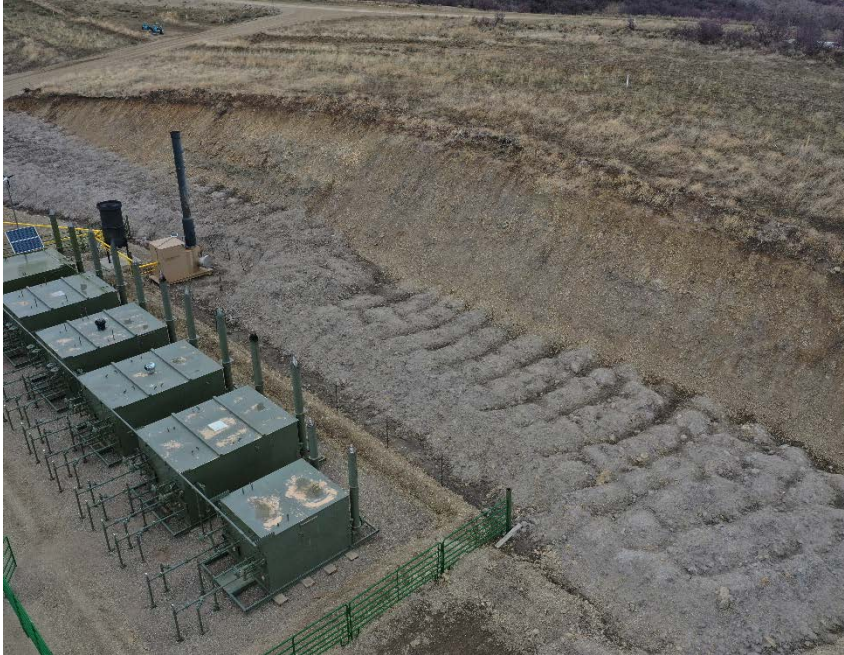
Photo #5 – Aerial view of cut slope on east side of pad. Beneficial reuse of cuttings described in doc #402163214 has not been completed.

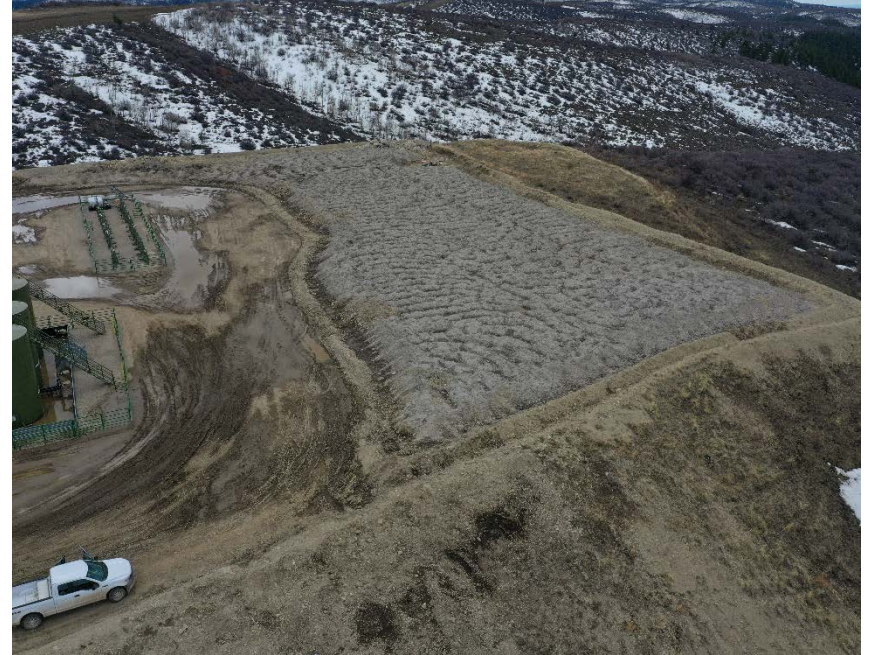
Photo #6 –Overview of land treatment area in southwest side of pad. Land treatment of cuttings is documented under Remediation Project #11653, which was approved for closure on 10/9/2018 (doc #401752256).

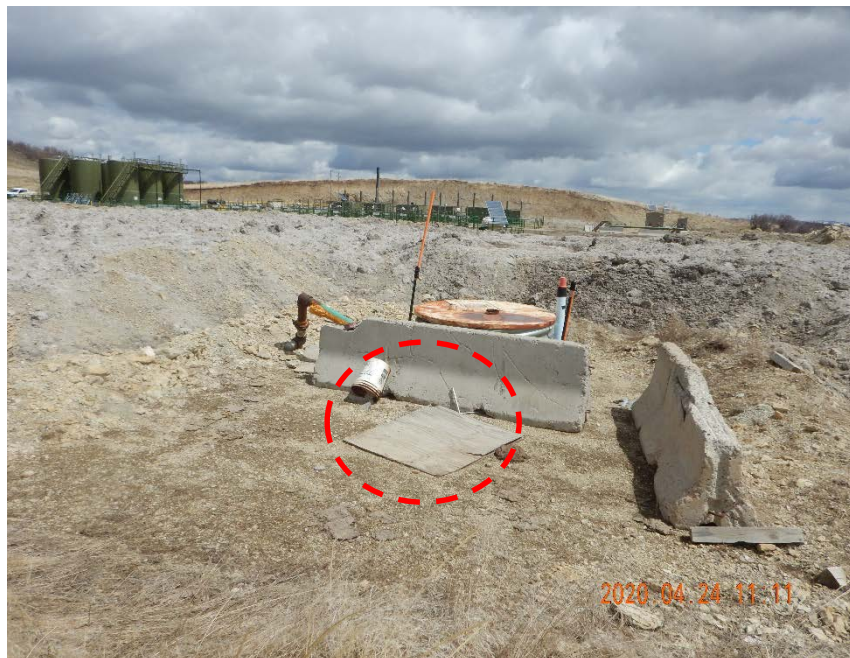
Photo #7 – Trash and debris located at valve can at south end of pad.

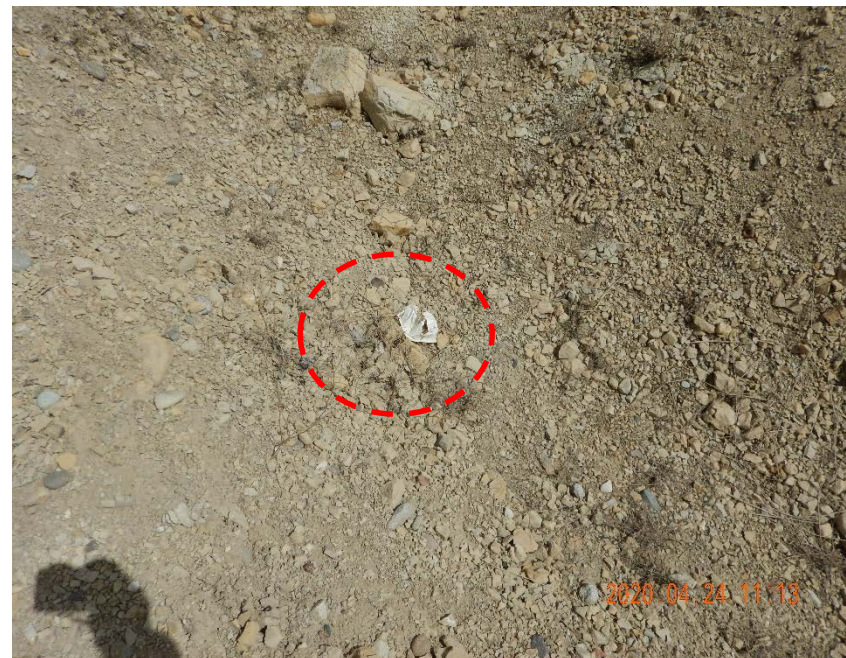
Photo #8 – Trash along west side of land treatment unit. (1)

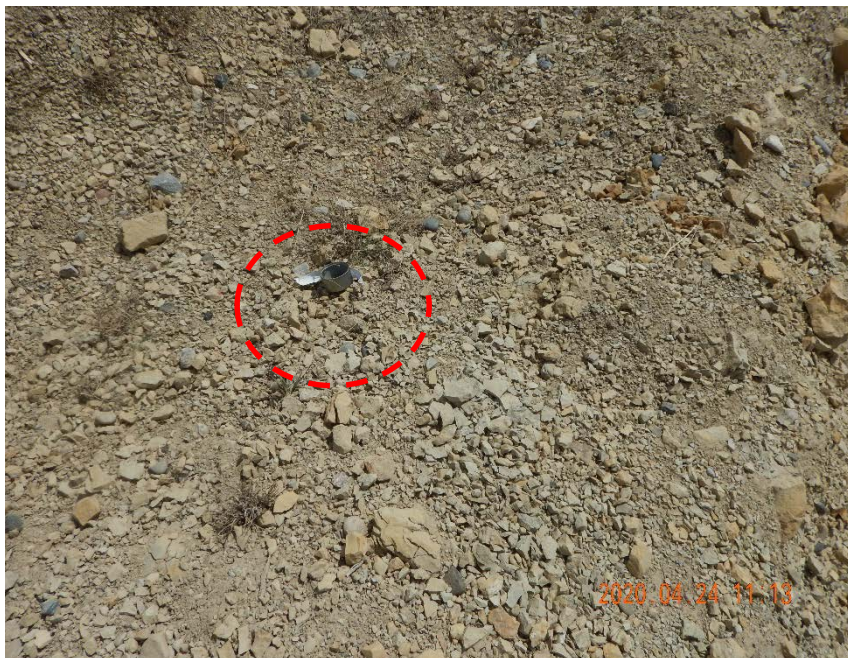
Photo #9 - Trash along west side of land treatment unit. (2)

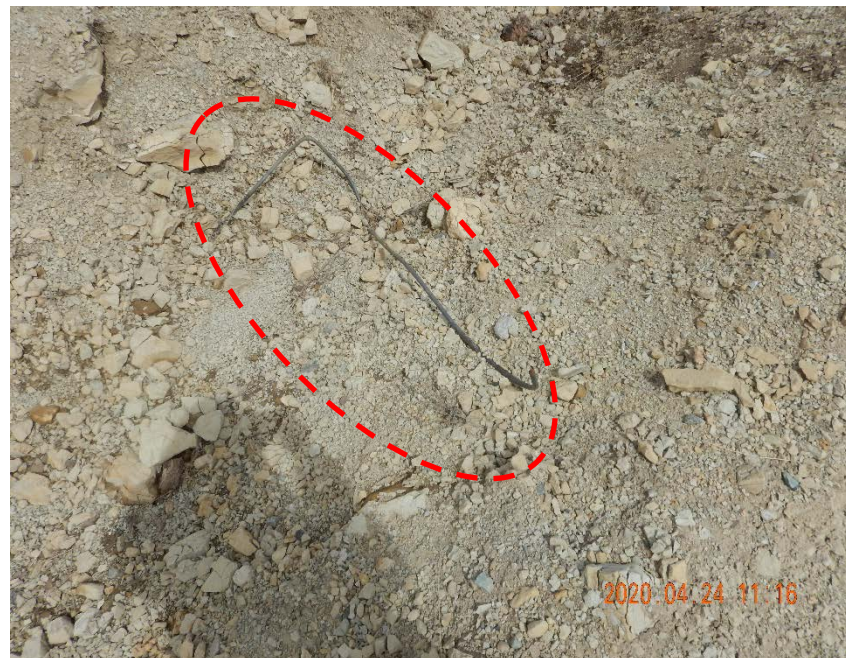
Photo #10 – Trash along north side of land treatment unit.

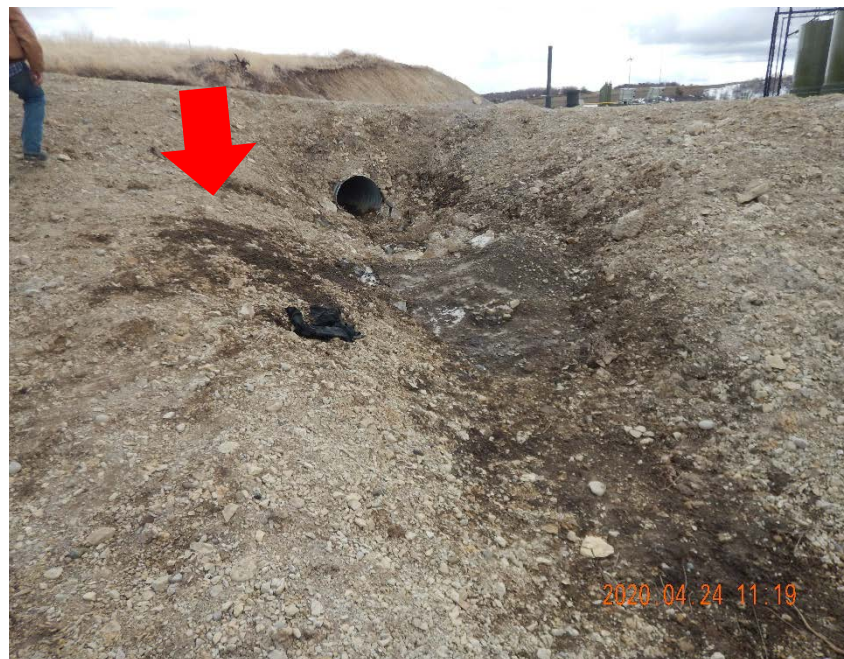
Photo #11 – Trash and stained soil located beneath culvert at north end of pad. Hydrocarbon odors were observed in the dark soil at this location (red arrow). Operator was notified of this issue via phone on 4/24/2020.
