Inspection Photos

Location Name: NEW ELK 24-16 FOLLOW UP

API#: 05-071-09473

INSP. #: 695102763

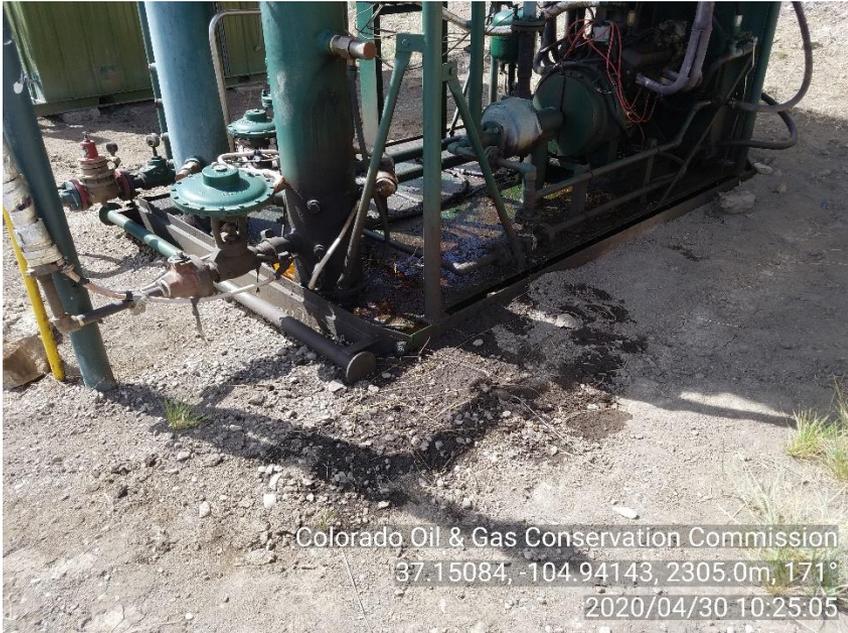
PHOTO 3: Stained soil around HYD skid. Non E&P Waste not properly stored, handled, transported, treated, or disposed per Rule 907A CA DATE 5-7-20. THIS IS SECOND NOTICE FOR THIS CORRECTIVE ACTION.

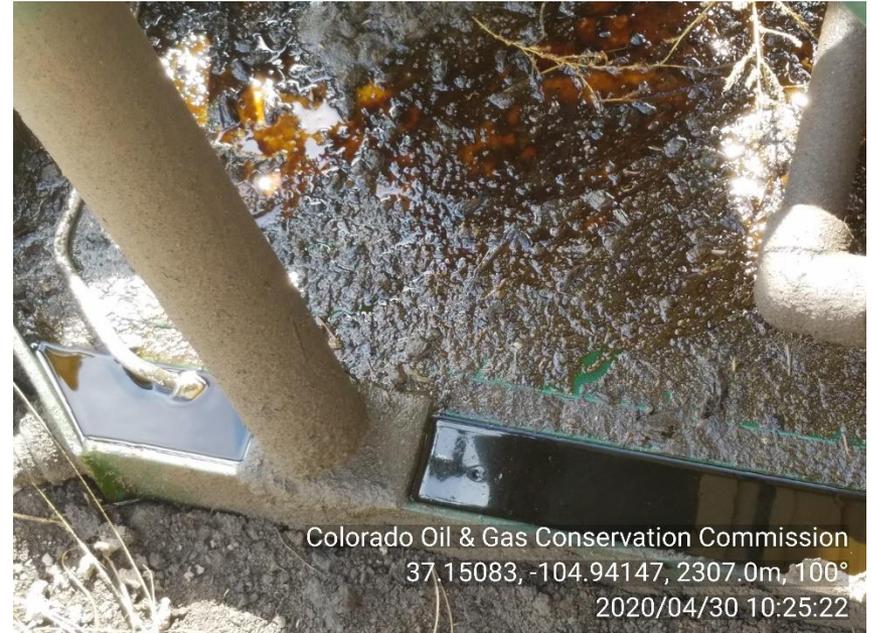
PHOTO 4: STANDING OIL IN COMPRESSOR SKID. Comply with general provisions of the oil and gas act for wildlife protection. CA DATE 5-7-20.
