Inspection Photos
Location Name: NEW ELK 25-04
API#: 05-071-09535
INSP. #: 695102765

Inspection Photos

Location Name: NEW ELK 25-04

API#: 05-071-09535

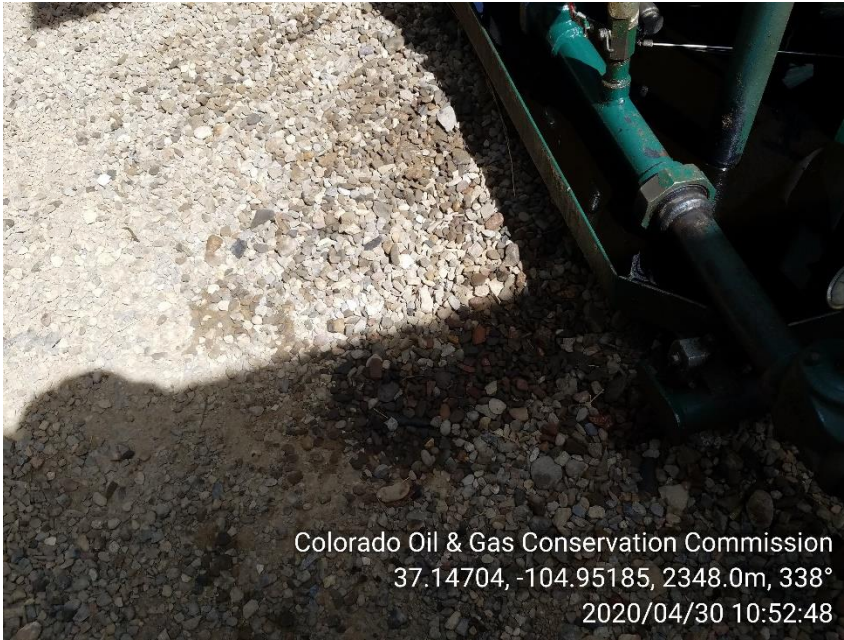
PHOTO 3: AREA OF IMPACTED SOIL AROUND COMPRESSOR SKID. Conduct maintenance on equipment, cleanup stained material and review self inspection processes. CA DATE 5-7-20. (REMOVE ALL IMPACTED SOIL ON LOCATION).

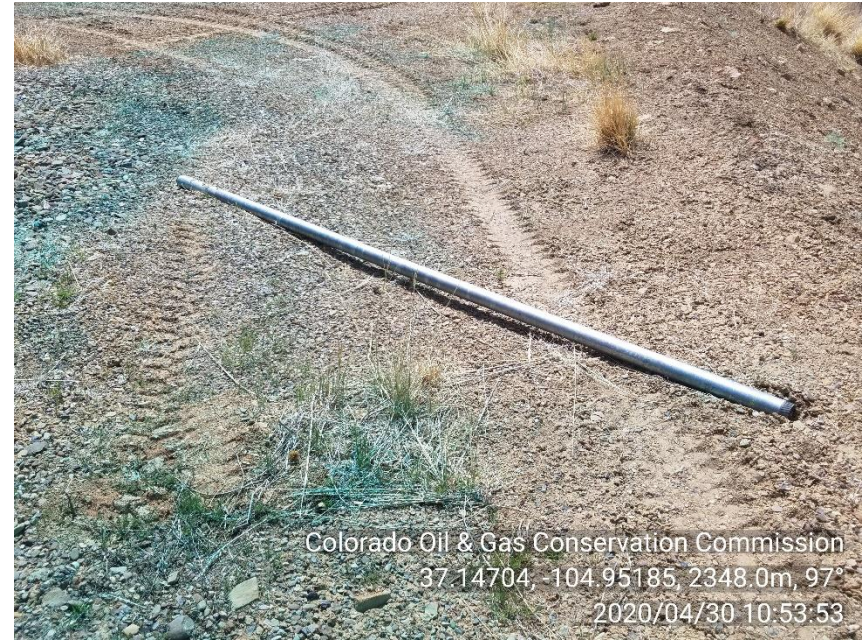
PHOTO 4: UNUSED EQUIPMENT STORED ON LOCATION. REMOVE UNUSED EQUIPMENT COMPLY WITH RULE 603.F. CA DATE 5-9-20.

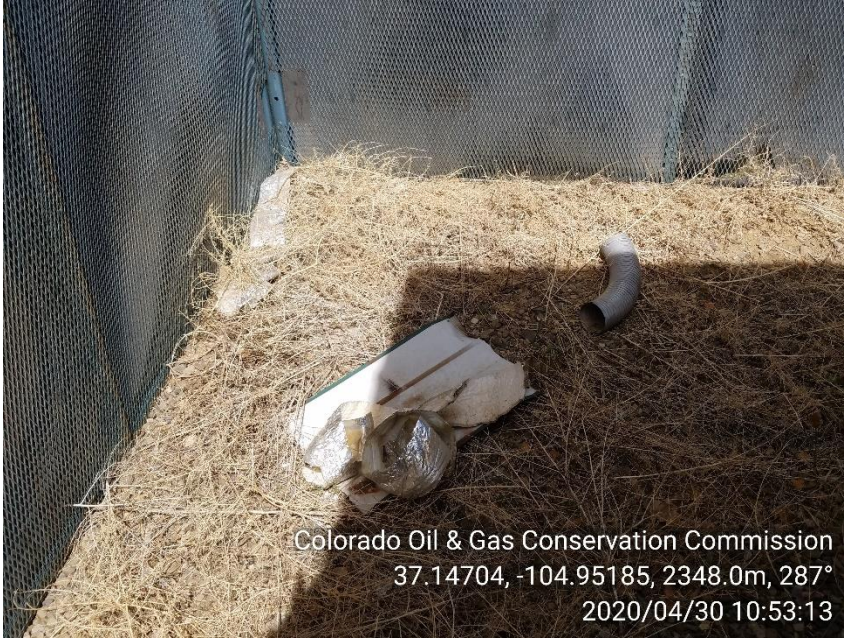
PHOTO 5: TRASH INSIDE COMPRESSOR SOUND WALLS. REMOVE ALL TRASH IN AND AROUND LOCATION. COMPLY WITH RULE 603.F. CA DATE 5-9-20.

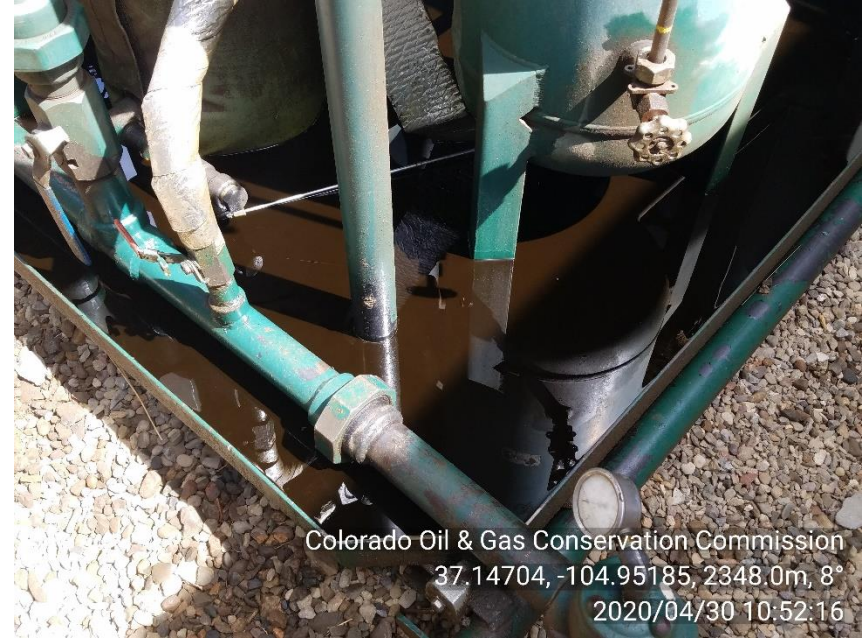
PHOTO 6: STANDING OIL IN COMPRESSOR SKID APPEARS AND ENGINE OIL IS BEING DRAINED INTO SKID AND LEFT. Comply with general provisions of the oil and gas act for wildlife protection. 5-7-20.
