Final Reclamation Inspection

Operator: PDC ENERGY INC - 69175

Location ID: 329181

Inspection Photos
Location Name: BECKER #5-10
Location ID: 329181

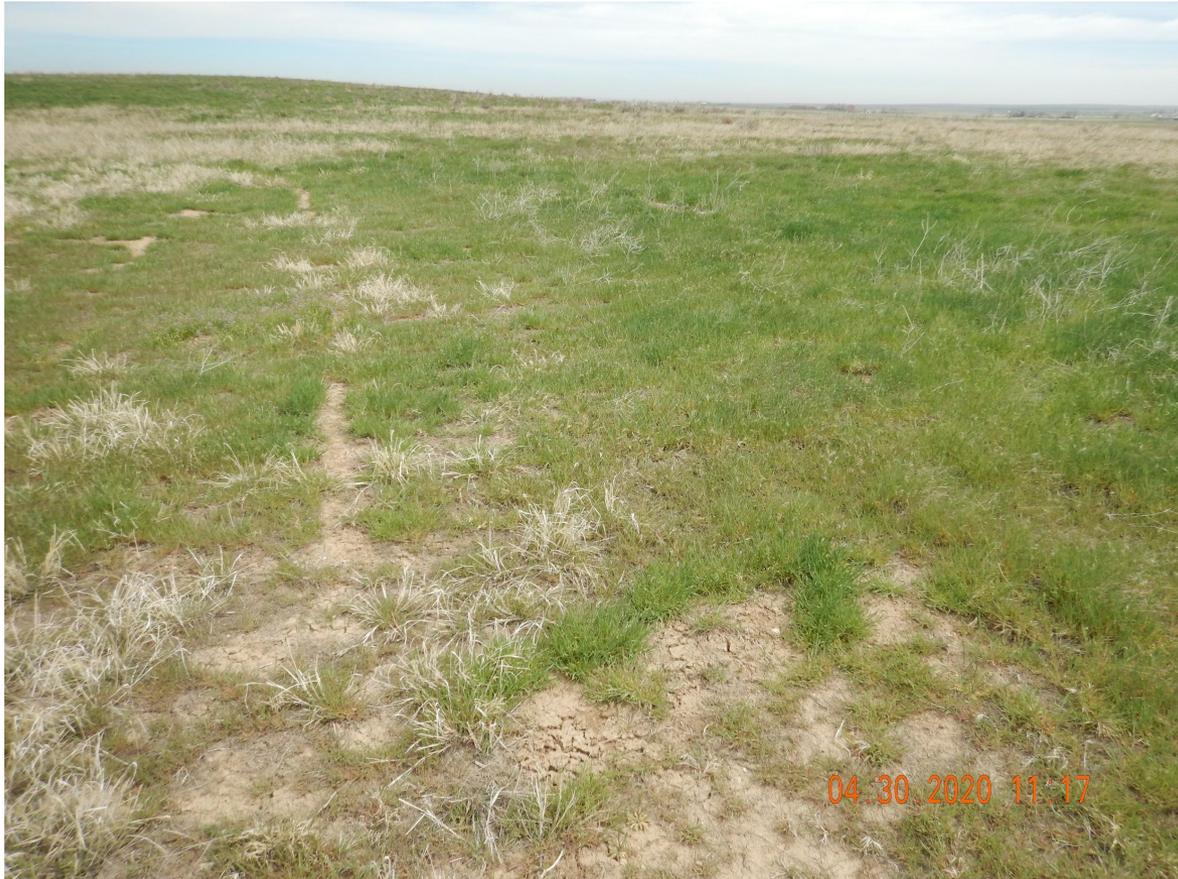
Photo 1. Photo taken from the southern well location, facing North. Photo illustrates well location consists mostly of cheatgrass. Sand dropseed was observed but mostly in the reference areas.

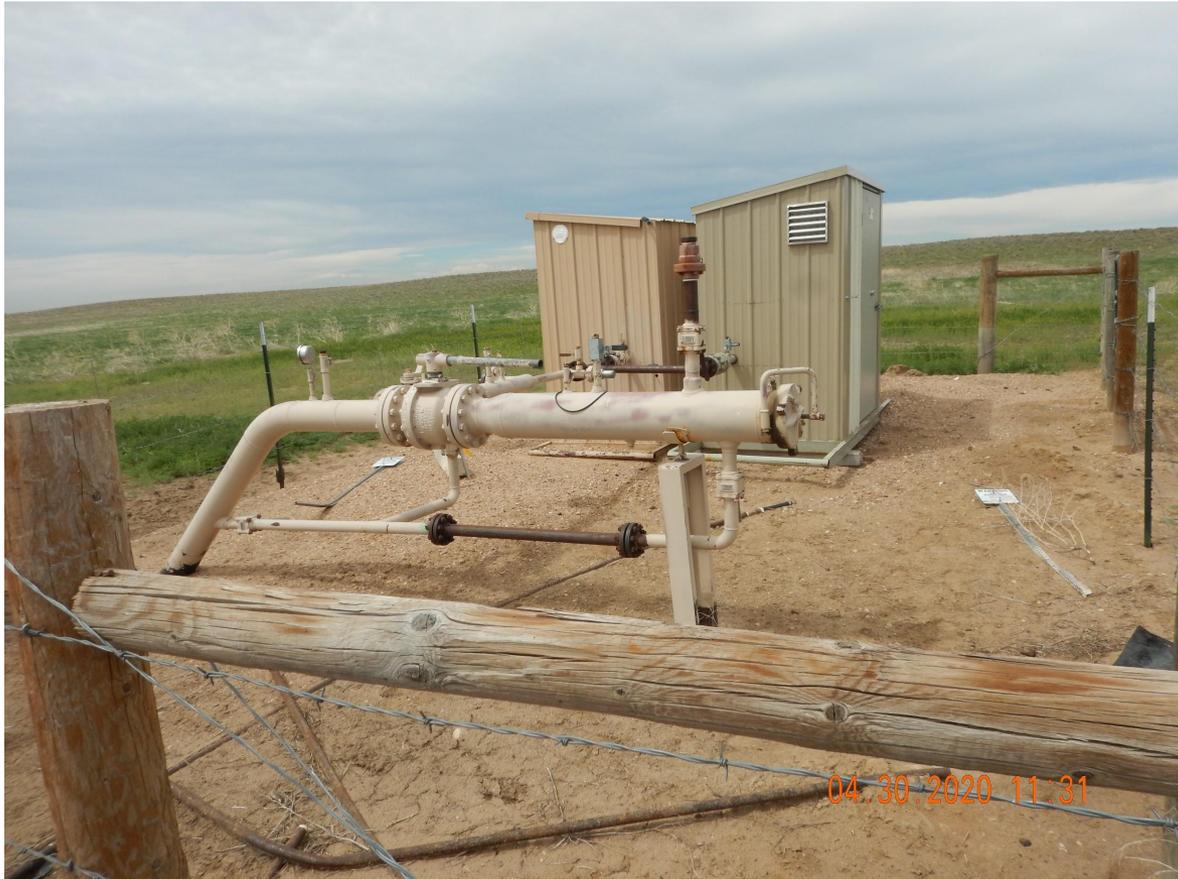
Photo 2. Photo taken from the associated offsite tank battery location, facing West. Photo illustrates Operator has failed to remove all equipment.

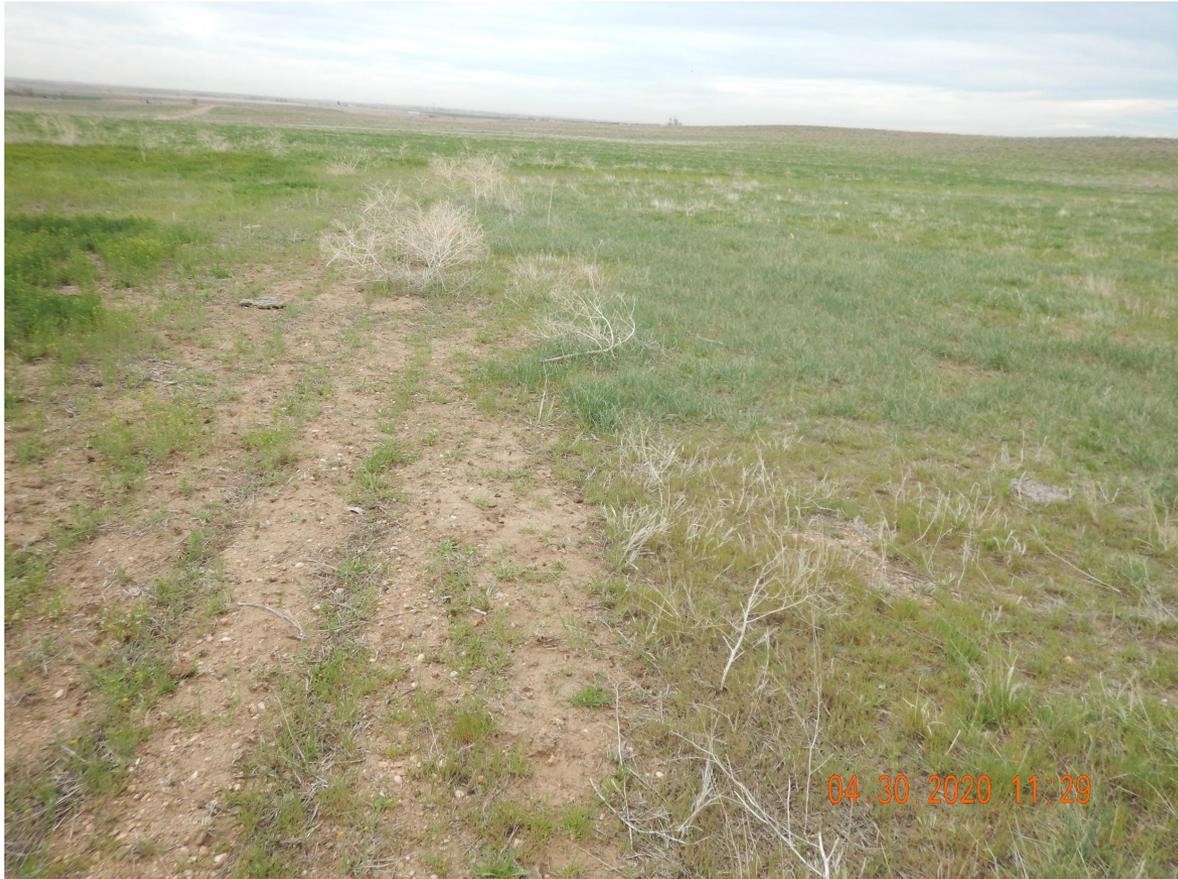
Photo 3. Photo taken from the western associated offsite tank battery location, facing South. Photo illustrates Operator performed final reclamation activities with the evidence of drill rows; however, location consists mostly of weedy, annual vegetation (cheatgrass and flixweed) and bare ground.
