Final Reclamation Inspection

Operator: PDC ENERGY INC - 69175

Location ID: 322943

Inspection Photos
Location Name: BECKER #5-1
Location ID: 322943

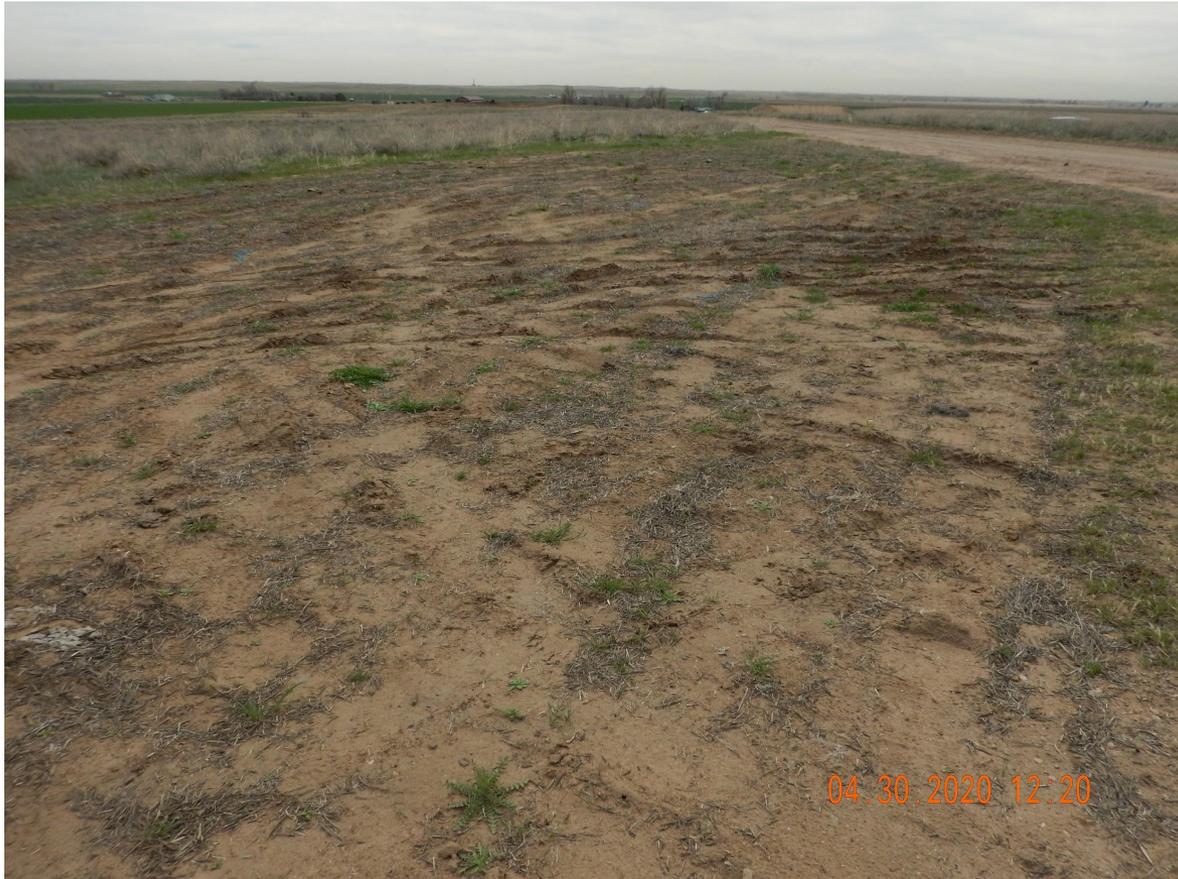
Photo 1. Photo taken from the well location, facing South. Photo illustrates the well location consists mostly of weedy, annual vegetation and bare ground. Appears vehicle traffic has potentially compacted the reclamation area and comprised the success of revegetation.

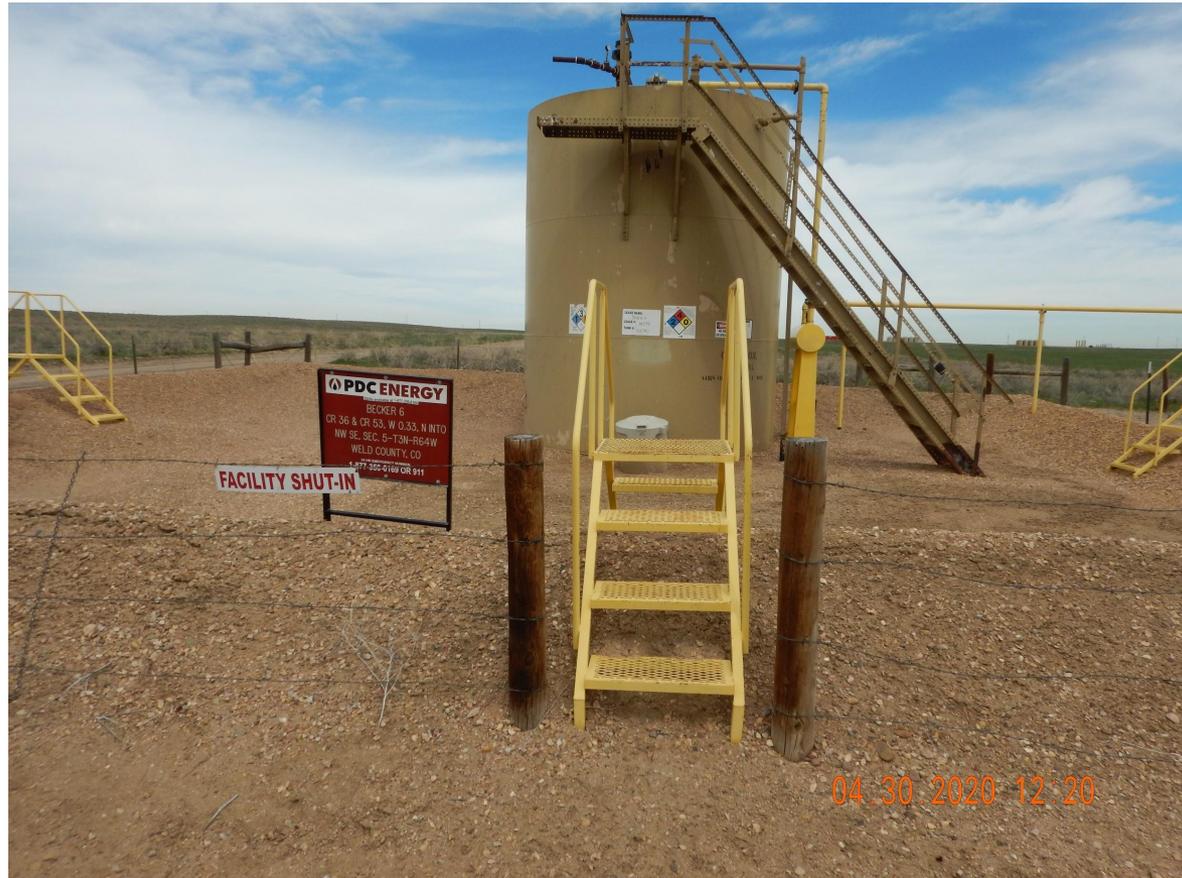
Photo 2. Photo taken from the associated tank battery, facing North. Photo illustrates the tank battery is still in use for another nearby well.
