Inspection Photos
Operator: BP America
API#: 067-05115
Date: 5/8/2020

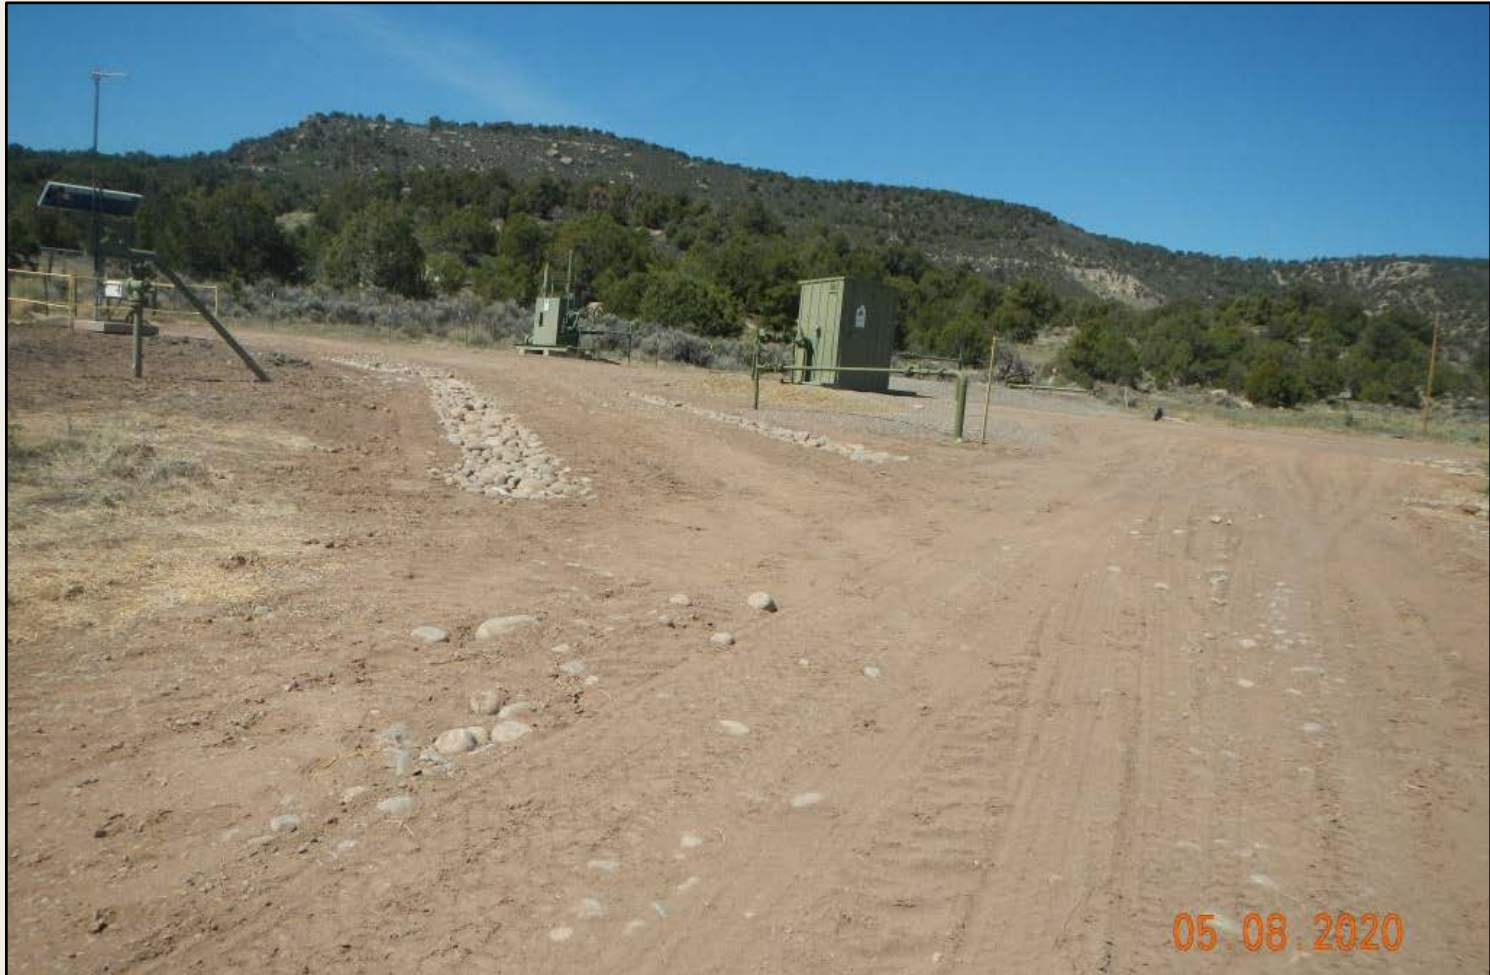
Photo 1. View of the southern project area from the well pad entrance facing center. Erosional channels are lined with rock, Russian thistle debris is removed.

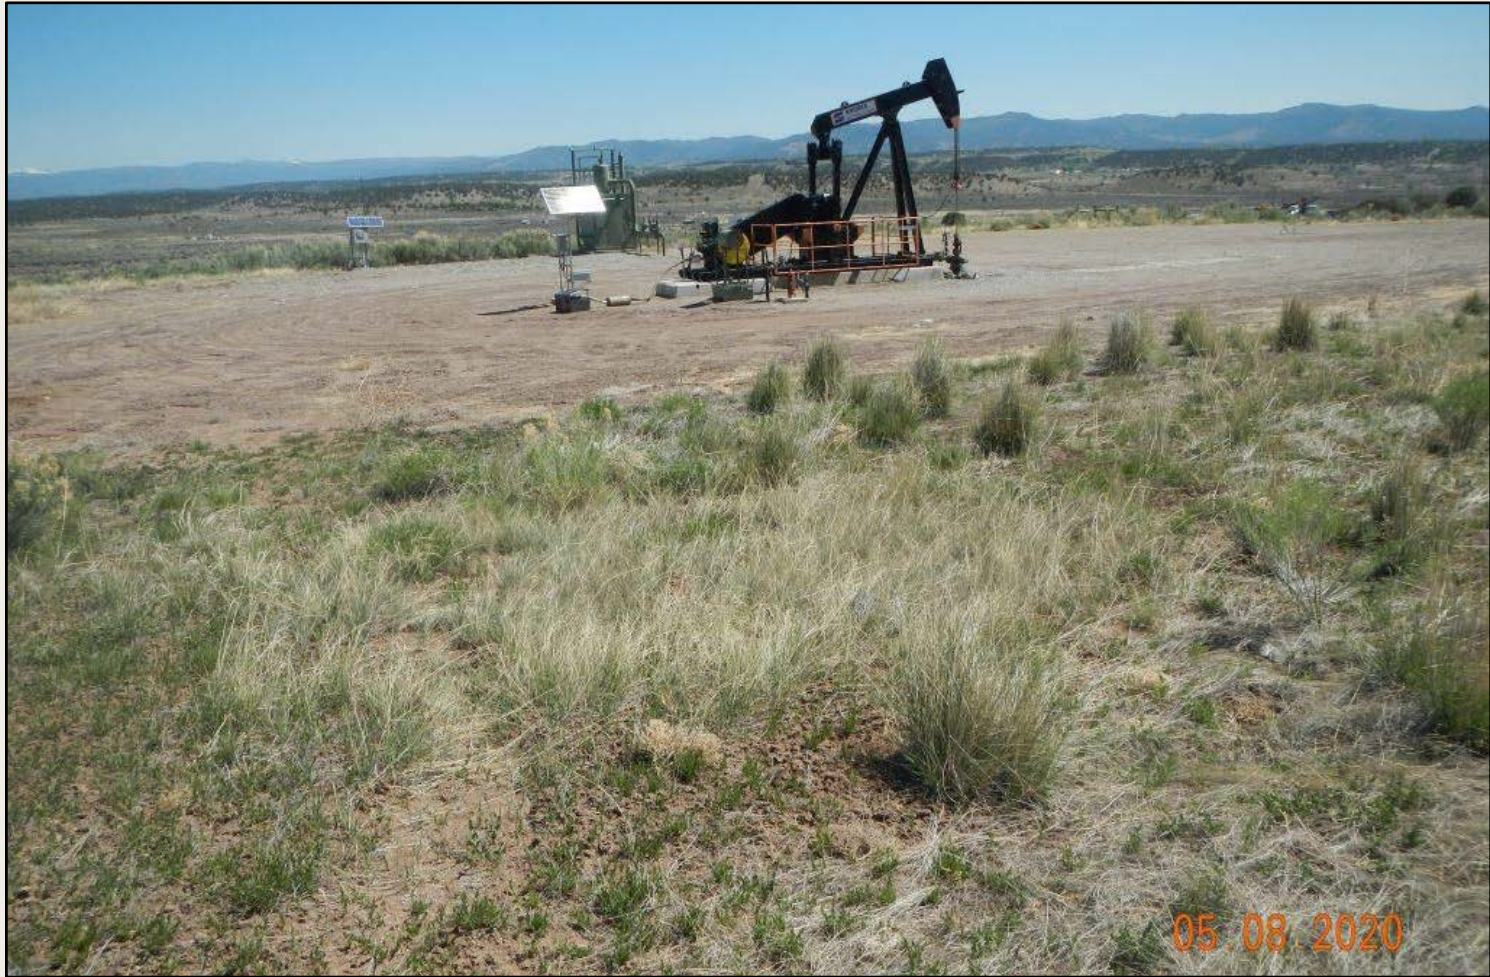
Photo 2. View of the northern well pad from the western edge facing center. Russian thistle debris is removed.

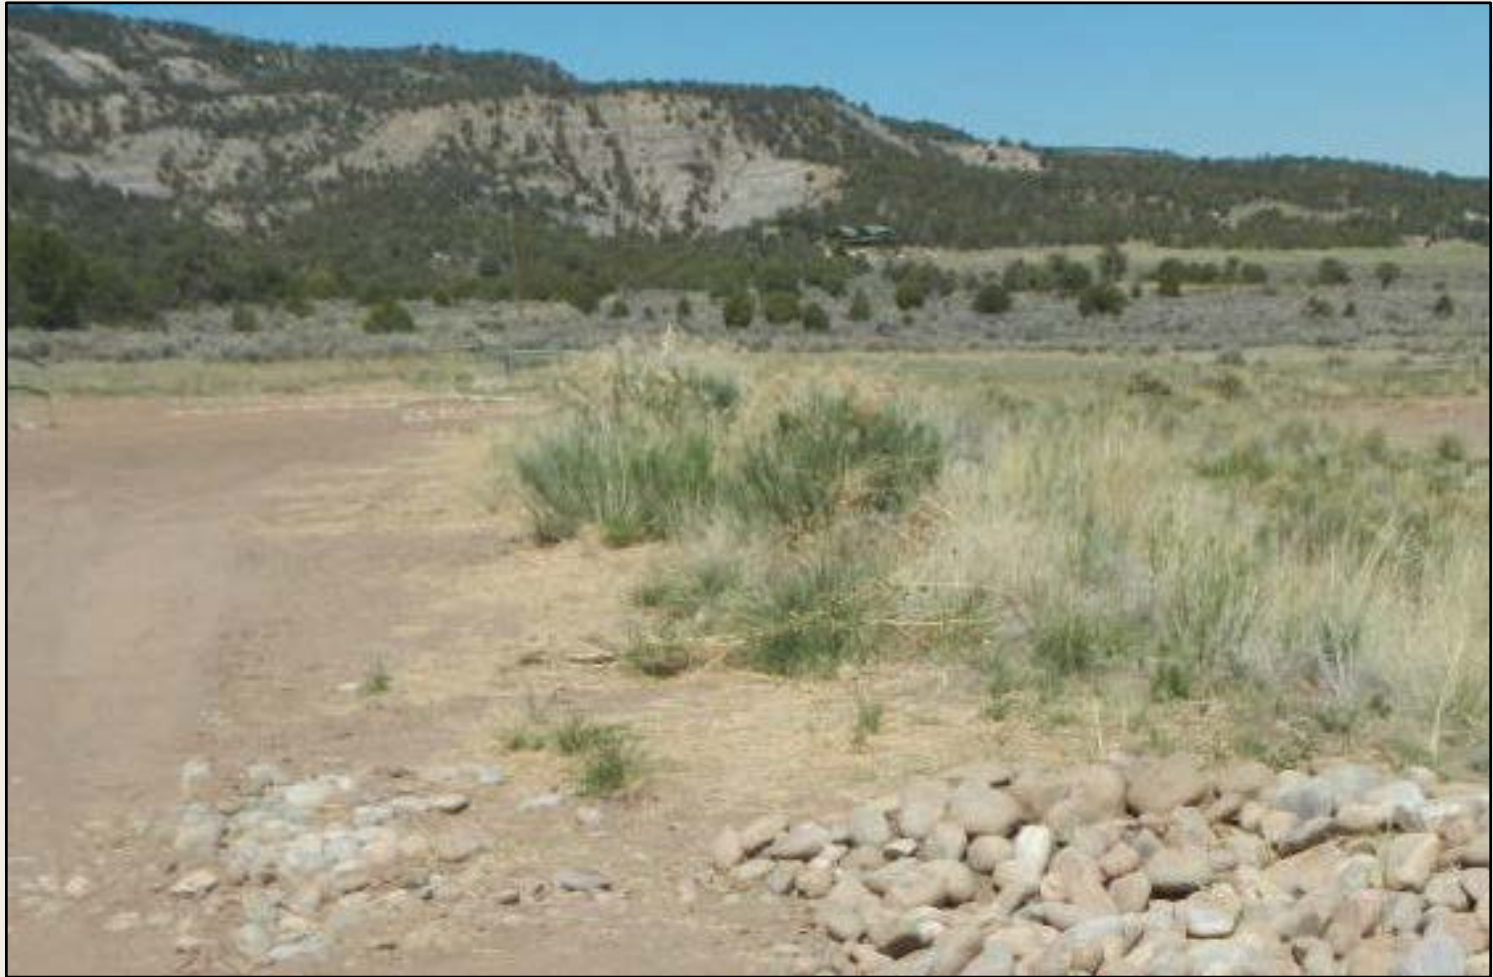
Photo 3. View of the central fill slope facing westward. Cobble lined rundowns placed in erosional features.

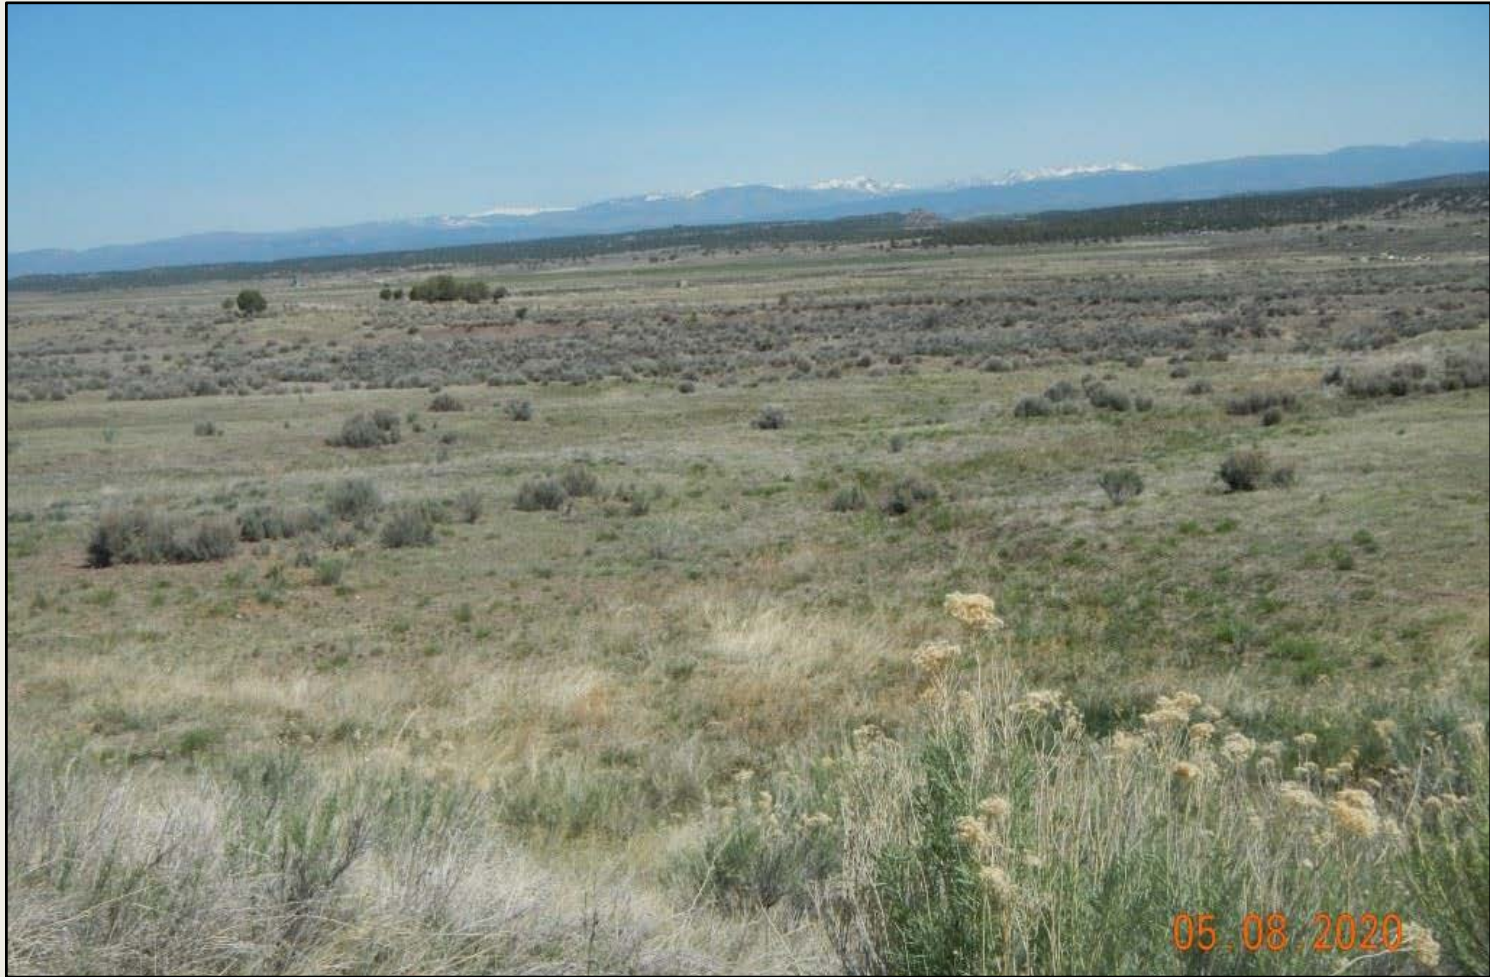
Photo 4. View of reference area comprised of open sagebrush shrubland with herbaceous understory (ie: western wheatgrass, blue grama)
