Inspection Photos

5/07/2020

Operator: CAERUS PICEANCE LLC # 10456

Location ID: 335809

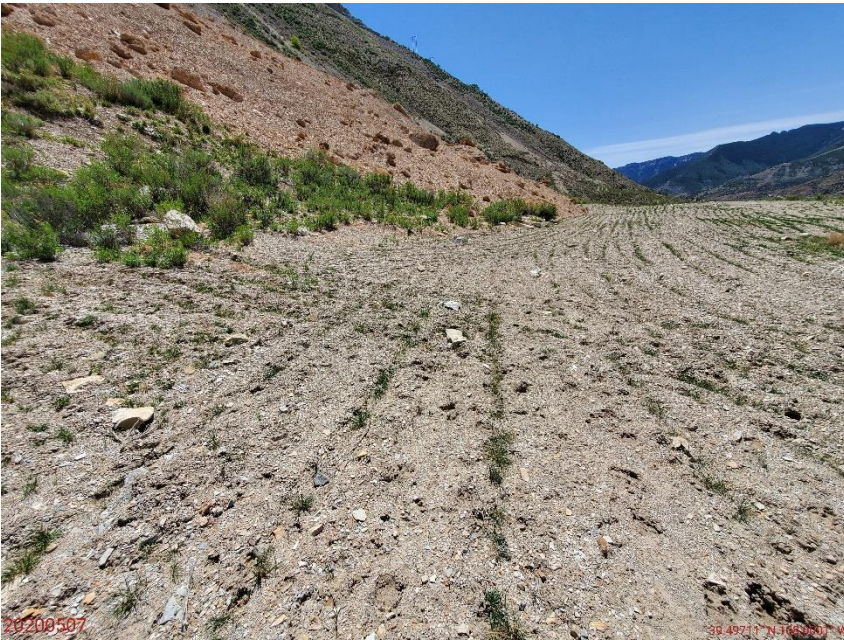
Photo 1: Photo taken from the north end of the Location, facing southeast. Photo shows Location remains flat, and has not been contoured in accordance with Rule 1004.a. Records indicate this is due to safety concerns regarding the stability of the adjacent landslide area.

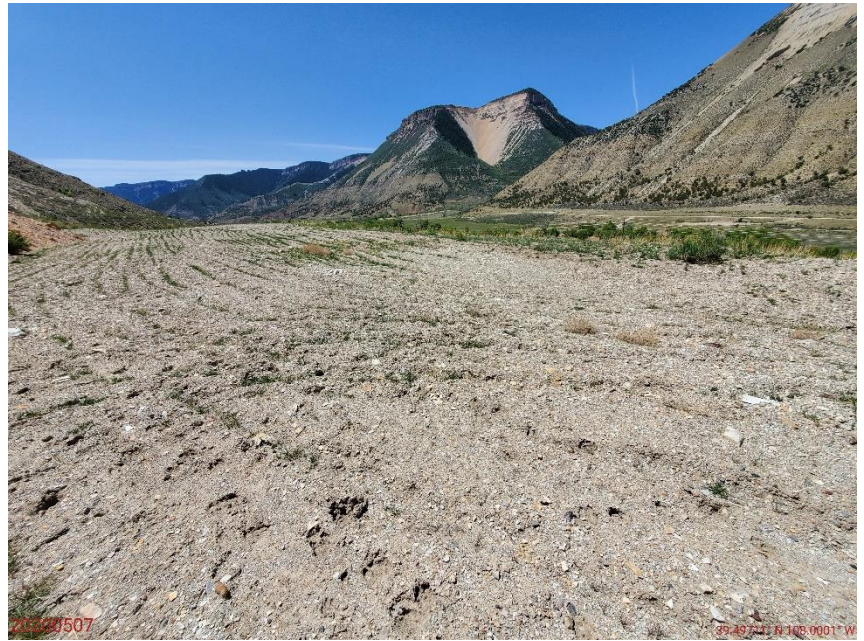
Photo 2: Photo taken from the north end of the Location, facing southwest. See comments under photo 1.

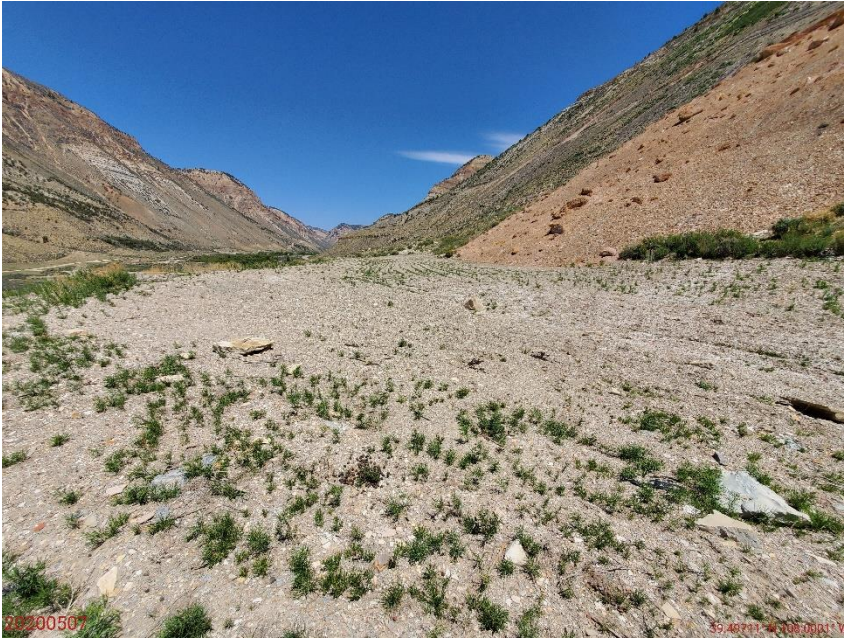
Photo 3: Photo taken from south end of the Location, facing north. Photo also shows large areas of the Location where vegetative establishment does not appear to be occurring

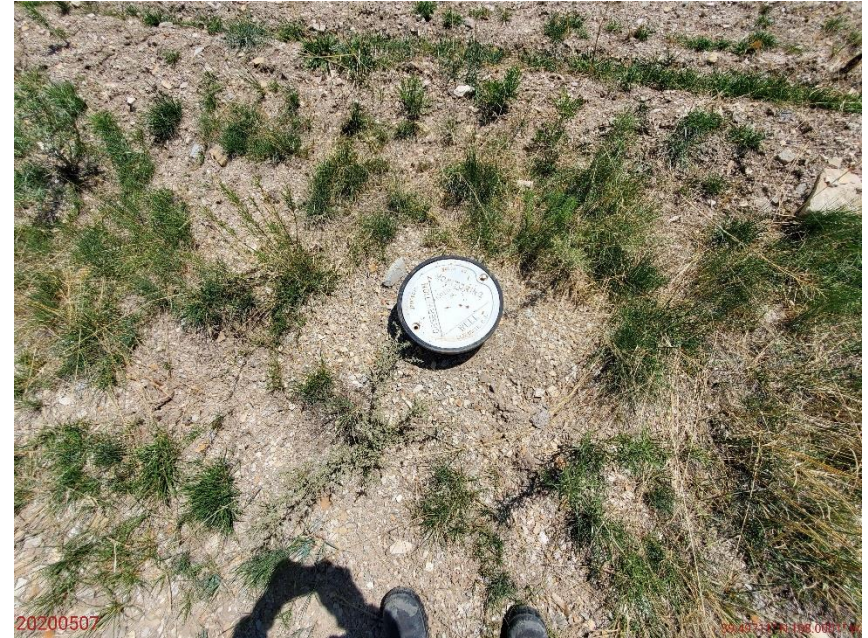
Photo 4: Photo taken from the south end of the Location. Photo shows what appears to be an inclinometer installed to monitor seismic and surface movement conditions of the Location.

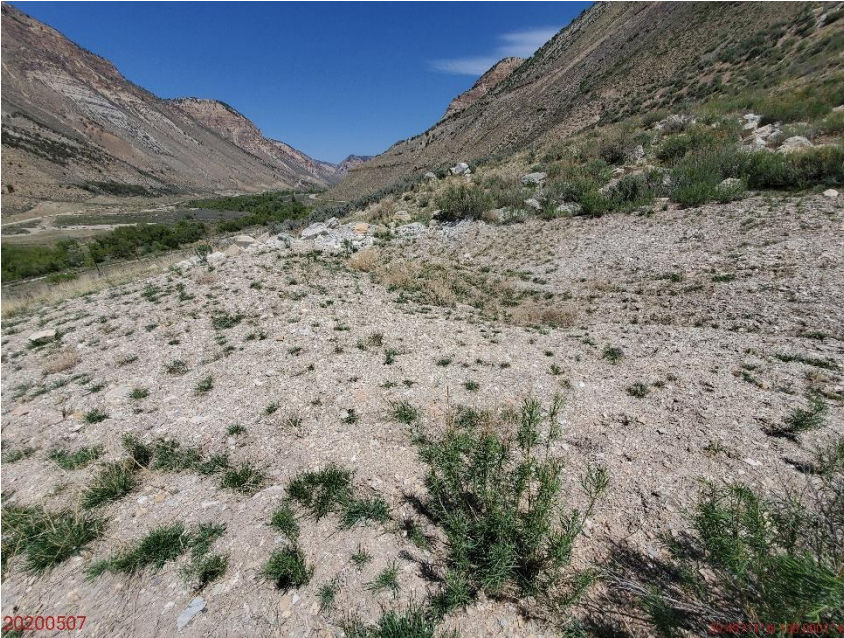
Photo 5: Photo taken from the north end of the Location, facing north. Photo shows area where access road meets location.

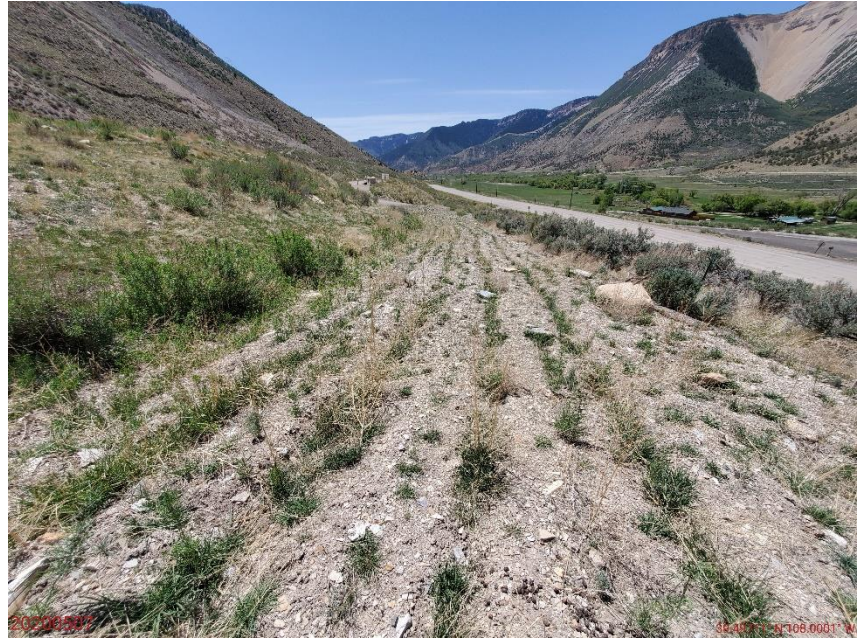
Photo 6: Photo taken from access road, facing south. Photo shows vegetative establishment on the access road.
